**AERIAL ASSESSMENT OF ACID SULFATE SOILS HAZARDS
ALONG THE DARLING RIVER CORRIDOR, WESTERN
NEW SOUTH WALES**

Summary report of aerial assessment conducted 19th – 21st September 2008

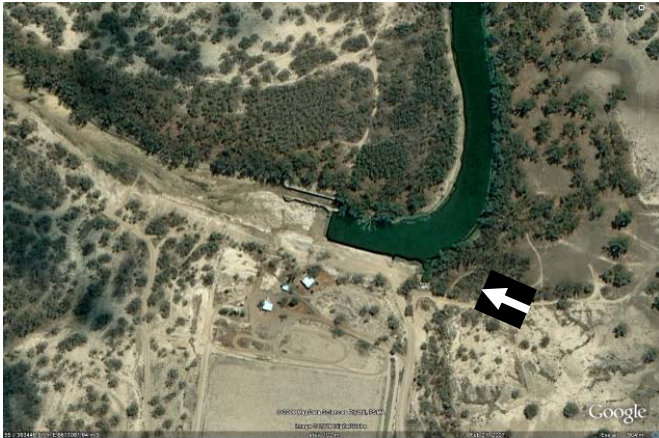
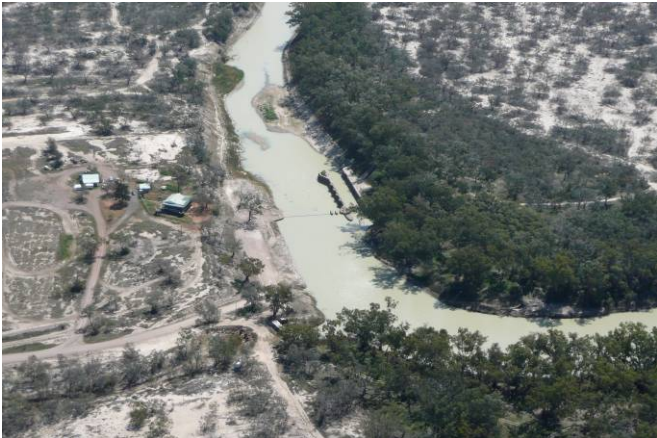
Site name	Site location	Visual ASS risk	CNES/SPOT image	Oblique aerial photograph
A. Bourke Weir	Darling River Zone 55, 393446 E, 6671081 S	Low to moderate – nearly permanent inundation? Predominantly living trees on banks.	27 th February 2007, Digital Globe

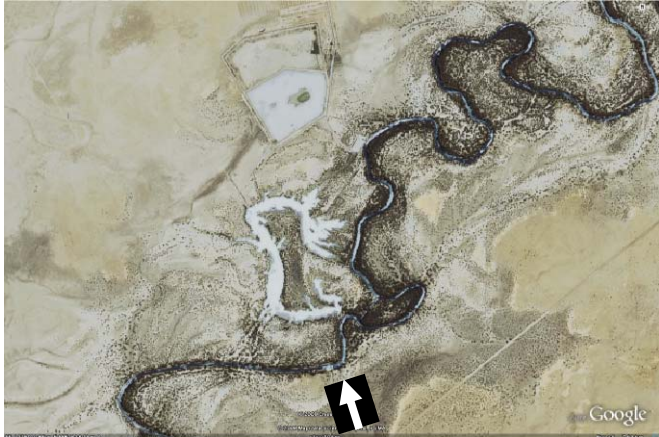
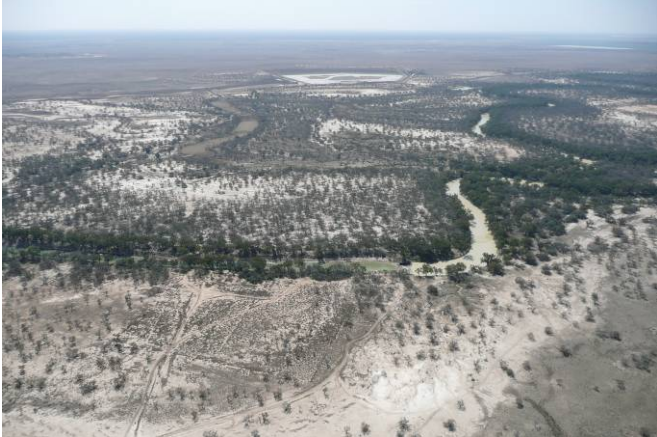
B. Weir near Orange Tree Lagoon	Darling River Zone 55, 376020 E, 6654628 S	Low to moderate – colour difference between water upstream (turbid) and downstream (clear); possible indication of salinity? Predominantly living trees on banks.	Unknown image acquisition date, Digital Globe

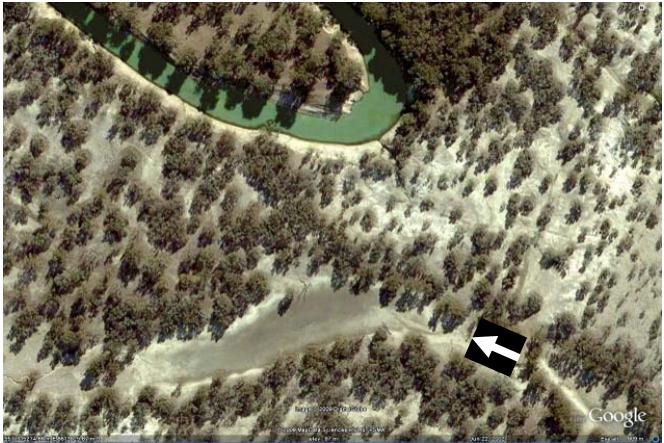
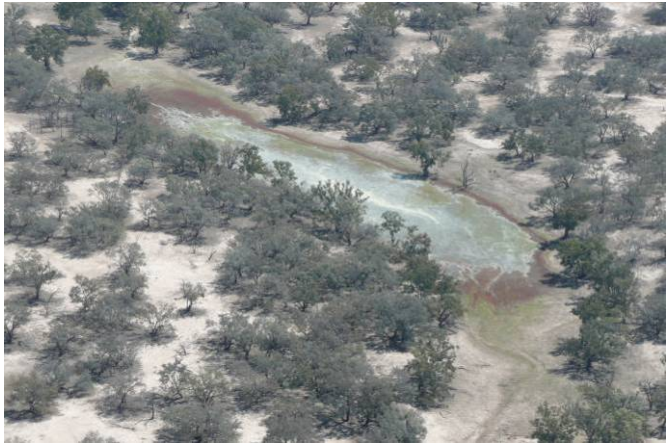
Site name	Site location	Visual ASS risk	CNES/SPOT image	Oblique aerial photograph
C. Abandoned meander ~7.5 km southwest of Louth	Darling River floodplain Zone 55, 315274 E, 6613925 S	Low – some discolouration at margins due to aquatic vegetation; predominantly living trees on banks.	22 nd June 2002, Digital Globe

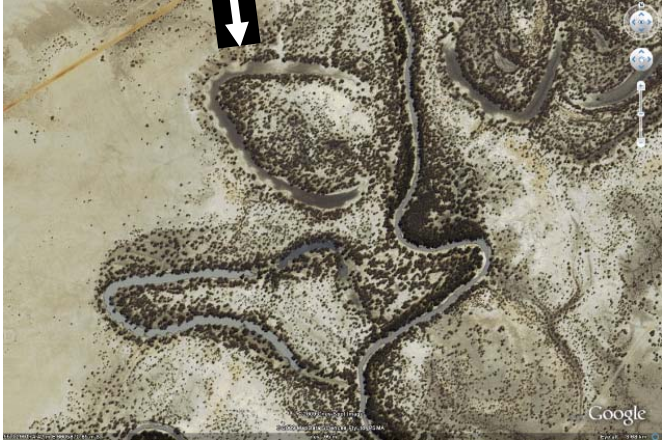
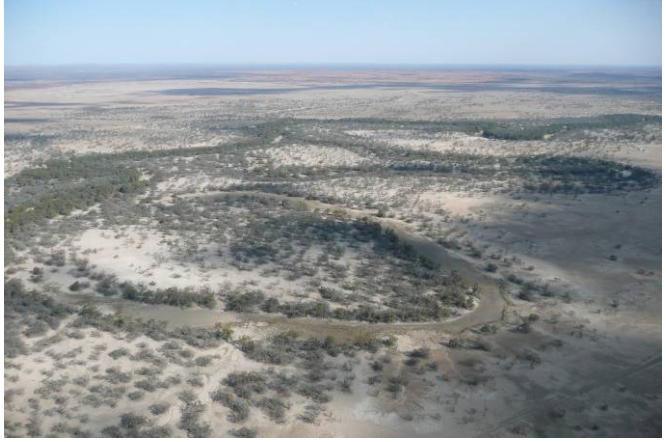
D. Abandoned meander ~27 km southwest of Louth	Darling River floodplain Zone 55, 299174 E, 6605870 S	Low – some discolouration; predominantly living trees on banks.	Unknown image acquisition date, Digital Globe

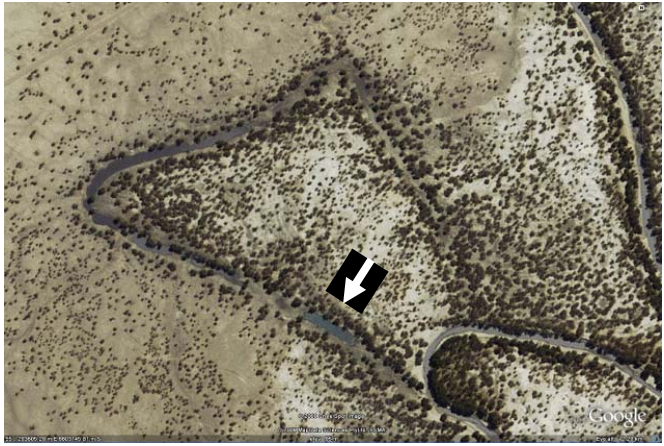
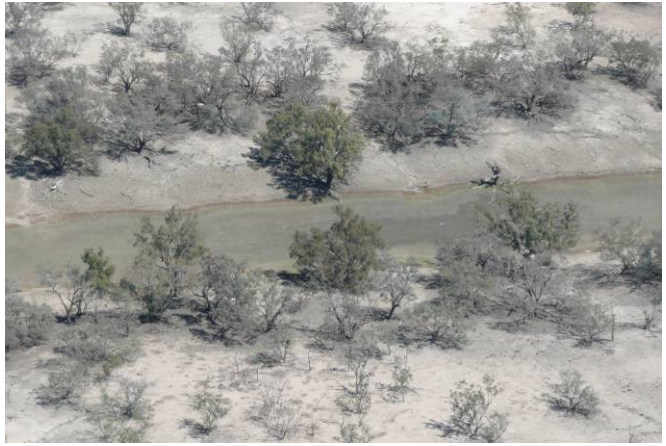
Site name	Site location	Visual ASS risk	CNES/SPOT image	Oblique aerial photograph
E. Abandoned meander ~35 km southwest of Louth	Darling River floodplain Zone 55, 293605 E, 6603145 S	Low – some discolouration at margins due to aquatic vegetation; predominantly living trees on banks.	Unknown image acquisition date, Digital Globe

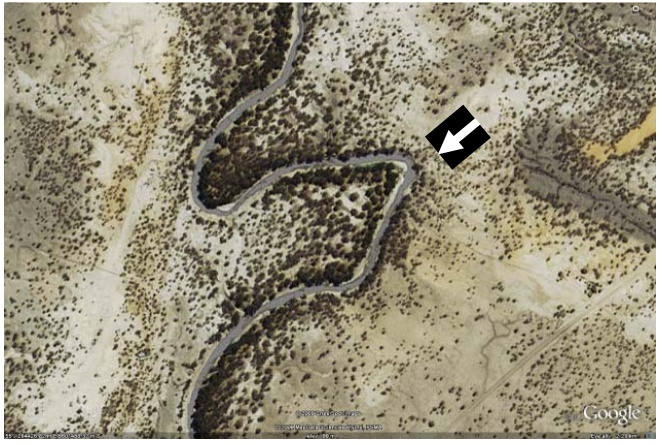
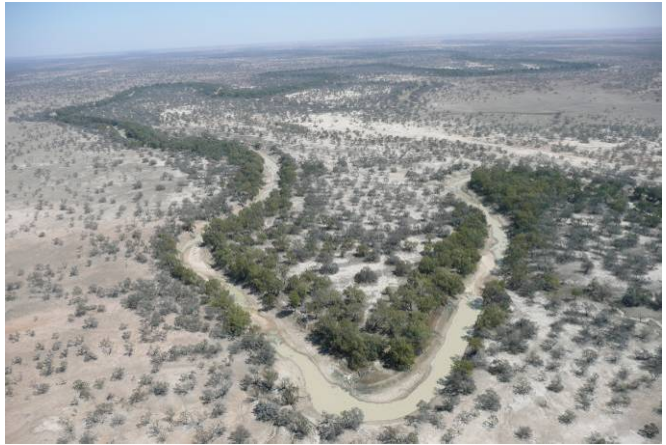
F. Meander ~36 km southwest of Louth	Darling River Zone 55, 294426 E, 6601488 S	Low – no discolouration; predominantly living trees on banks.	Unknown image acquisition date, Digital Globe

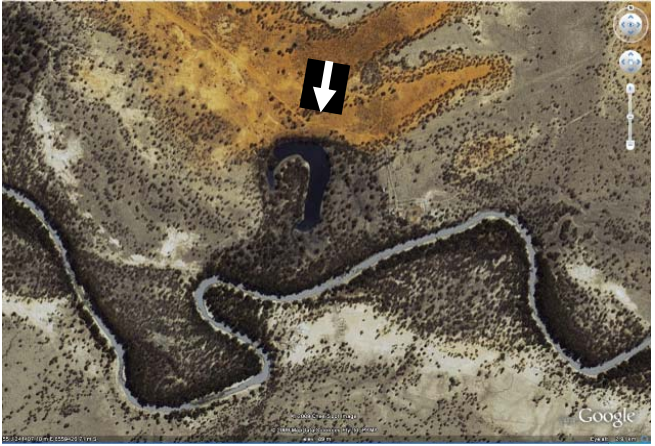
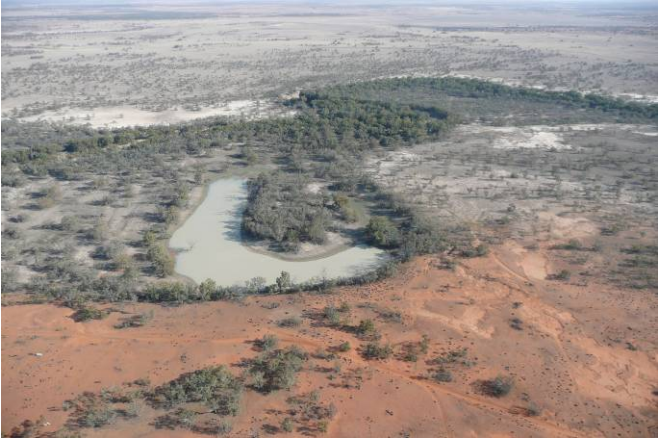
Site name	Site location	Visual ASS risk	CNES/SPOT image	Oblique aerial photograph
G. Abandoned meander ~22 km southwest of Tilpa	Darling River floodplain Zone 55, 241407 E, 6559426 S	Low – no discolouration (red sand dunes at northern margin); predominantly living trees on banks.	Unknown image acquisition date, Digital Globe

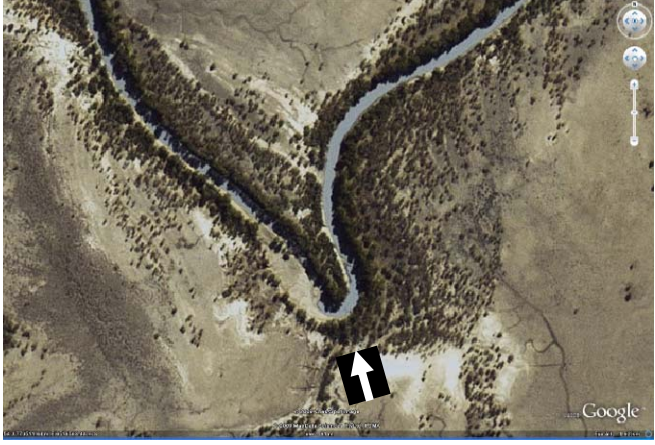
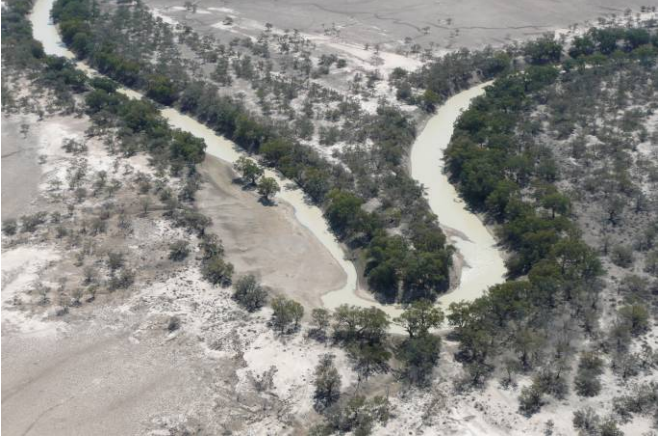
H. Meander ~87 km southwest of Tilpa	Darling River Zone 54, 773511 E, 6518563 S	Low – no discolouration in channel, some scalding on floodplain; predominantly living trees on banks.	Unknown image acquisition date, Digital Globe

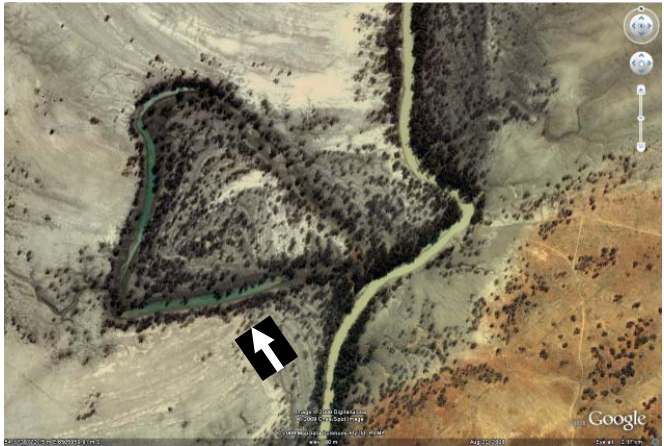
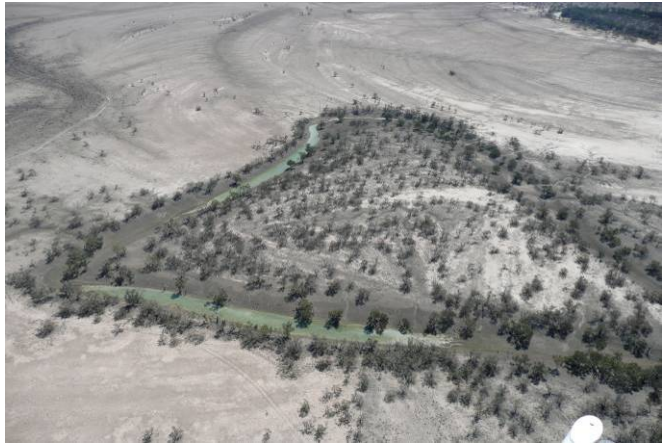
Site name	Site location	Visual ASS risk	CNES/SPOT image	Oblique aerial photograph
I. Abandoned meander ~16 km northeast of Wilcannia	Darling River floodplain Zone 54, 738770 E, 6505959 S	Low – some discolouration at margins due to aquatic vegetation; predominantly living trees on banks.	20 th August 2008, Digital Globe

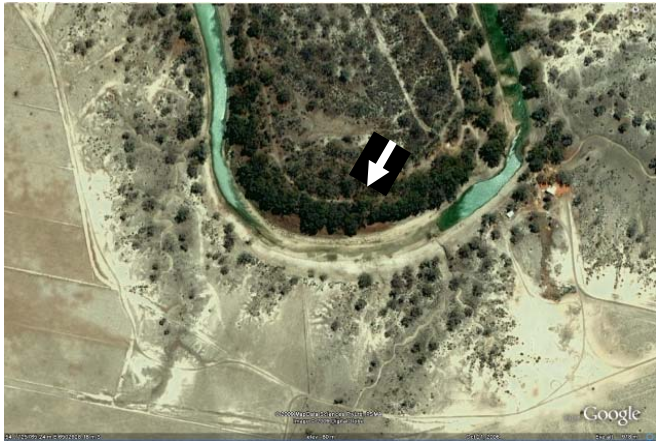
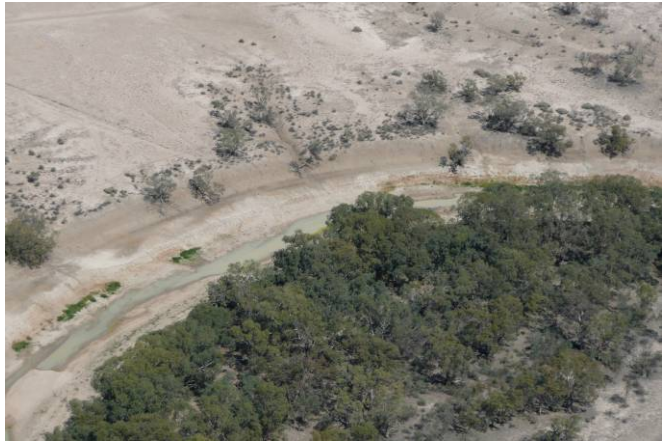
Sites overpassed that were of little note were too numerous to record, but examples of these and key sites of 'low' and 'low to moderate' ASS hazards (qualitative ranking from visual assessment) are given in Table 1. Sites including Bourke Weir and Balaka Lake were deemed to have 'low to moderate' likelihood of ASS hazard due to their probable regular or prolonged inundation. Some abandoned meanders and floodplain depressions near Louth, Tilpa, Wilcannia, Menindee and Pooncarie showed signs of orange/red/green colouration. However, once one site was checked on the ground (site M), this type of colouration was noted to be caused by wet and/or dry aquatic vegetation (e.g. azolla) at the sites. All the recorded sites had living trees (river red gums) around their margins, indicating reasonable ecosystem health. One meander near Wilcannia (site J) showed signs of orange seepage on one bank and was situated next to an old irrigation block.

J. Meander ~3 km south of Wilcannia	Darling River Zone 54, 725765 E, 6502928 S	Low to moderate – some discolouration at margin due to saline seepage from adjoining irrigation block? Predominantly living trees on banks.	21 st October 2006, Digital Globe

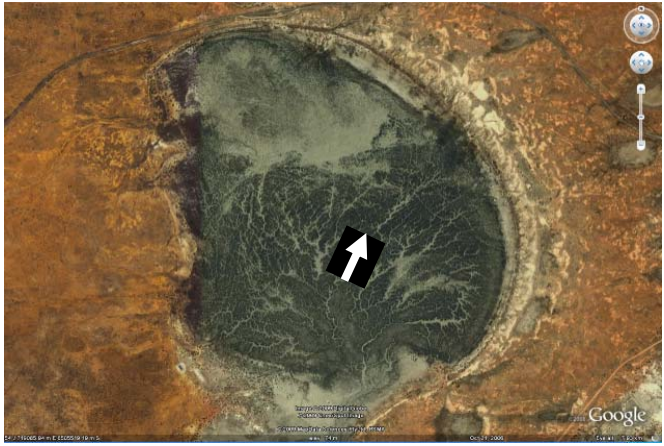
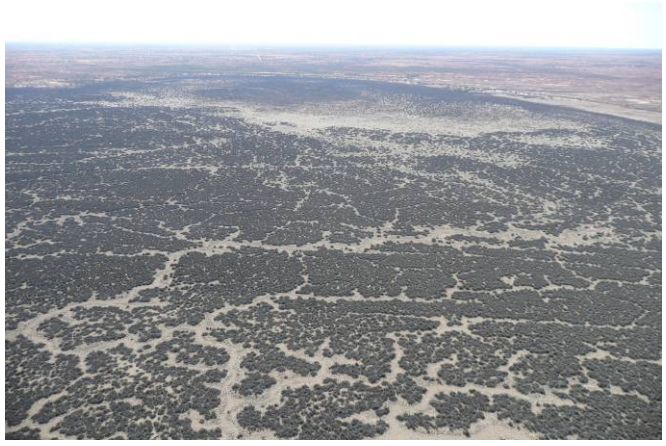
Site name	Site location	Visual ASS risk	CNES/SPOT image	Oblique aerial photograph
K. Lake Woytchugga	Darling River floodplain (playa lake) Zone 54, 719085 E, 6505519 S	Low – living vegetation on dry lake bed.	21 st October 2006, Digital Globe

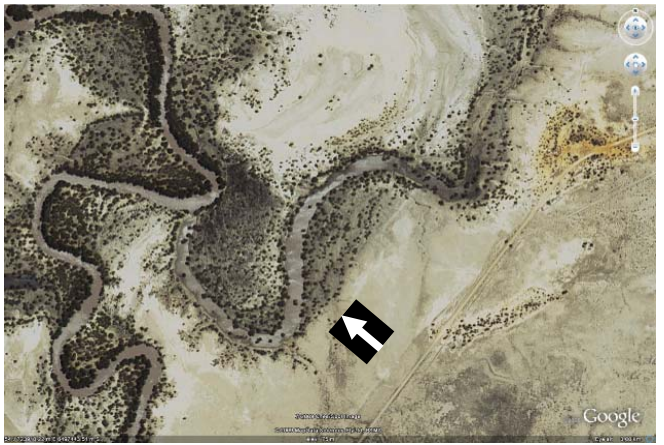
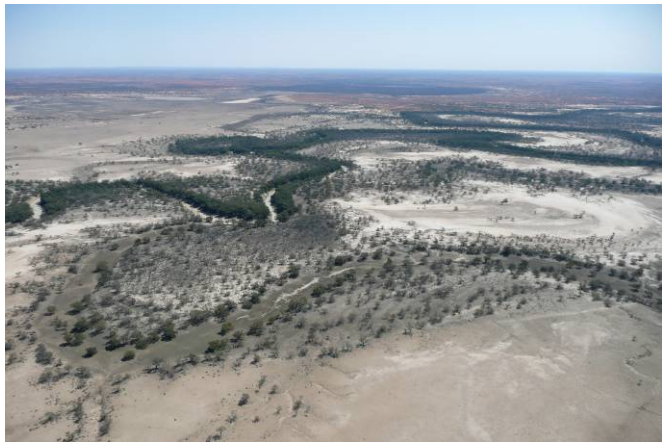
L. Abandoned meander ~9.5 km south of Wilcannia	Darling River floodplain Zone 54, 723918 E, 6497443 S	Low – some discolouration at margins due to aquatic vegetation; predominantly living trees on banks.	Unknown image acquisition date, Digital Globe

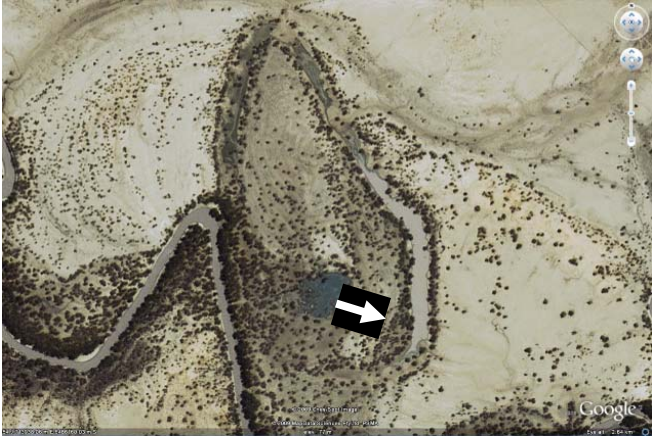
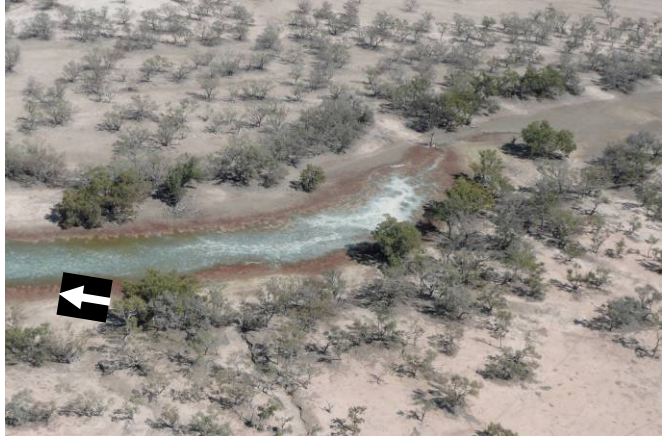
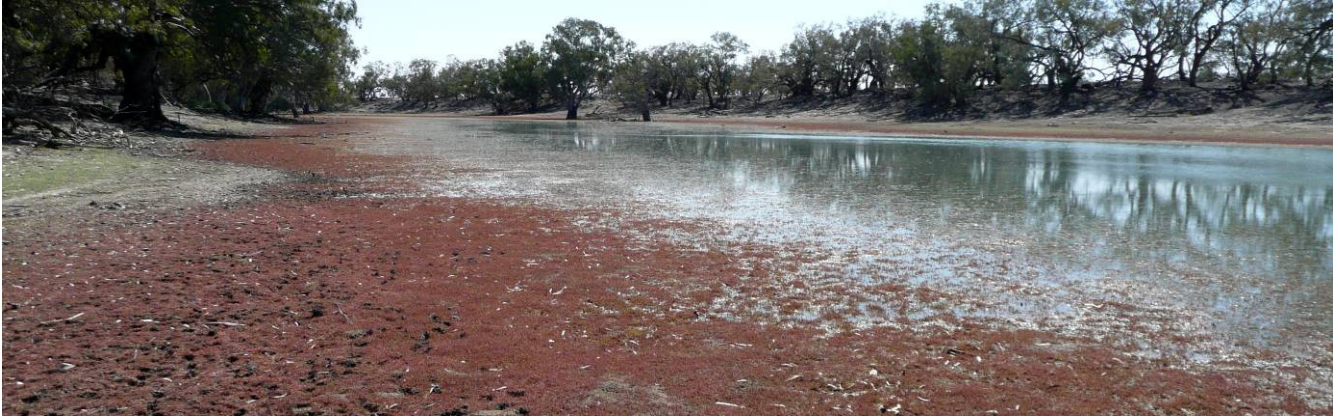
Site name	Site location	Visual ASS risk	CNES/SPOT image	Oblique aerial photograph
M. Abandoned meander ~26 km southwest of Wilcannia	Darling River floodplain Zone 54, 713938 E, 6486160 S	Low – some discolouration at margins due to aquatic vegetation; predominantly living trees on banks.	Unknown image acquisition date, Digital Globe

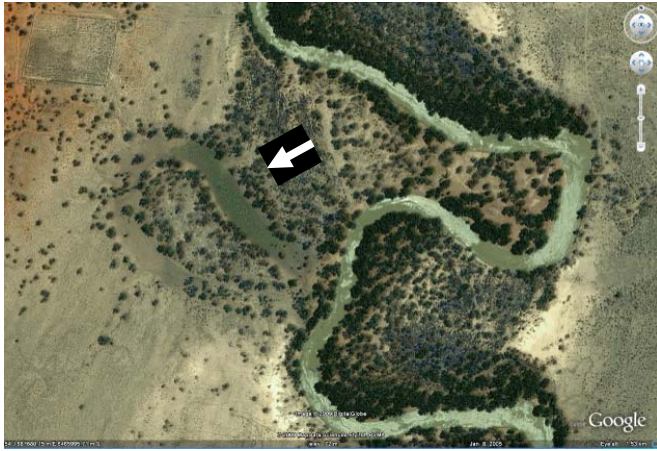
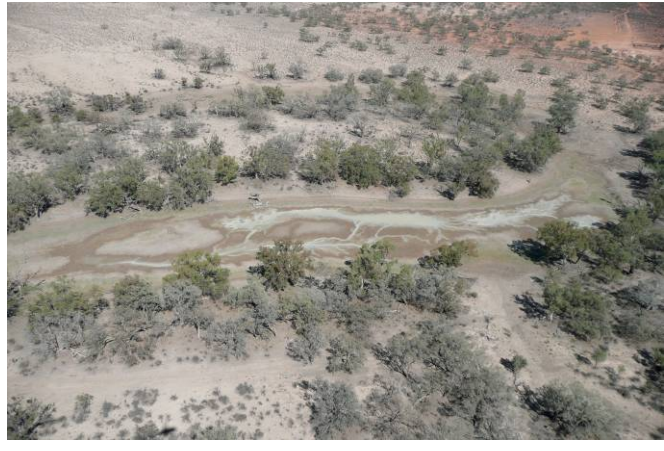
Site name	Site location	Visual ASS risk	CNES/SPOT image	Oblique aerial photograph
N. Abandoned meander ~63 km southwest of Wilcannia	Darling River floodplain Zone 54, 687680 E, 6465995 S	Low – some discolouration at margins due to aquatic vegetation; predominantly living trees on banks.	8 th January 2005, Digital Globe

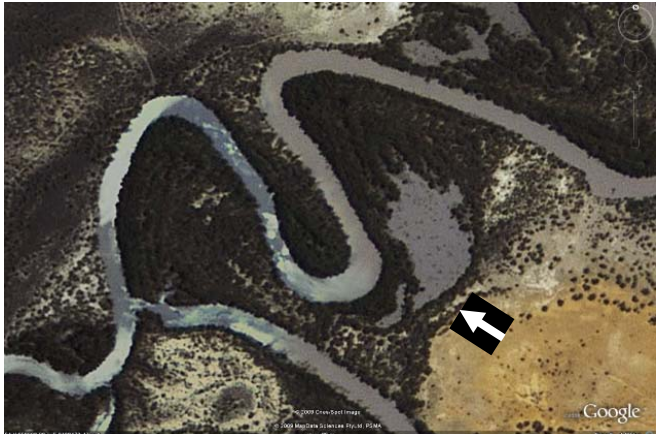
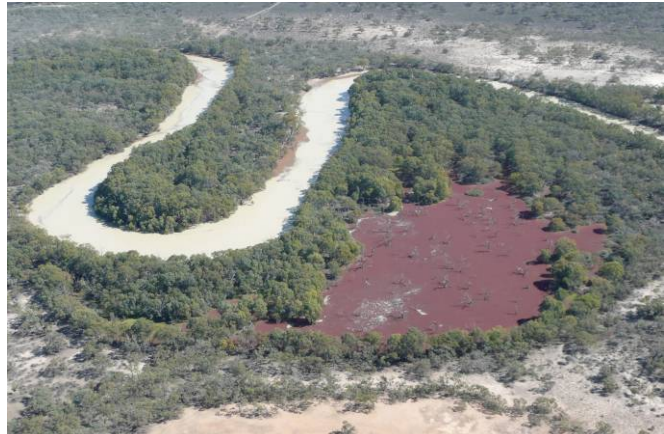
O. Floodplain depression ~36 km northeast of Menindee	Darling River floodplain Zone 54, 659003 E, 6436472 S	Low to moderate – red aquatic vegetation, nearly permanently inundated? Predominantly living trees at margins.	Unknown image acquisition date, Digital Globe

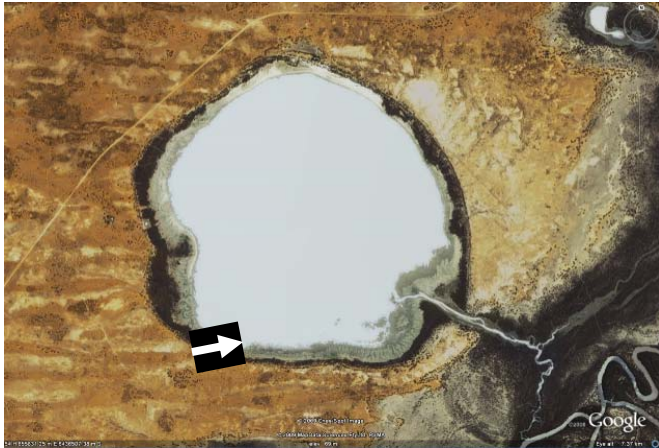
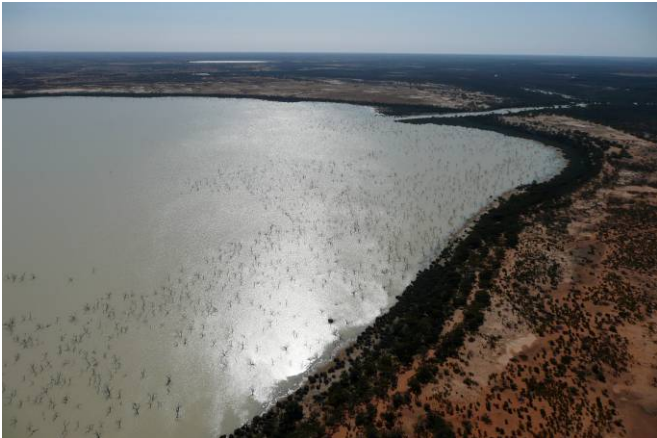
Site name	Site location	Visual ASS risk	CNES/SPOT image	Oblique aerial photograph
P. Balaka Lake	Darling River floodplain (playa lake) Zone 54, 655831 E, 6436507 S	Low to moderate – regularly inundated? Predominantly living vegetation at margins.	Unknown image acquisition date, Digital Globe

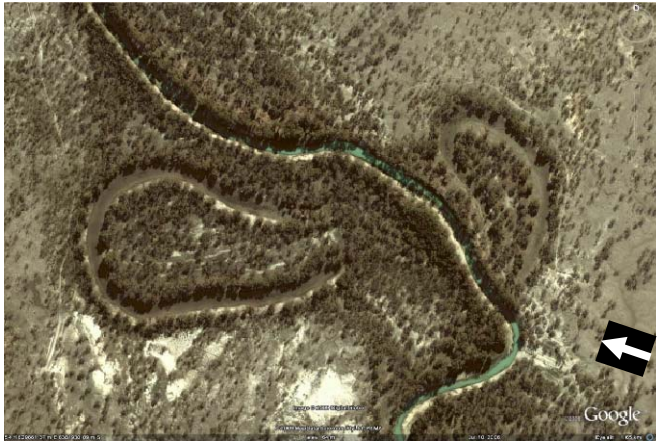
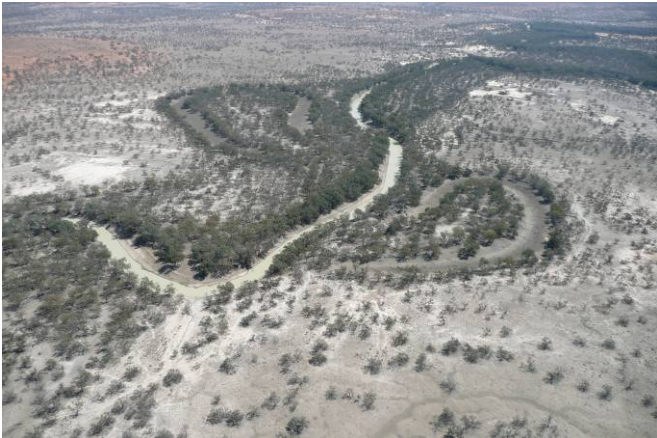
Q. Abandoned meanders ~38 km south of Menindee	Darling River floodplain Zone 54, 629661 E, 6381930 S	Low – no discolouration; predominantly living trees on banks.	10 th July 2006, Digital Globe

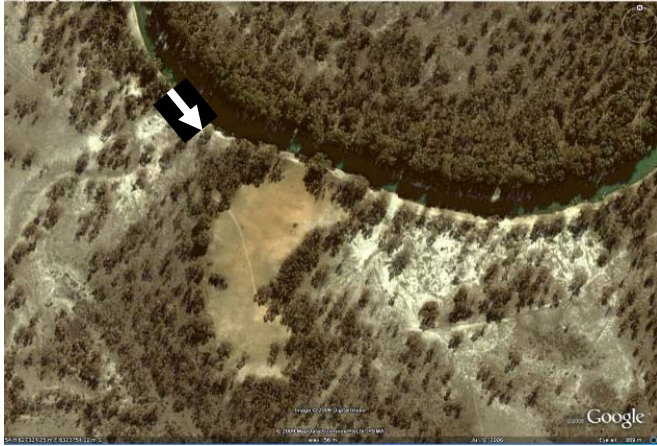
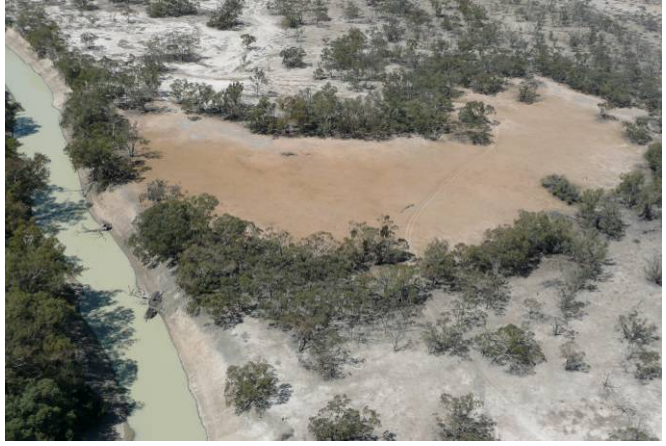
Site name	Site location	Visual ASS risk	CNES/SPOT image	Oblique aerial photograph
R. Floodplain depression ~26 km northwest of Pooncarie	Darling River floodplain Zone 54, 627321 E, 6323751 S	Low – some discolouration; predominantly living trees at margins.	10 th July 2006, Digital Globe

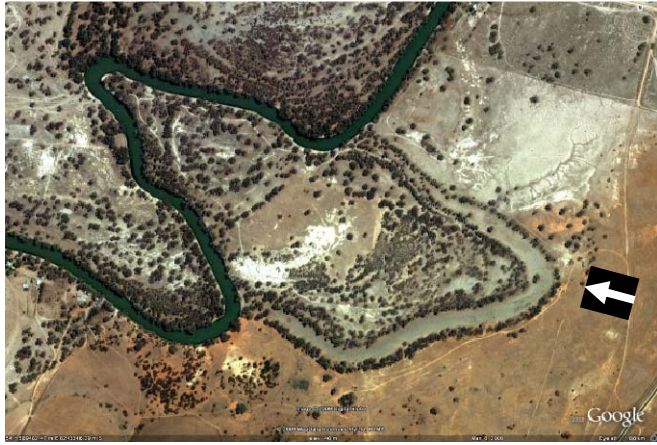
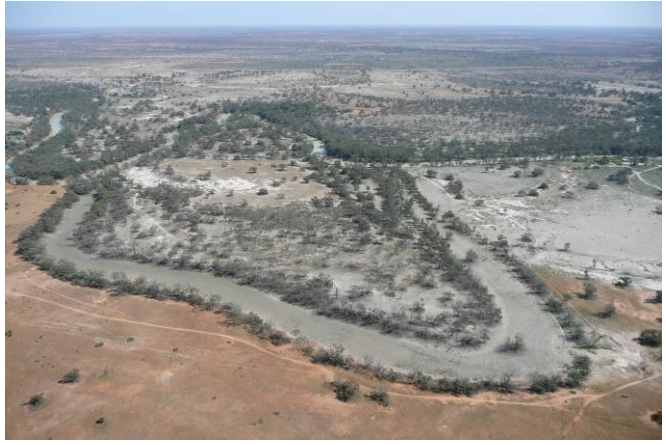
S. Andruco Lagoon	Darling River floodplain Zone 54, 589926 E, 6243053 S	Low – no discolouration; predominantly living trees on banks.	6 th March 2006, Digital Globe
