Assessment of Acid Sulfate Soil Materials in the Mildura Region of the Murray-Darling Basin.

N.J. Ward, R.T. Bush, L.A. Sullivan, P. Cheeseman, R. McGrath,
D.M. Fyfe, J. Coughran and V.N.L. Wong

FINAL REPORT

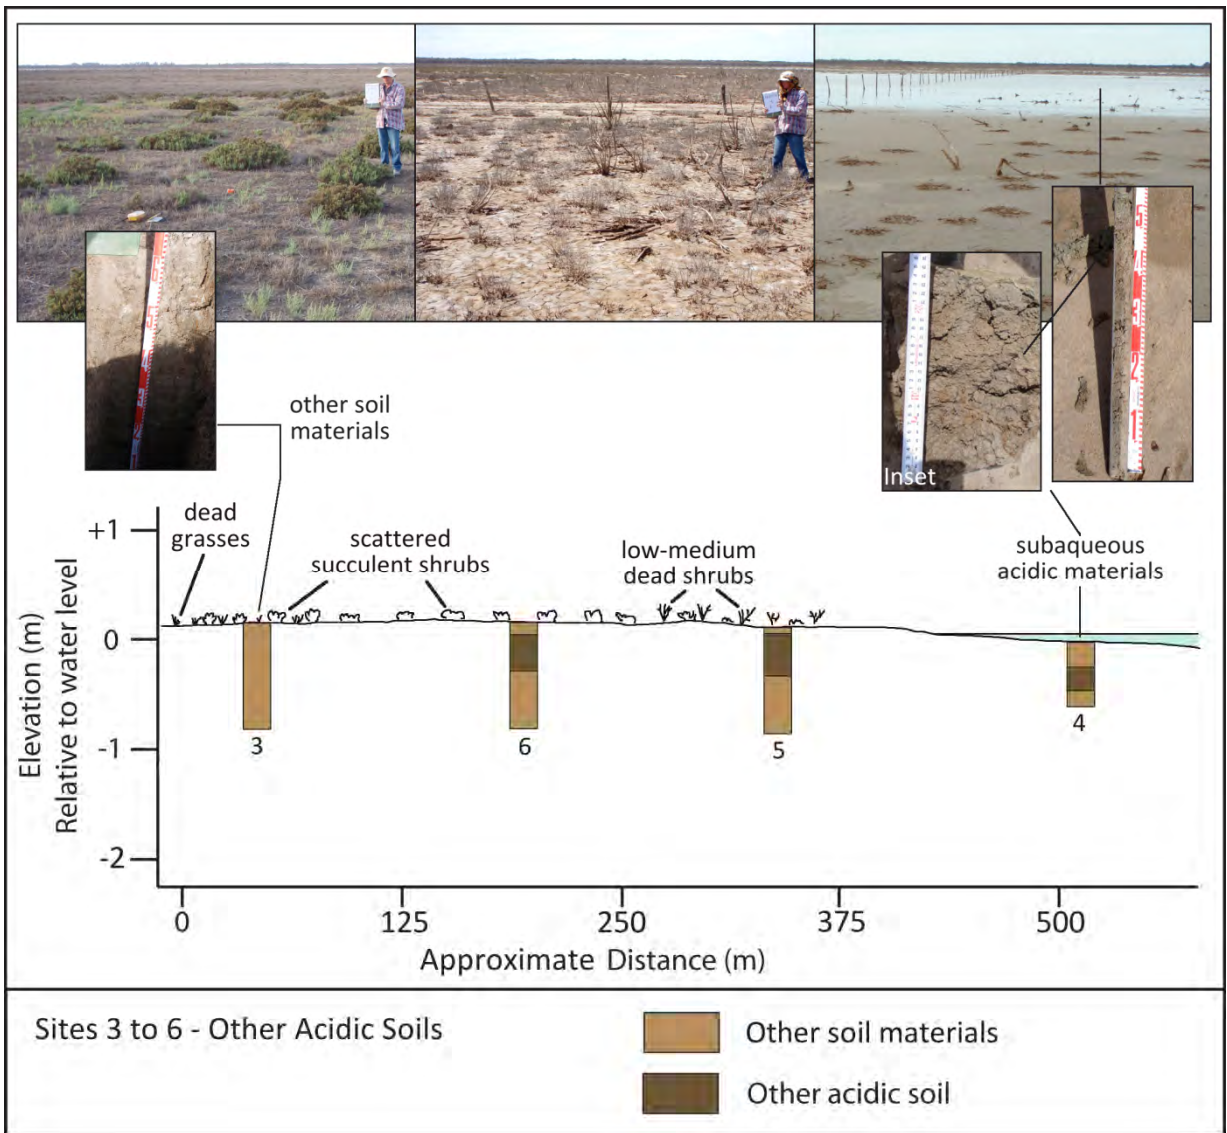
Figure 8-2. Conceptual cross section diagram showing the toposquence relationship of the Karadoc Swamp Wetland sediments/soil materials throughout the wetland.

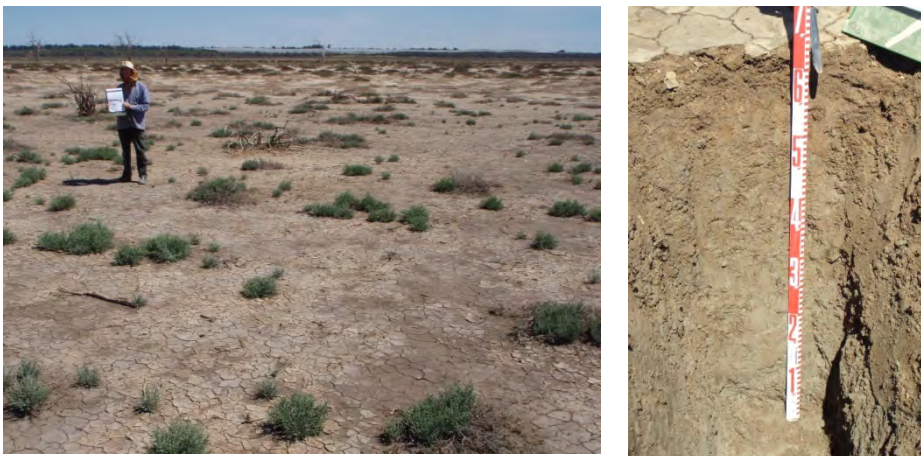
Figure 8-3. Photographs of site 40156_1, showing the bare cracking clay surface with salt visible, low succulent shrubs to 20 cm, and the soil profile.

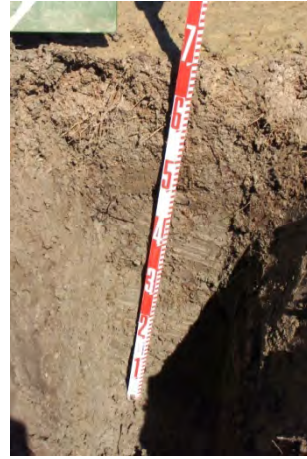
Figure 8-4. Photographs of site 40156_2, showing the denser succulent vegetation and surface pooling, and the soil profile.

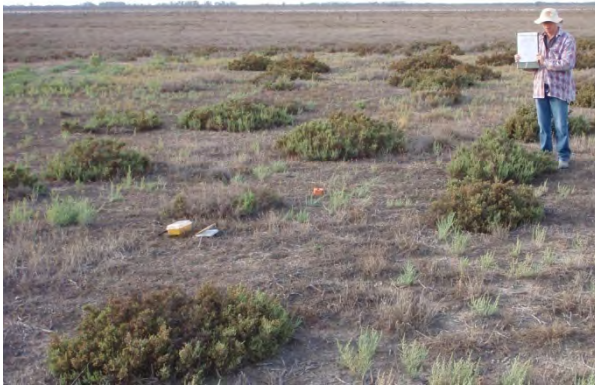
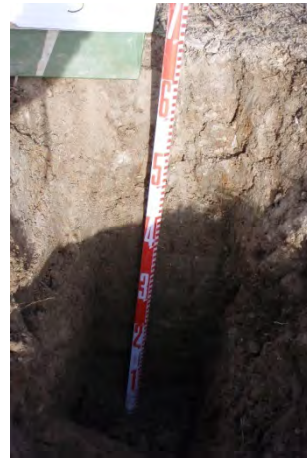
Figure 8-5. Photographs of site 40156_3, showing the dry, cracking surface and sparse succulent vegetation amongst a matrix of dry grasses and forbs, and the soil profile.

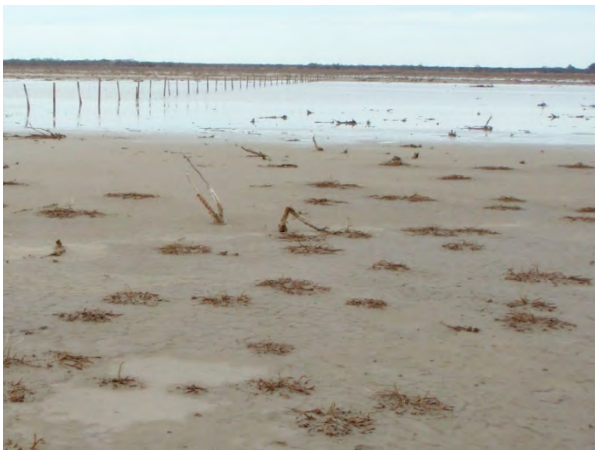
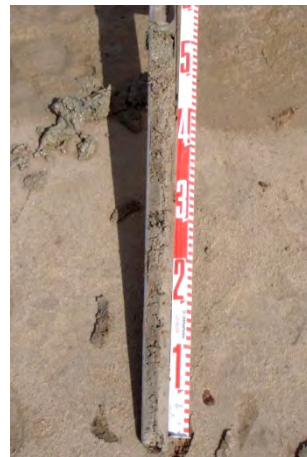
Figure 8-6. Photographs of site 40156_4, showing the water body from which the sample was taken, and the soil core.

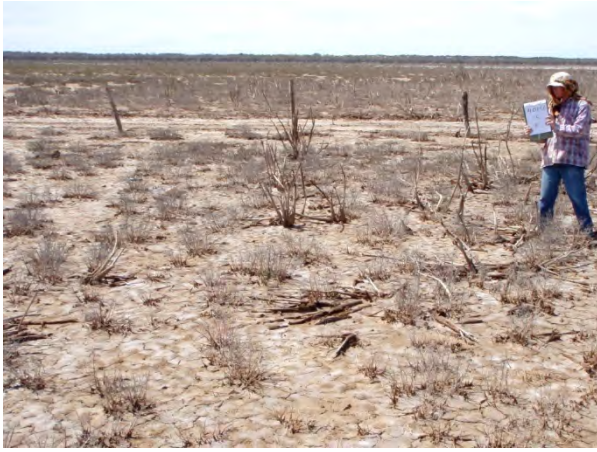
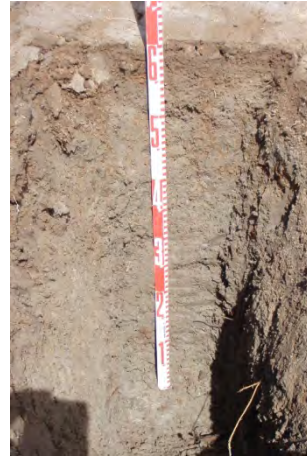
Figure 8-7. Photographs of site 40156_5, showing the moist but cracking brown clay and the dead low shrub vegetation, and the soil profile.

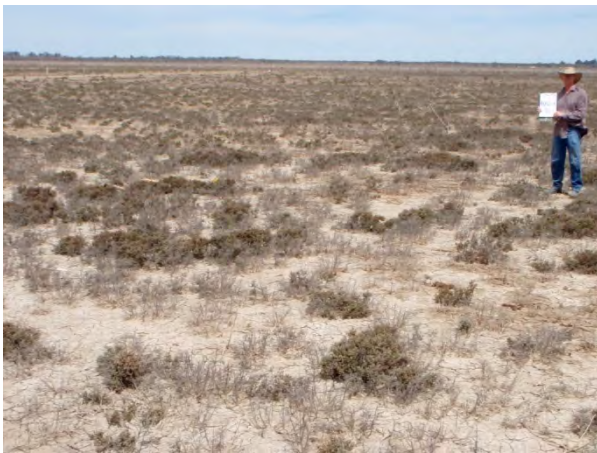
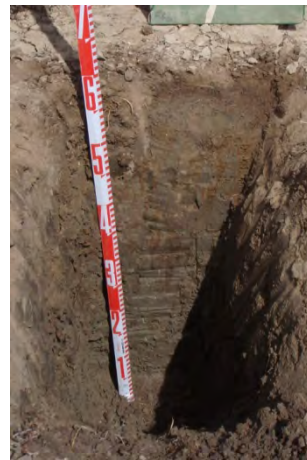
Figure 8-8. Photographs of site 40156_6, showing the low shrubby vegetation, predominantly on mounds, and the soil profile.

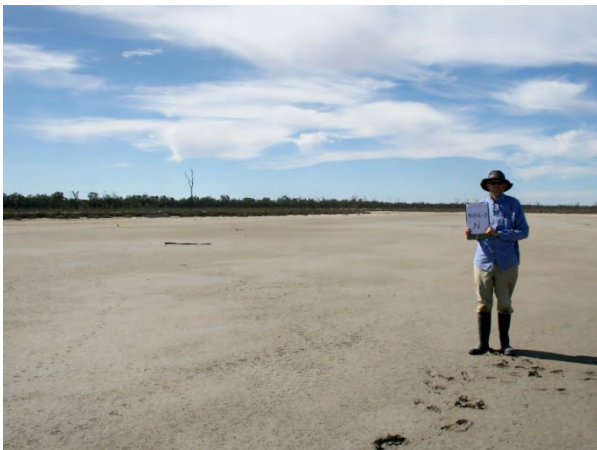
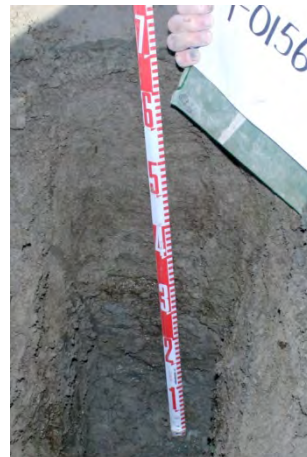
Figure 8-9. Photographs of site 40156_7, showing the bare, moist surface of the outlet channel, and the soil profile.

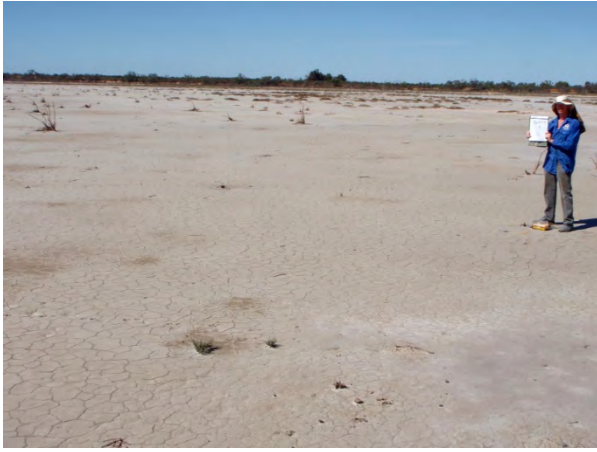
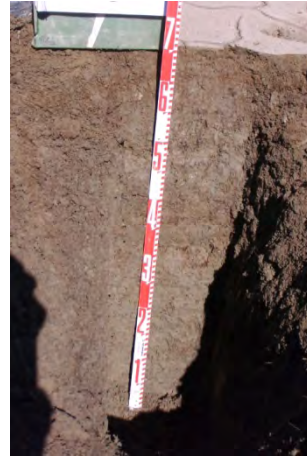
Figure 8-10. Photographs of site 40156_8, showing bare, cracking clay surface, and the soil profile.

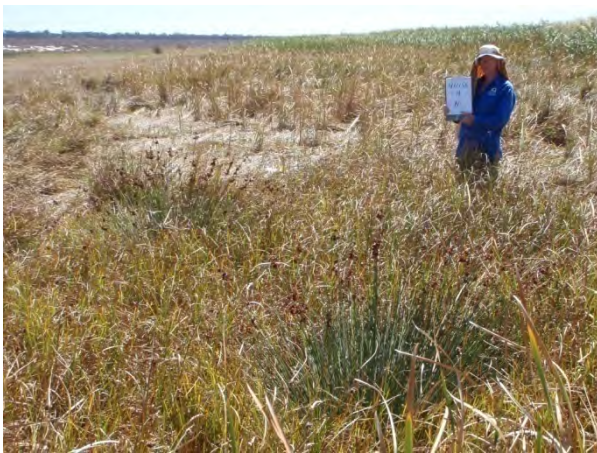
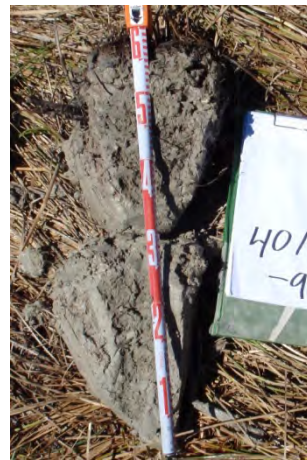
Figure 8-11. Photographs of site 40156_9, showing the location of the site along the edge of the main reed bed, and the soil profile.

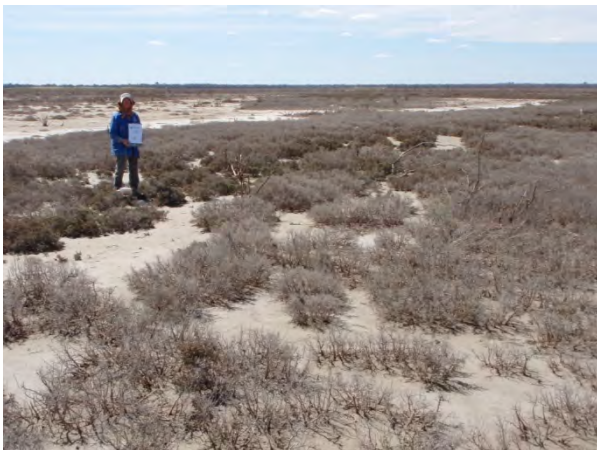
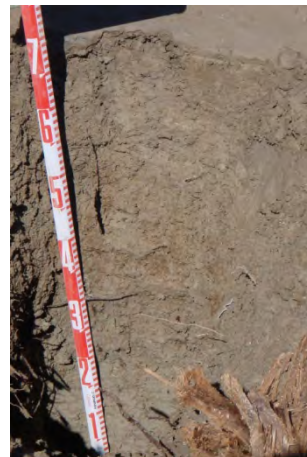
Figure 8-12. Photograph of site 40156_10, showing the situation of the site within a drainage line, and the low succulent shrub cover.

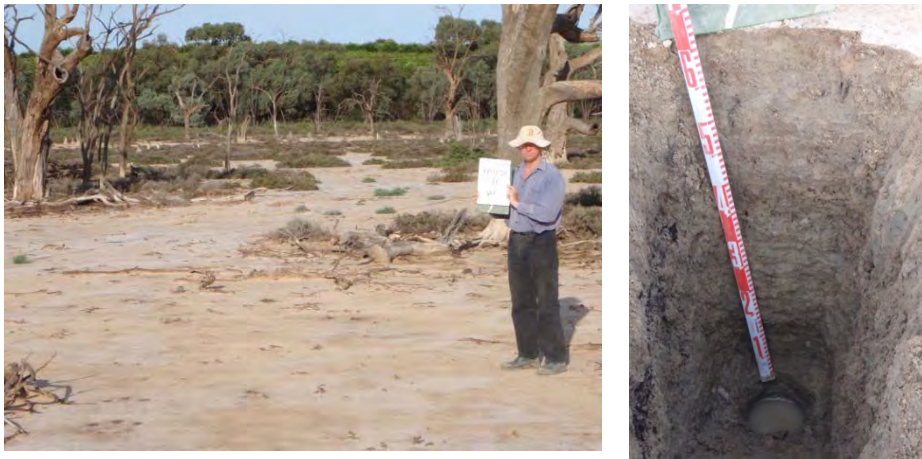
Figure 8-13. Photographs of site 40156_11, showing the situation of the site in the zone of mature, dead trees at the edge of the lake, and the soil profile.

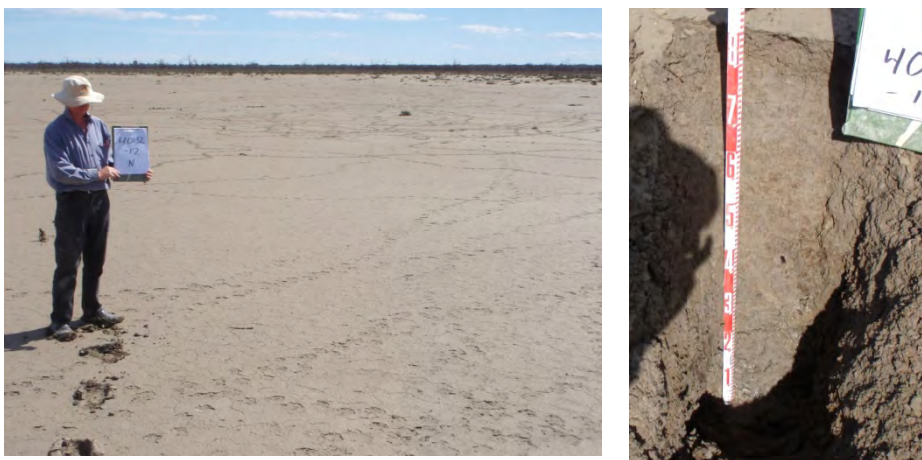
Figure 8-14. Photographs of site 40156_12, showing the moist lake bed surface with waterbird tracks, and the soil profile.

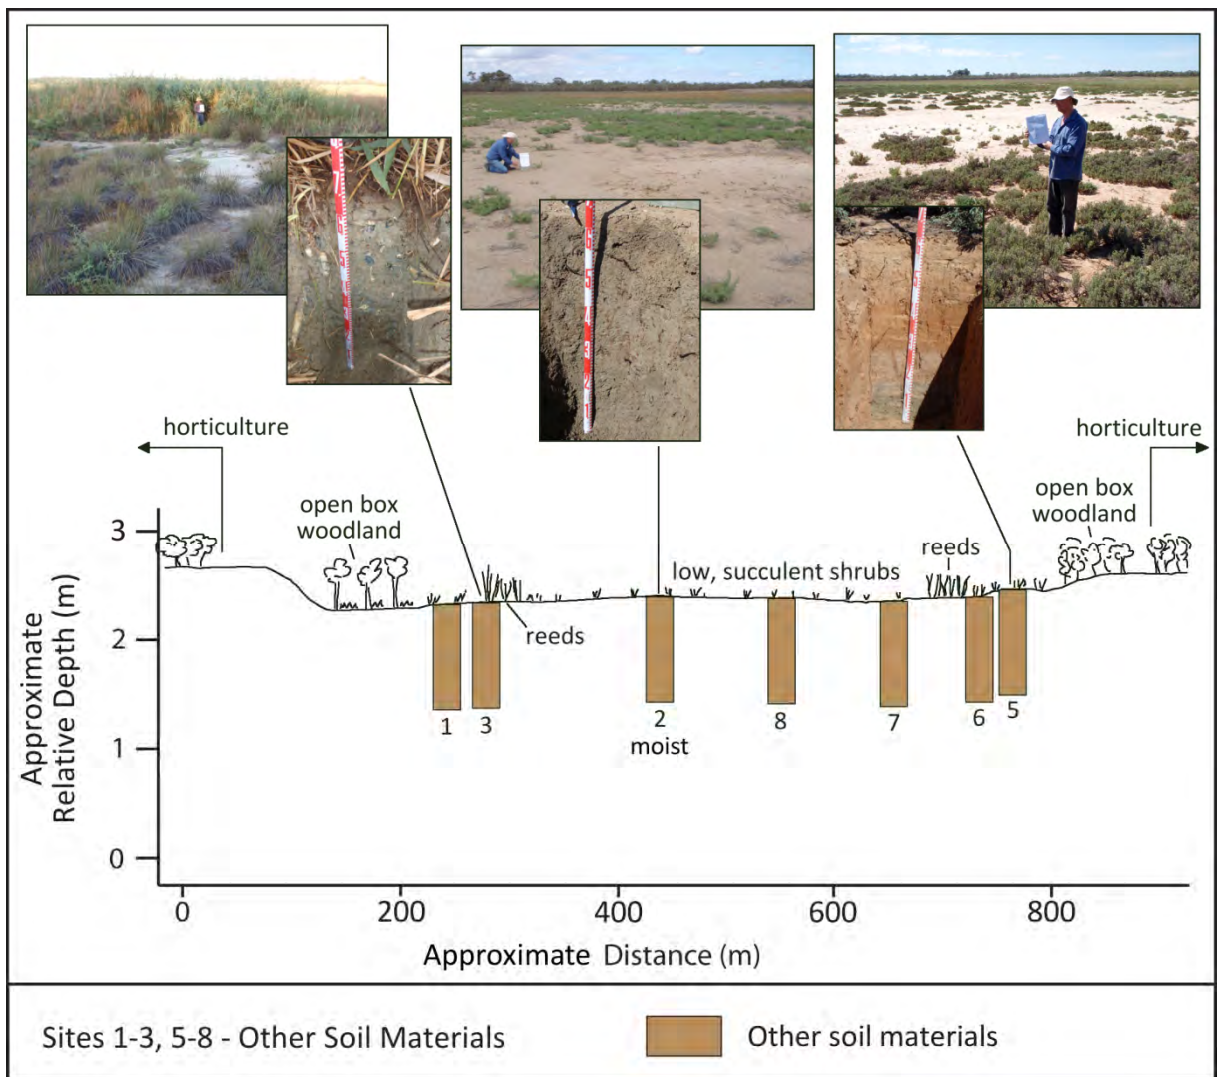
Figure 8-22. Conceptual cross section diagram showing the toposequence relationship of the Lake Iraak sediments/soil materials throughout the wetland.

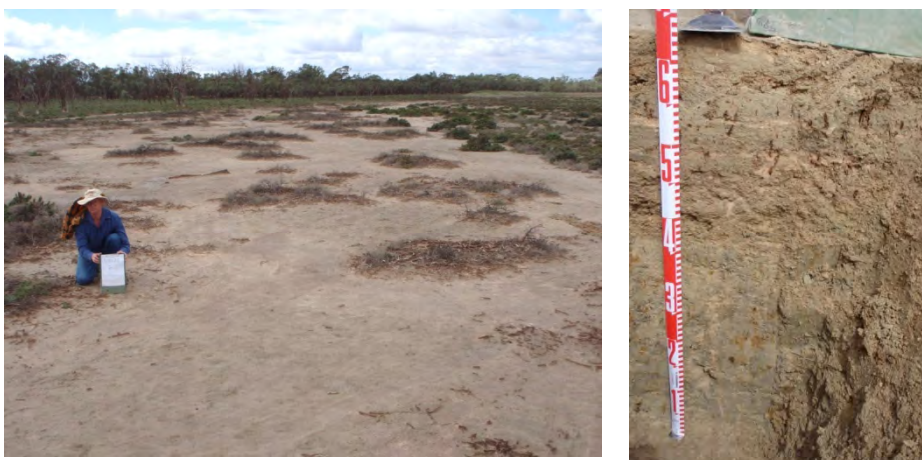
Figure 8-23. Photographs of site 40175_1, showing location of the site between a zone of living and dead trees and low, succulent shrubs, and the soil profile.

The profile 40175_1 (Figure 8-23) is situated in an area near the margin of the wetland in a zone of low, succulent shrubs. The profiles 40175_5 (Figure 8-27), 40175_6 (Figure 8-28), 40175_7 (Figure 8-29), 40175_8 (Figure 8-30) and 40175_2 (Figure 8-24) formed a transect from a low, red sand dune at the outer margin of the wetland (40175_5) towards the centre of the lake (40175_2), where a zone of lower succulent shrubs and moist soil occurred, with

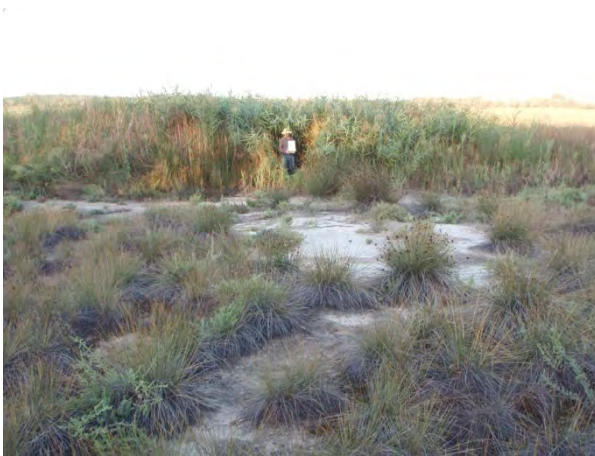
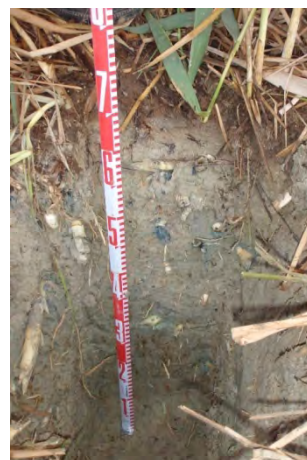
Figure 8-25. Photographs of site 40175_3, showing the reed bed from which the sample was taken, and the soil profile.

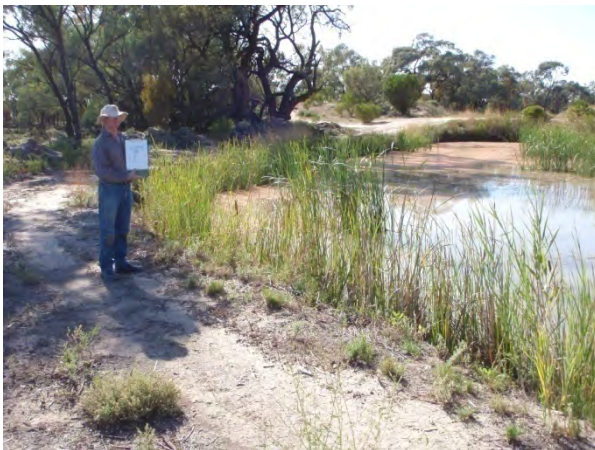
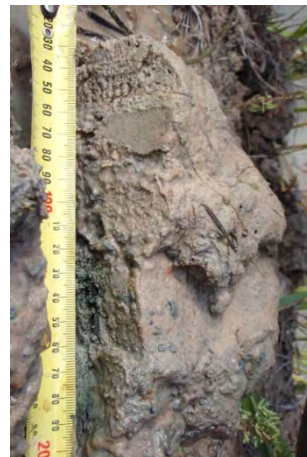
Figure 8-26. Photographs of site 40175_4, showing the modified channel from which samples were taken, and the soil core.

visible salt efflorescences. The profile 40175_3 (Figure 8-25) was situated in the middle of a small reed bed, and profile 40175_4 (Figure 8-26) was situated in the middle of the channel. Additional site and profile description data are presented in Tables 8-11 and 8-12, respectively.

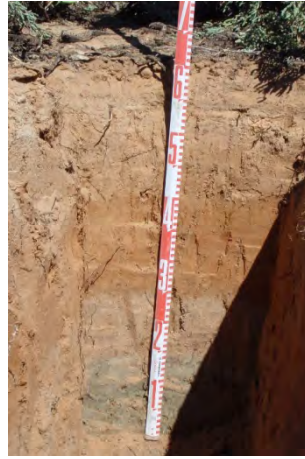
Figure 8-27. Photographs of site 40175_5, showing the low, red sand dune from which the sample was taken among low, succulent vegetation, and the soil profile.

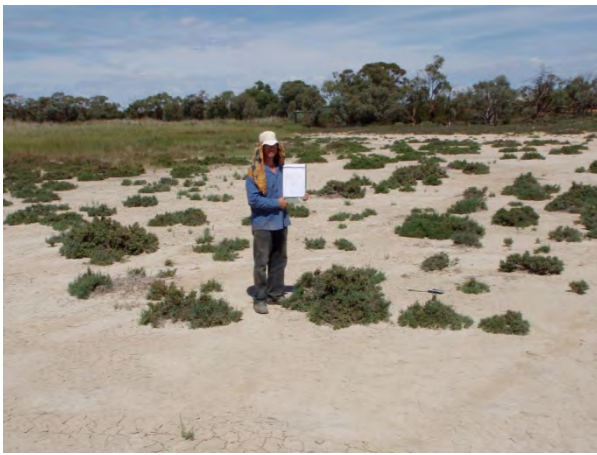
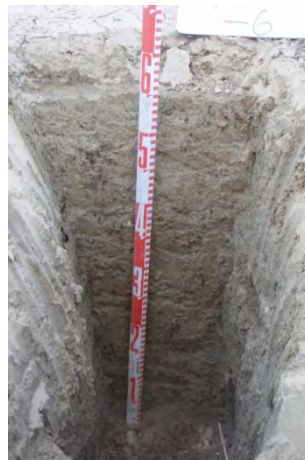
Figure 8-28. Photographs of site 40175_6, showing the bare, grey, cracking clay surface and light succulent vegetation cover, and the soil profile.

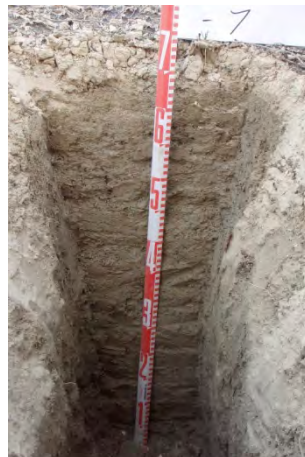
Figure 8-29. Photographs of site 40175_7, showing a biological crust over a grey, cracking clay surface with low succulent vegetation, and the soil profile.

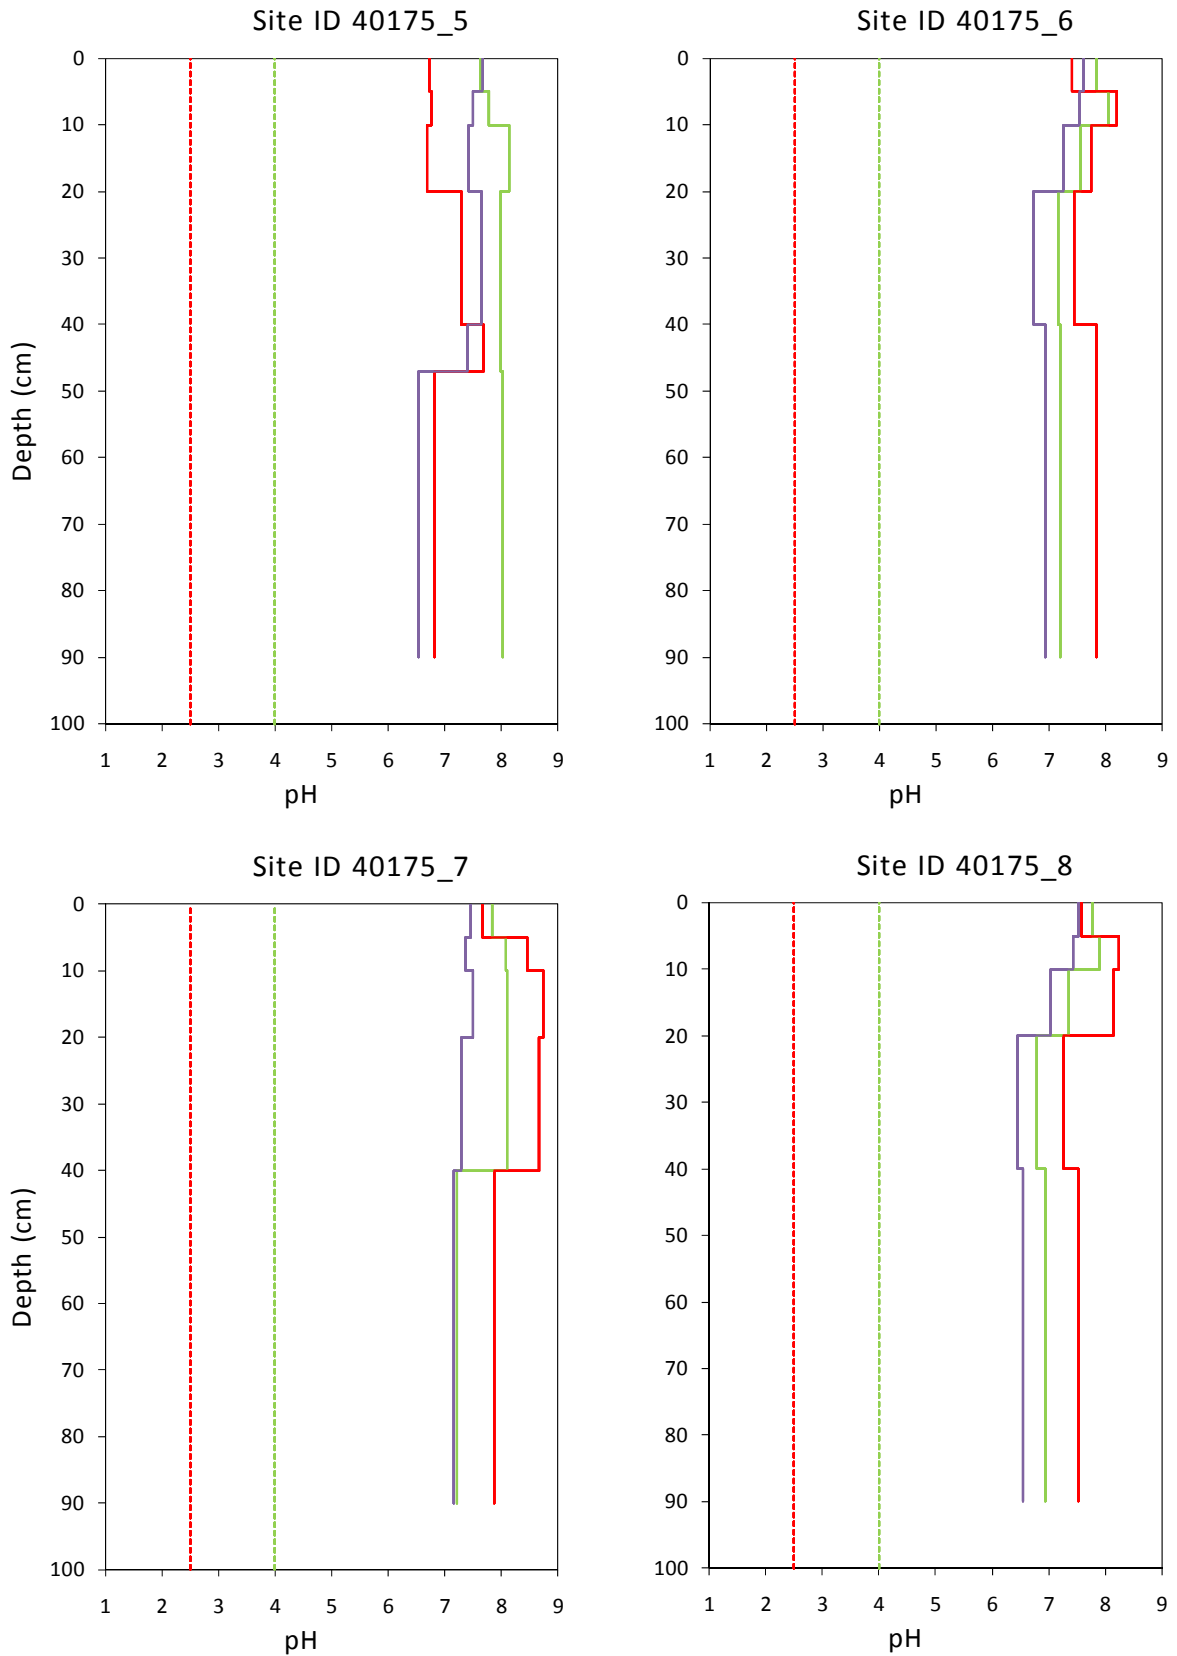
Figure 8-32. Depth profiles of soil pH for Lake Iraak (40175_5 – 40175_8), showing soil pH (pH_W as green line), peroxide treated pH (pH_{FOX} as red line) and ageing pH ($pH_{incubation}$ after at least eight weeks as purple line). Critical pH_W and $pH_{incubation}$ value of 4 (green dashed line) and critical pH_{FOX} value of 2.5 (red dashed line).

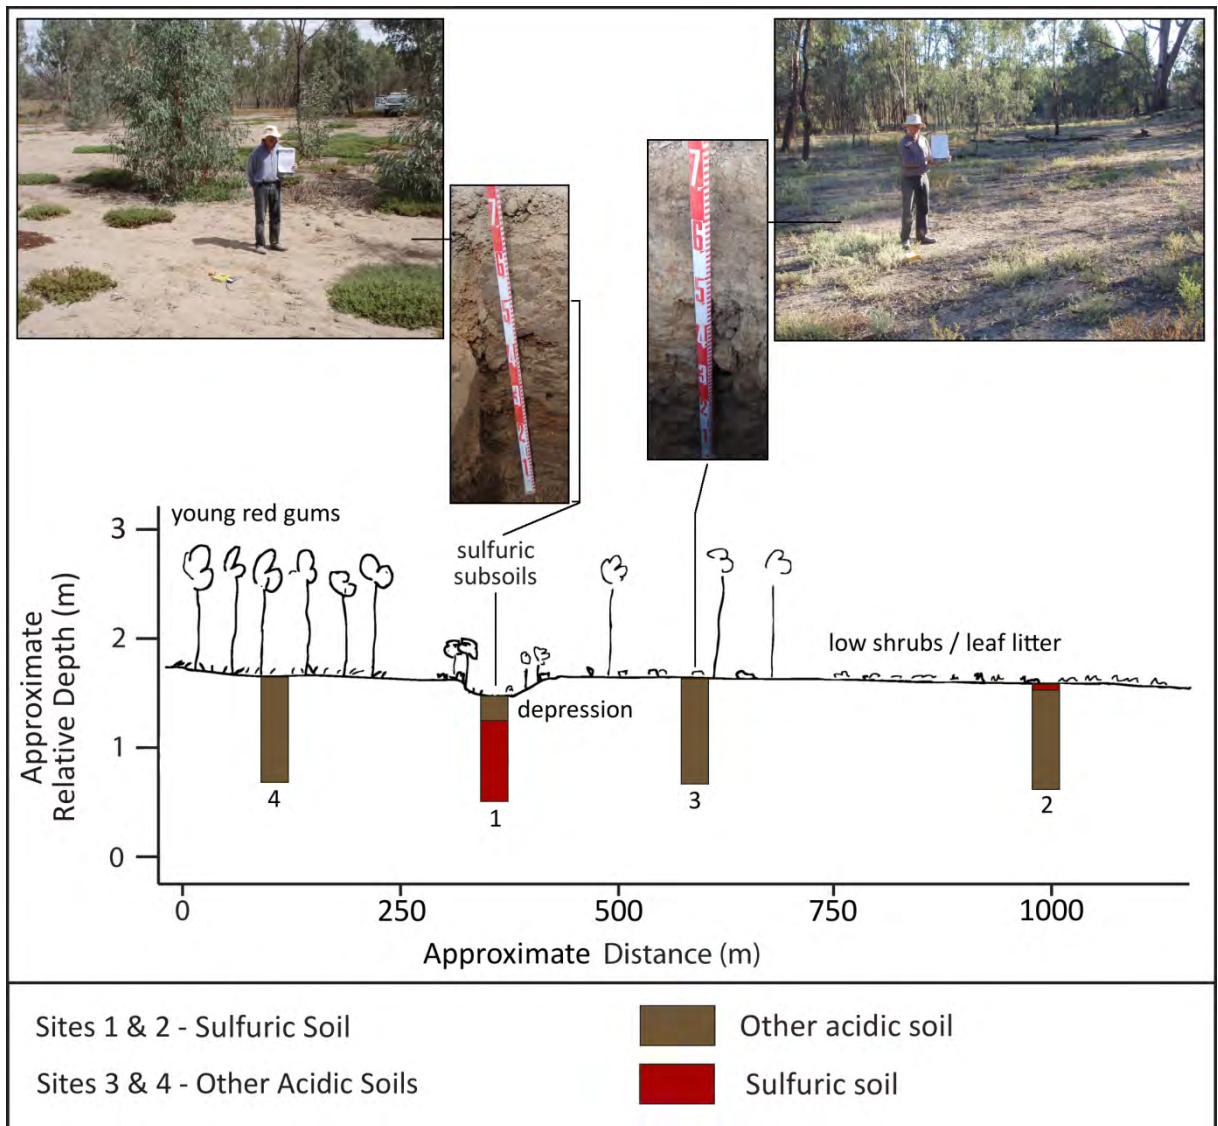
Figure 8-36. Conceptual cross section diagram showing the toposquence relationship of the Spencers Bend Billabong sediments/soil materials throughout the wetland.

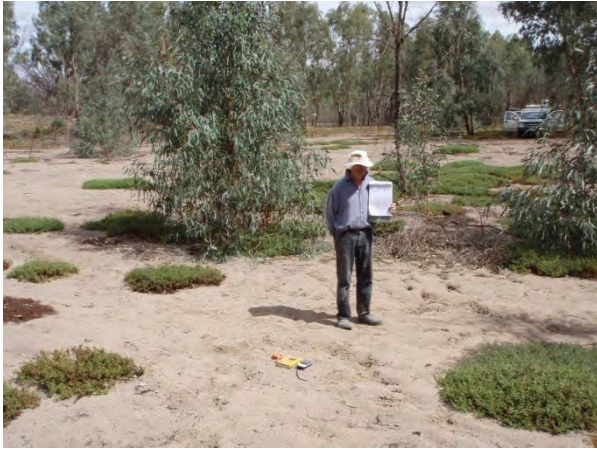
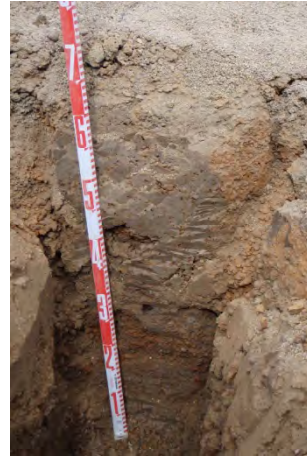
Figure 8-37. Photographs of site 40190_1, showing the depression at the lowest point of the billabong, and the soil profile.

The profile 40190_1 (Figure 8-37) was situated in the lowest point of the billabong, in a distinctive, circular depression. The profile 40190_2 (Figure 8-38) was situated at the southern end of the billabong, amongst perennial grasses and forb ground cover in the centre of the channel. The profile 40190_3 (Figure 8-39) was situated in the centre of the billabong (near the ox-bow bend), amongst low forbs and sparse, immature red gums. The profile 40190_4 (Figure 8-40) was situated in a young, open Red Gum forest at the northern end of the billabong. Additional site and profile description data are presented in Tables 8-16 and 8-17, respectively.

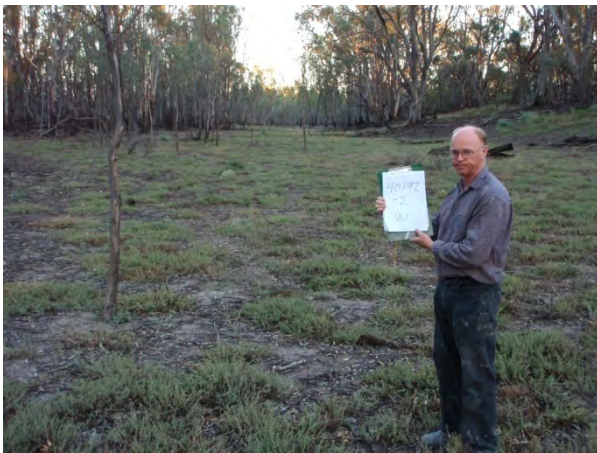
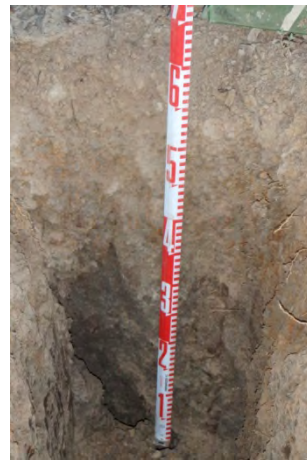
Figure 8-38. Photographs of site 40190_2, showing the billabong channel with low ground forbs and grasses, and the soil profile.

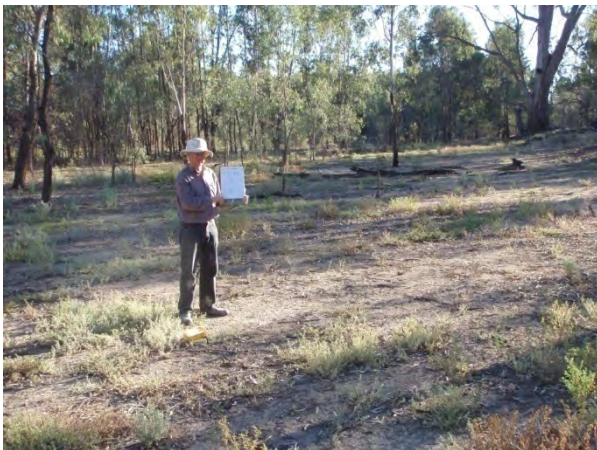
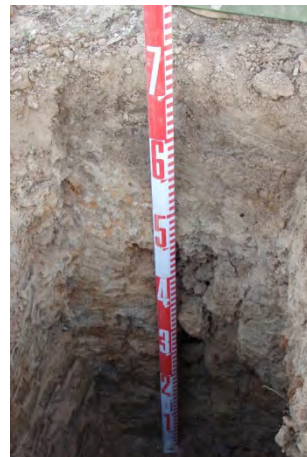
Figure 8-39. Photographs of site 40190_3, showing the low forbs and scattered immature red gums, and the soil profile.

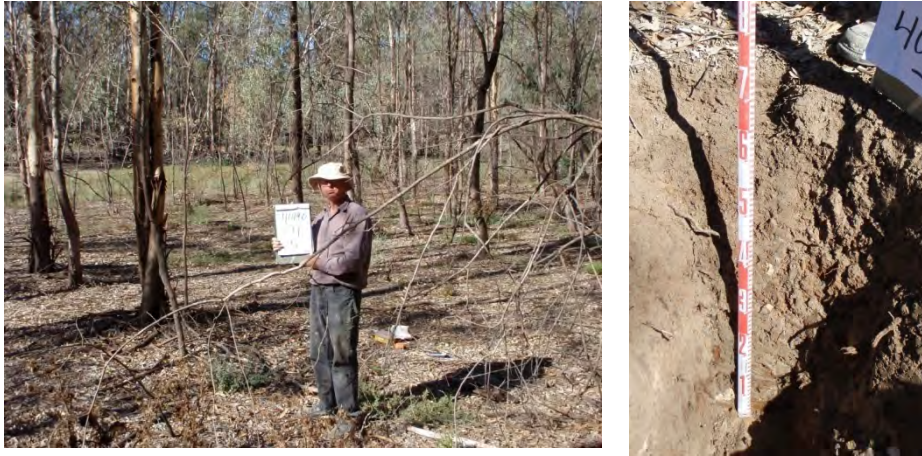
Figure 8-40. Photographs of site 40190_4, showing the open, young Red Gum forest with 90% ground cover (mostly litter), from which the sample was taken, and the soil profile.

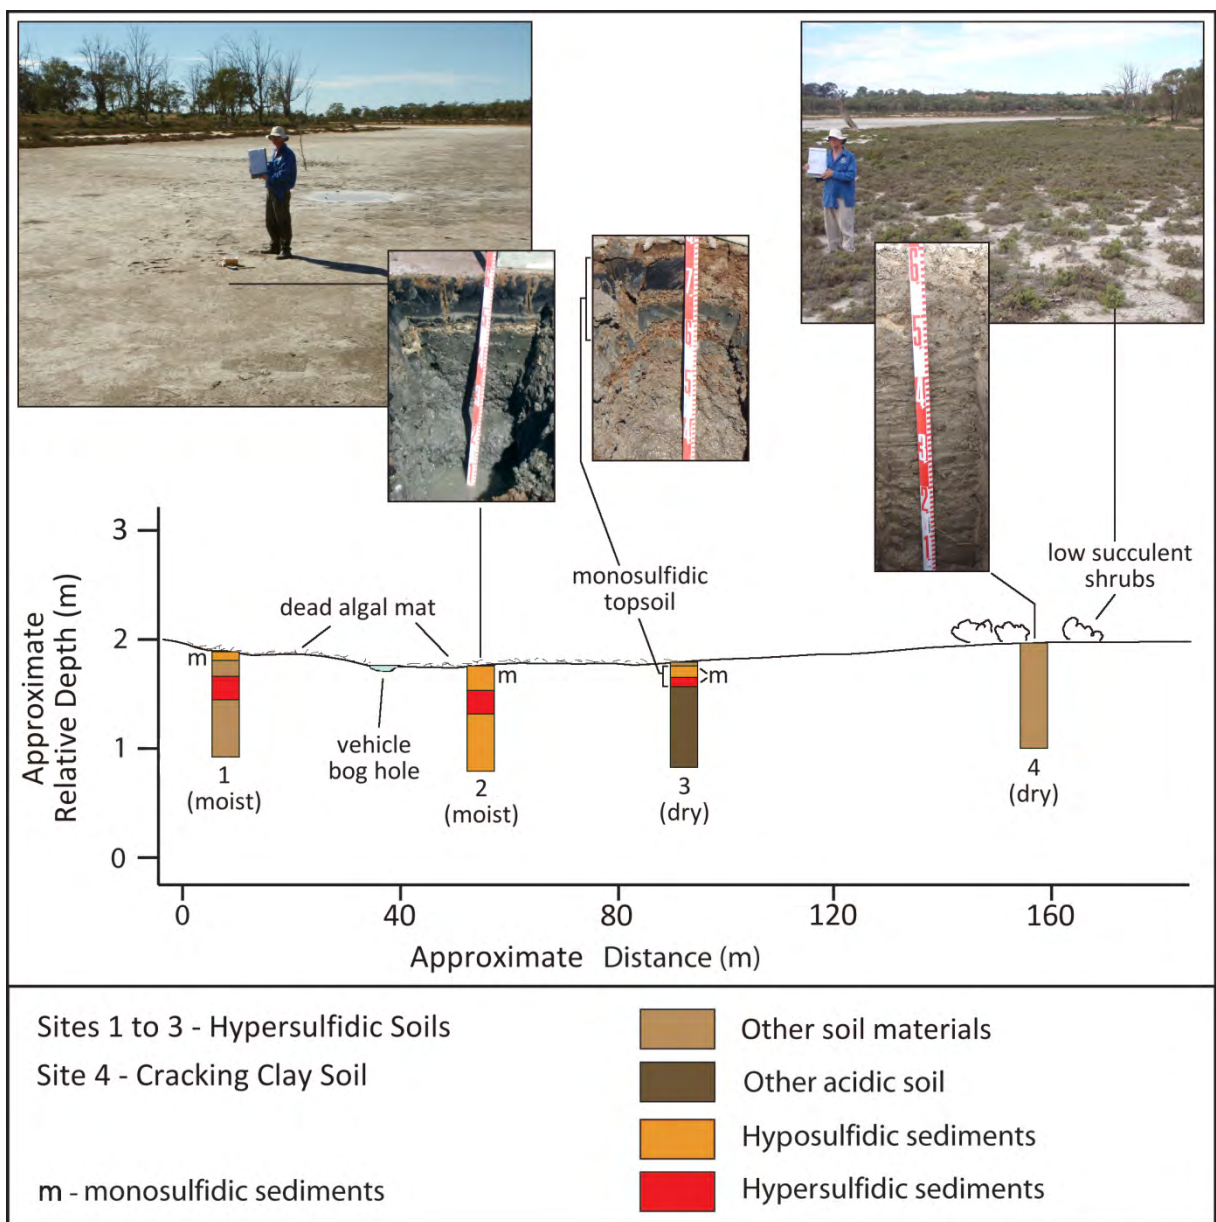
Figure 8-44. Conceptual cross section diagram showing the toposequence relationship of the Brickworks Lagoon sediments/soil materials throughout the wetland.

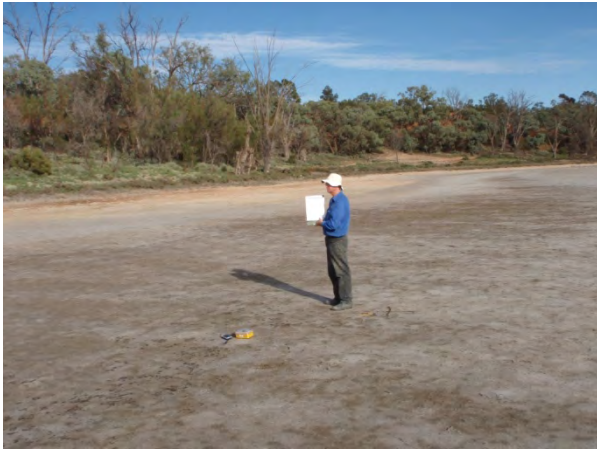
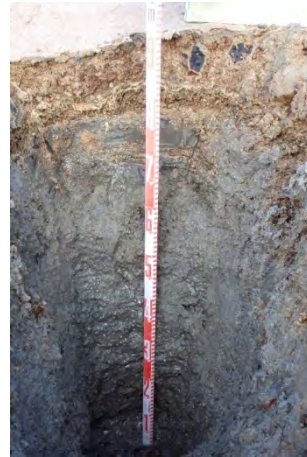
Figure 8-45. Photographs of site 40864_1, showing the bare clay from which the sample was taken, and the soil profile.

The four sampled sites were chosen to represent different moisture characteristics of the wetland, and were situated in deep to shallow sections of the channel. The profiles 40864_1 (Figure 8-45), 40864_2 (Figure 8-46) and 40864_3 (Figure 8-47) were situated in bare, salt-encrusted clay. The profile 40864_4 (Figure 8-48) was situated in a zone vegetated by low, succulent shrubs on raised mounds. Additional site and profile description data are presented in Tables 8-21 and 8-22, respectively.

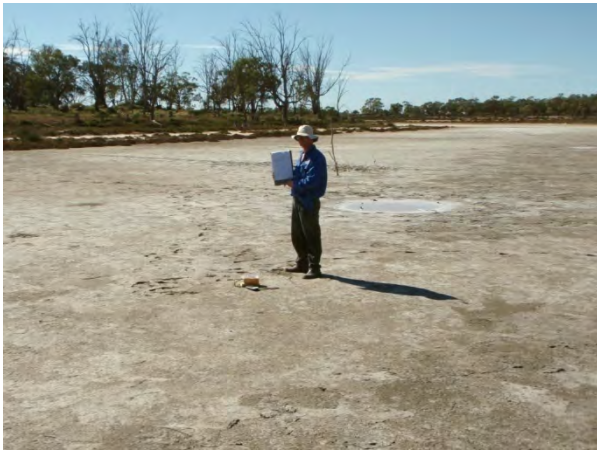
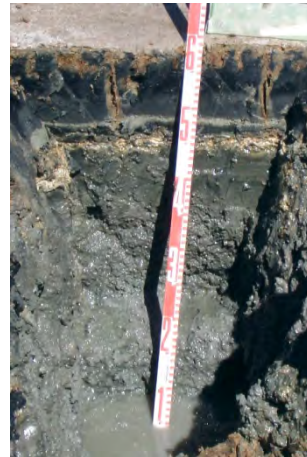
Figure 8-46. Photographs of site 40864_2, showing the bare, cracking clay surface, and the soil profile.

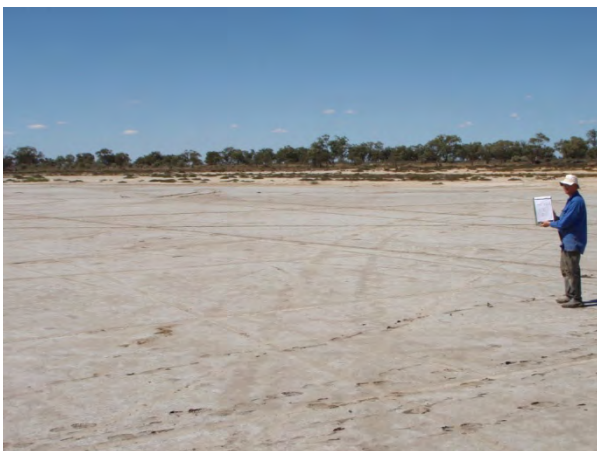
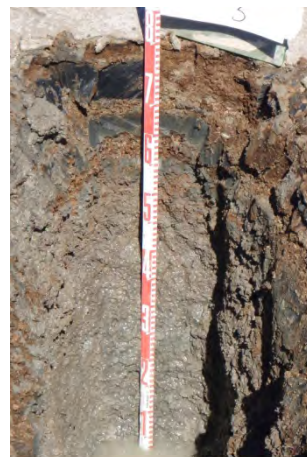
Figure 8-47. Photographs of site 40864_3, showing the bare, cracking clay surface, and the soil profile.

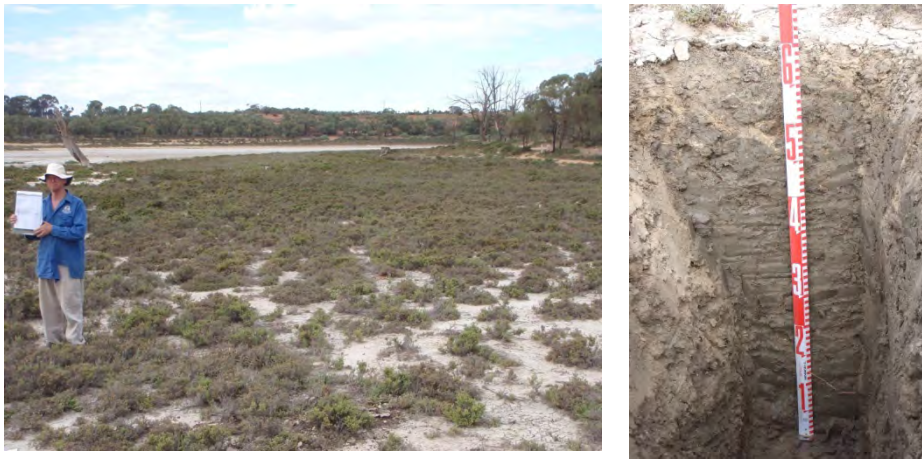
Figure 8-48. Photographs of site 40864_4, showing the cracking clay surface with low succulent shrubs, and the soil profile.

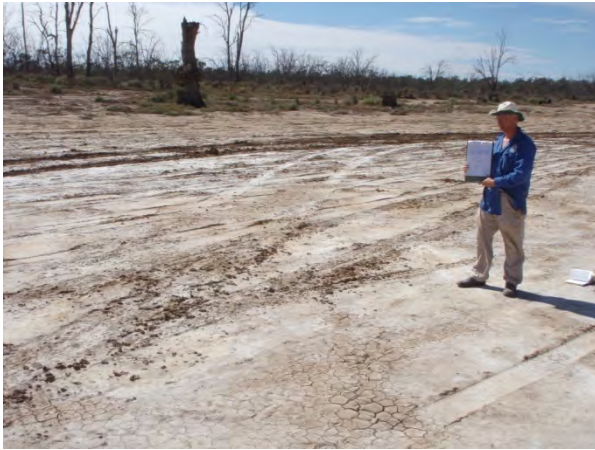
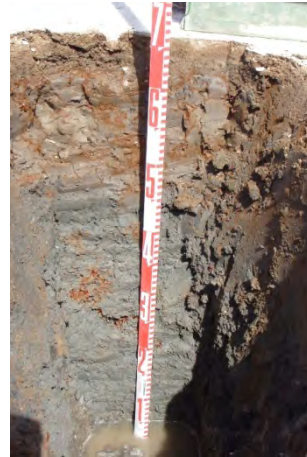
Figure 8-54. Photographs of site 40805_2, showing the bare cracking clay surface, and the soil profile.

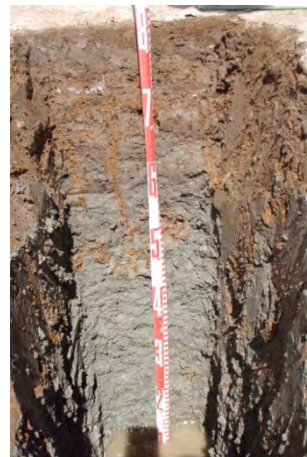
Figure 8-55. Photographs of site 40805_3, showing the bare cracking clay surface, and the soil profile.

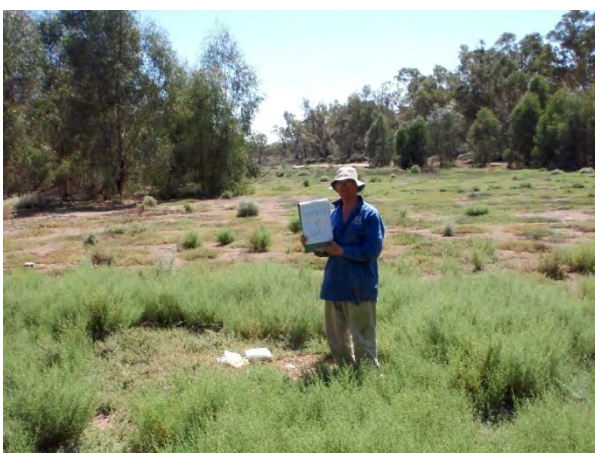
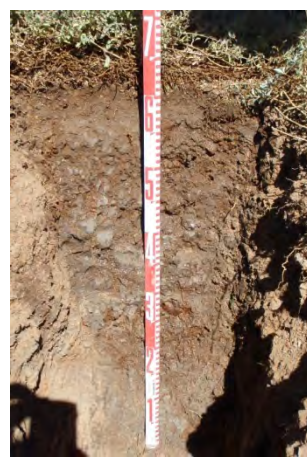
Figure 8-56. Photographs of site 40805_4, showing the location of the site amongst low forbs and groundcovers, and the soil profile.

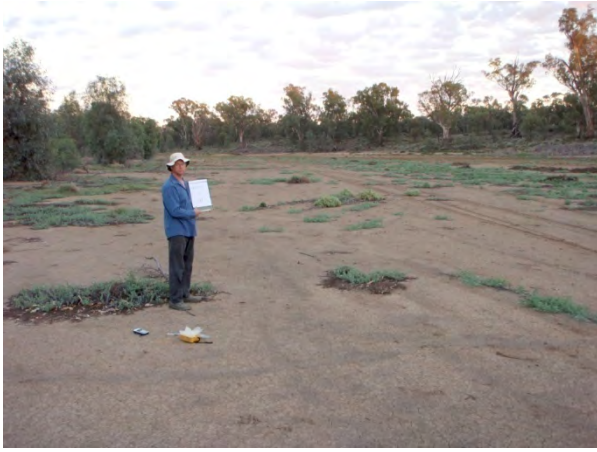
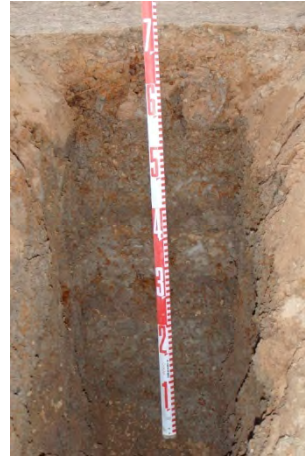
Figure 8-57. Photographs of site 40805_5, showing the soft, cracking clay surface with minimal vegetation, and the soil profile.

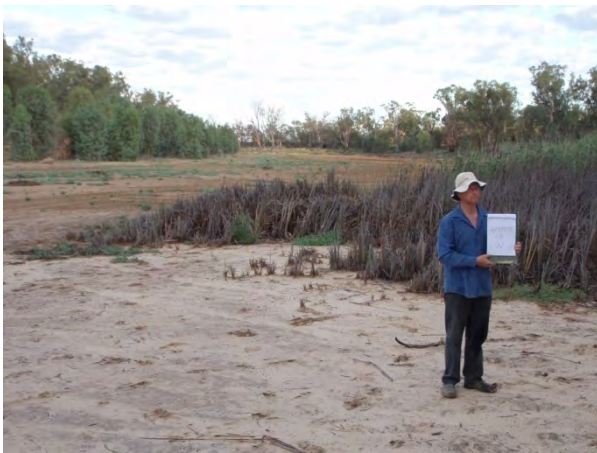
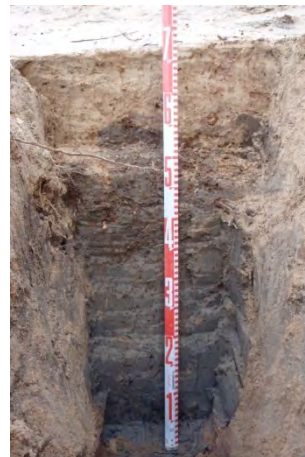
Figure 8-58. Photographs of site 40805_6, showing the sandy, depositional area adjacent to the bank, and the soil profile.

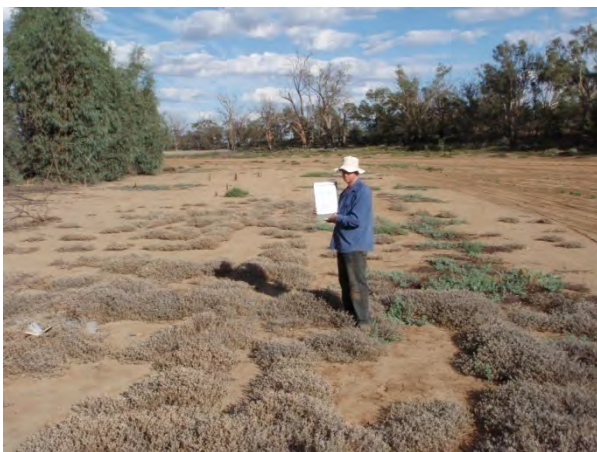
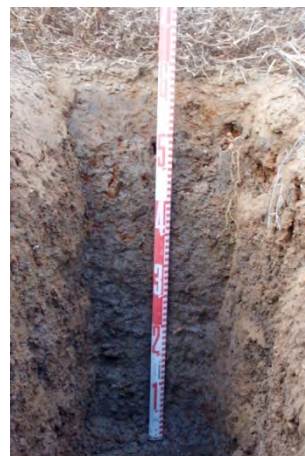
Figure 8-59. Photographs of site 40805_7, showing the dead, low vegetation amongst otherwise bare clay, and the soil profile.

in between. The profile 40805_5 (Figure 8-57) was situated in fine, cracking, soft clay without any evident salt, with minimal coverage by low, succulent vegetation. The profile 40805_6 (Figure 8-58) was situated in a depositional area adjacent to the bank, with a predominantly sandy surface. The profile 40805_7 (Figure 8-59) was situated in soft, cracking clay, which was mostly bare apart from dead groundcovers. The profile 40805_8 (Figure 8-60) was situated in the deepest part of the river end of the lake, with completely bare, cracking clays and visible salt efflorescences. Additional site and profile description data are presented in Tables 8-27 and 8-28, respectively.

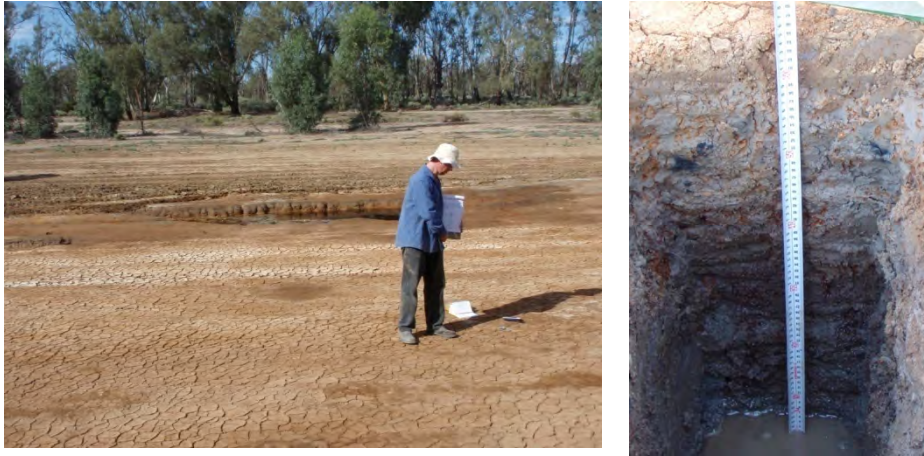
Figure 8-60. Photographs of site 40805_8, showing the bare cracking clay surface from which the sample was taken, and the soil profile. In the background is a pool formed by a bogged vehicle (not sampled).

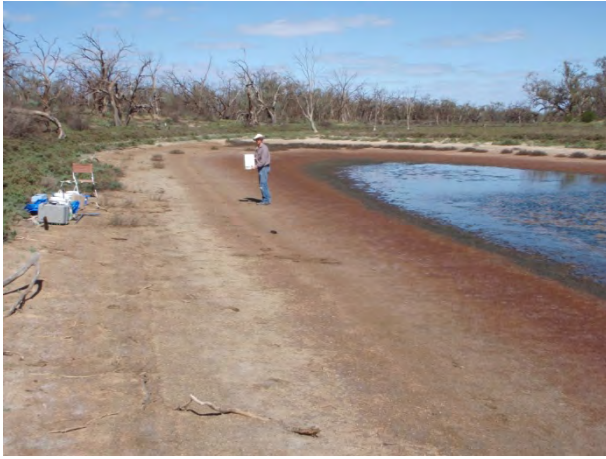
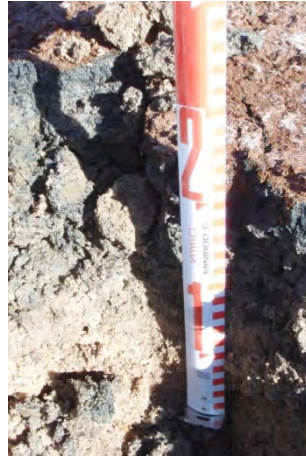
Figure 8-68. Photographs of site 40856_2, showing the pond from which the sample was taken, and the soil profile.

The profiles 40856_1 (Figure 8-67) and 40856_2 (Figure 8-68) were situated in the southern half of the wetland, the former on a raised, vegetated point bar of the creek channel, and the latter in the bed of a pond with surface water. The profiles 40856_3 (Figure 8-69) and 40856_4 (Figure 8-70) were situated in the northern half of the wetland, the former on the bank adjacent to the largest pond in the wetland, and the latter in the centre of that pond.
