Assessment of Acid Sulfate Soil Materials in the Mildura Region of the Murray-Darling Basin.

N.J. Ward, R.T. Bush, L.A. Sullivan, P. Cheeseman, R. McGrath,
D.M. Fyfe, J. Coughran and V.N.L. Wong

FINAL REPORT

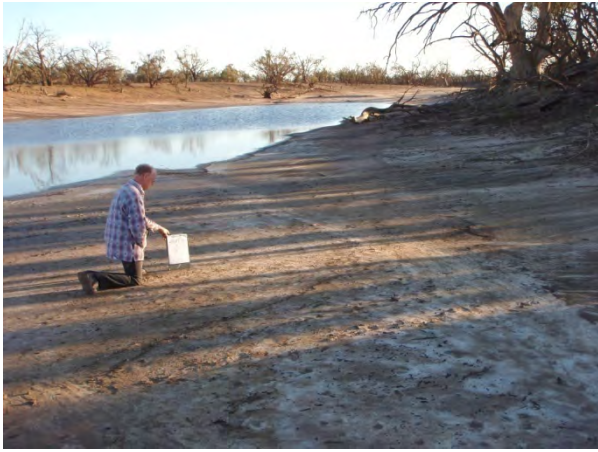
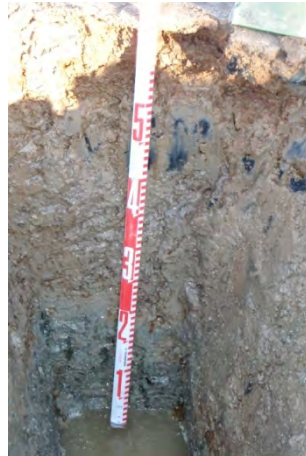
Figure 8-69. Photographs of site 40856_3, showing the bare banks of the pond from which the sample was taken, and the soil profile.

The profiles 40856_1 (Figure 8-67) and 40856_2 (Figure 8-68) were situated in the southern half of the wetland, the former on a raised, vegetated point bar of the creek channel, and the latter in the bed of a pond with surface water. The profiles 40856_3 (Figure 8-69) and 40856_4 (Figure 8-70) were situated in the northern half of the wetland, the former on the bank adjacent to the largest pond in the wetland, and the latter in the centre of that pond.

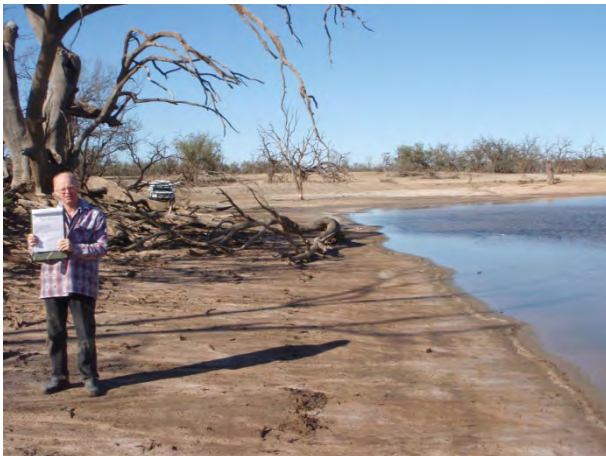
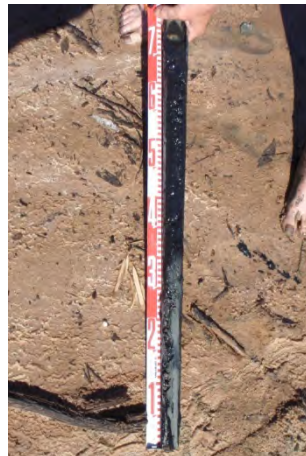
Figure 8-70. Photographs of site 40856_4, showing the pond from which the sample was taken, and the soil core.

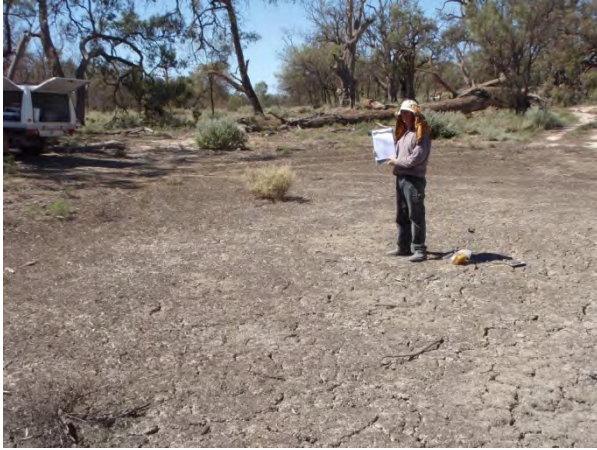
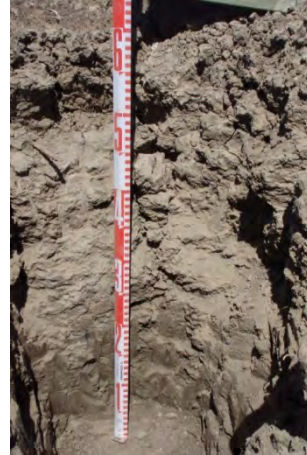
Figure 8-76. Photographs of site 21920_2, showing the bare cracking clay surface, and the soil profile.

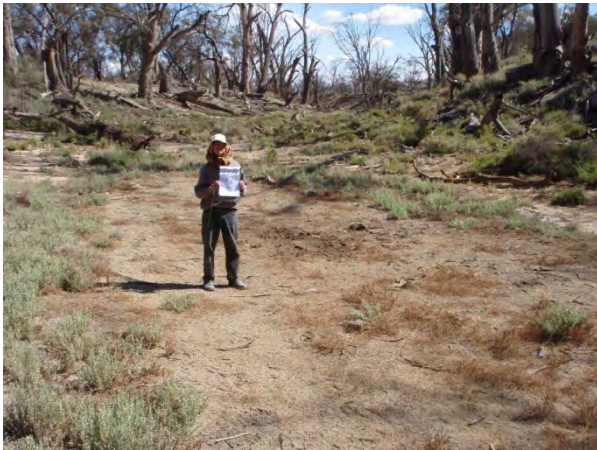
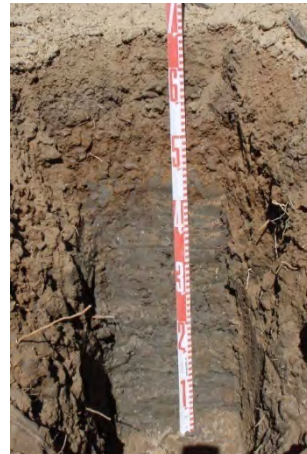
Figure 8-77. Photographs of site 21920_3, showing the situation of the site in a depression in a dried channel, and the soil profile.

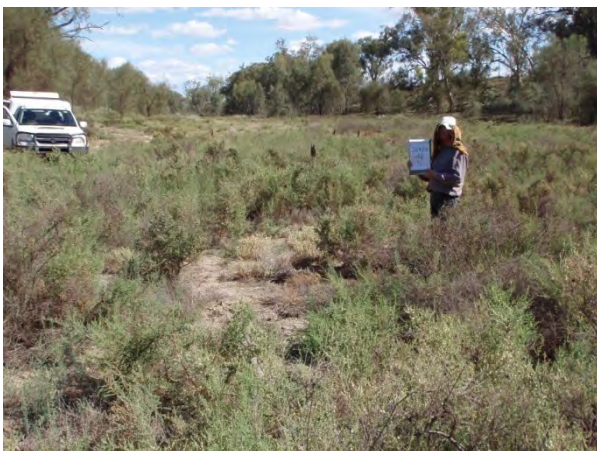
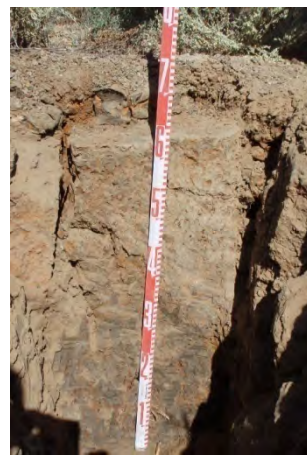
Figure 8-78. Photographs of site 21920_4, showing the sampling site amongst saltbush and forbs, and the soil profile.

The profiles 21920_1 (Figure 8-75), 21920_2 (Figure 8-76), 21920_3 (Figure 8-77) and 21920_4 (Figure 8-78) were all situated in the upper tributaries of the wetland, in wooded country (21920_4 was bordered by vineyards on the western side of the channel). The

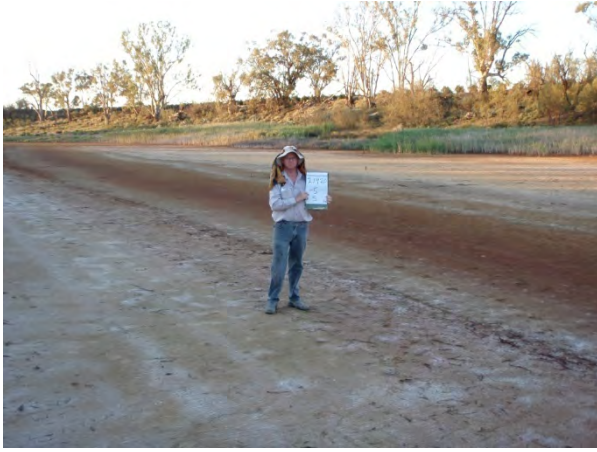
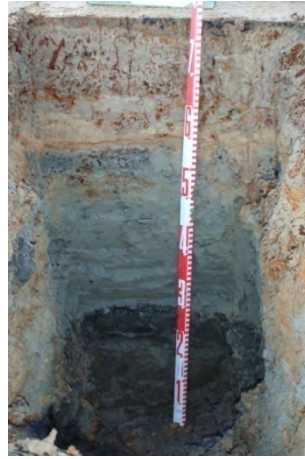
Figure 8-79. Photographs of site 21920_5, showing the situation of the site on the upper bank of the main channel, and the soil profile.

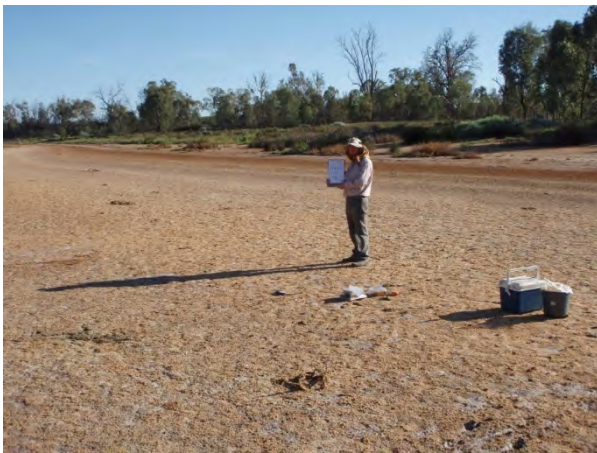
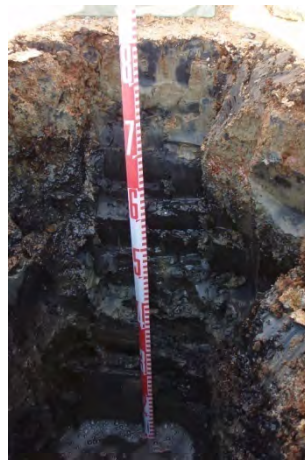
Figure 8-80. Photographs of site 21920_6, showing the site on the thalweg of the channel, with a heavy cover of salt efflorescences, and the soil profile showing the presence of MBO.

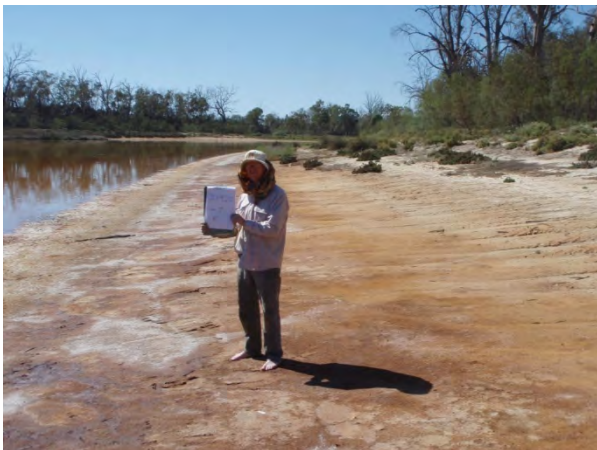
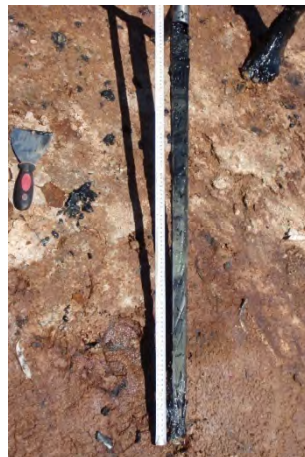
Figure 8-81. Photographs of site 21920_7, showing the waterbody (left of image) from which the sample was taken, and the soil core showing the presence of MBO.

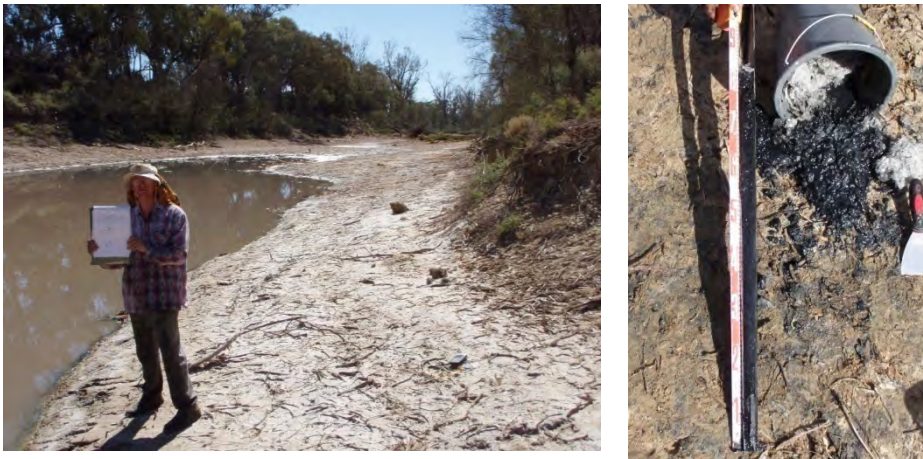
Figure 8-82. Photographs of site 21920_8, showing the water body from which the sample was taken (note the presence of MBO in the water at rear of image and along the water's edge in foreground), and the soil core showing the presence of MBO and thick salt crust.

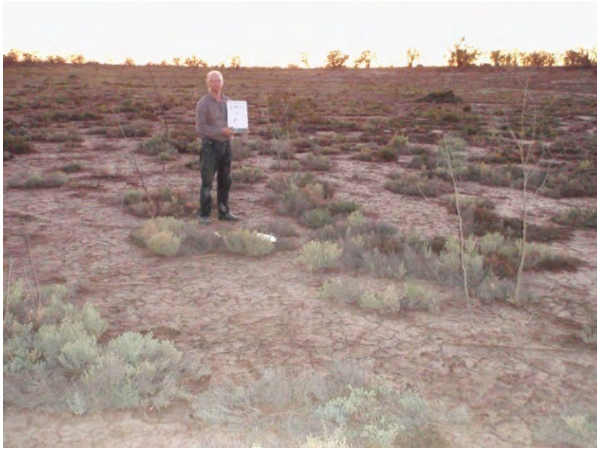
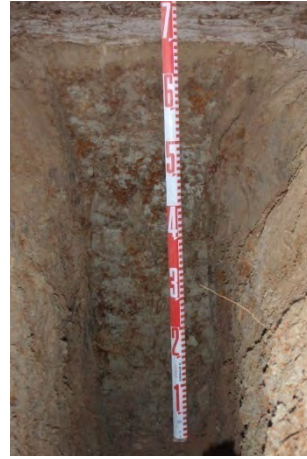
Figure 8-84. Photographs of site 21921_1, showing the cracking clay surface with low succulent shrubs, and the soil profile.

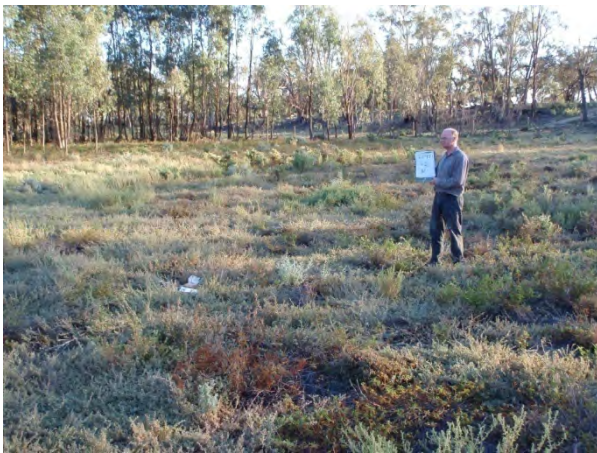
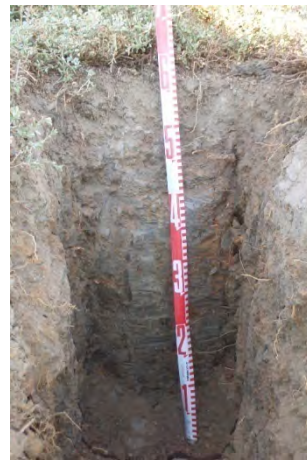
Figure 8-85. Photographs of site 21921_2, showing the situation of the site in dense vegetation, and the soil profile.

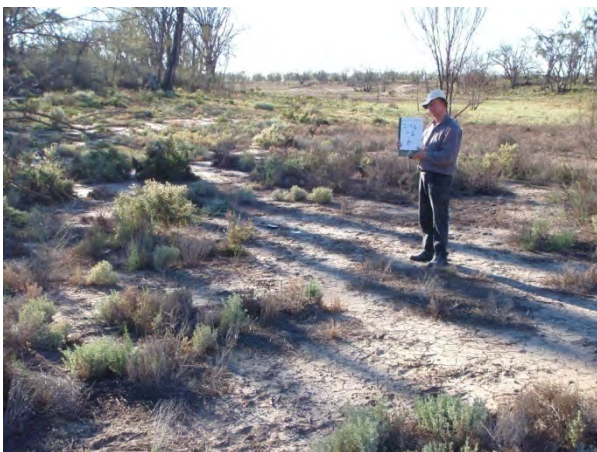
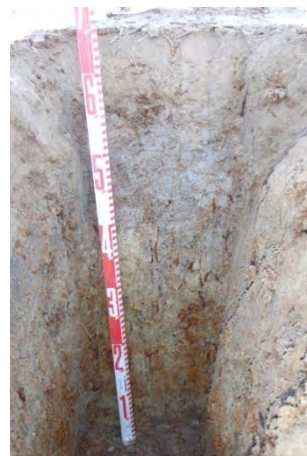
Figure 8-86. Photographs of site 21921_3, showing the mostly bare surface with low succulent shrubs, and the soil profile.

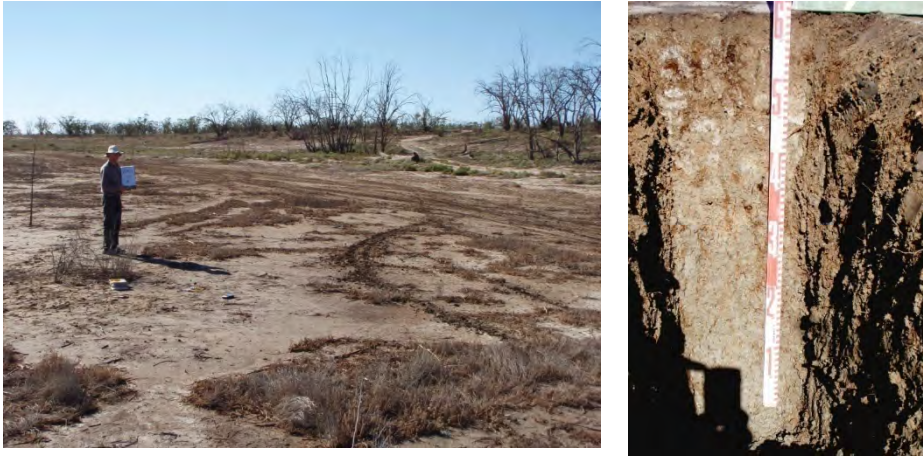
Figure 8-87. Photographs of site 21921_4, showing the moist clay surface with dense vehicle track damage, and the soil profile.
