## APPENDIX B1 – WETLAND DESCRIPTIONS FOR ASSESSMENT OF ACID SULFATE SOIL MATERIALS IN THE LOCK 1 TO WELLINGTON REGION OF THE MURRAY-DARLING BASIN

# 1 POMANDA BAY WETLAND (WETLAND ID. 12700)

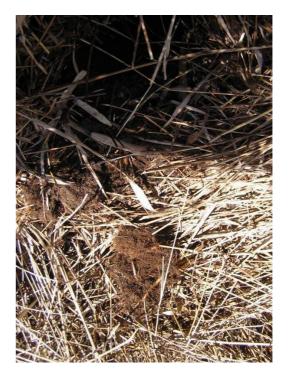
Figure 2-2. Photographs of site WSP1, showing the landscape with tall thick *Phragmites australis* (Common Reed), and the soil material extracted below a thick mat of plant material.

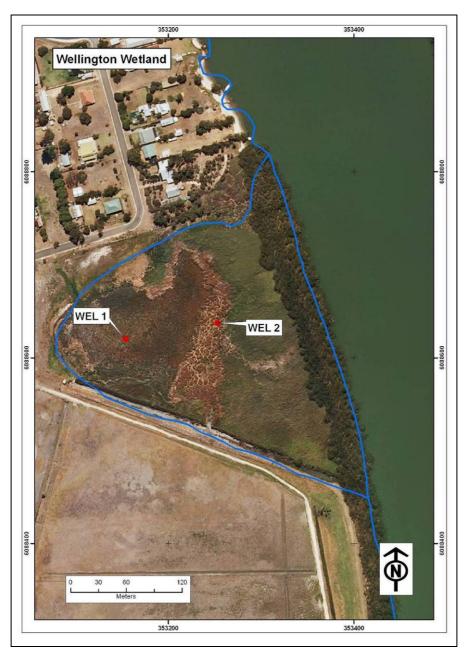
Figure 4-1. Wellington Wetland and sample site locations.

Wellington Wetland (Wetland ID. 12022) is situated on the western side of the River Murray, approximately 200 metres down river from the town of Wellington. The wetland is geomorphically categorised as a Murray Gorge basin (Pressey 1986) and is triangular in shape, with a total surface area of 6 hectares. It is bounded on the eastern river side by a levee bank and on the western side by a road and disused milking shed area up slope from the wetland. There are no obvious water connection channels with the river, except for an excavated channel on the southern boundary to provide water for irrigation. This is likely to overtop with high river levels. At the time when the soil survey was conducted in August 2008 the wetland surface was dry with large cracks (5 centimetres wide and down to 50 centimetres depth). *Typha latifolia* (Bulrush) was growing along the margins and below the willow trees that were growing adjacent to the levee bank. Two sites were described and sampled and their locations are shown in Figure 4-1.

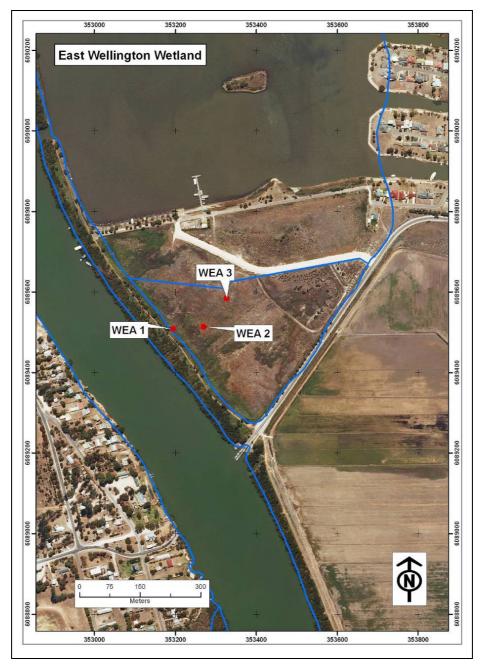
Figure 5-1. East Wellington Wetland and sample site locations.

East Wellington Wetland (Wetland ID. 12702) is situated on the eastern side of the River Murray, up river and adjacent to the Wellington car ferry ramp. The wetland is triangular in shape, with a total surface area of 12 hectares. It is bounded on the western side by a levee bank that separates the river from the wetland, and on the other sides by raised areas with the main road and a marina access road. There is no obvious water connection channel with the river. At the time when the soil survey was conducted in August 2008 the wetland was dry with large surface cracks (5 centimetres wide and down to more than 50 centimetres below the surface) throughout the wetland. *Phragmites australis* (Common Reed) vegetation was growing around the margins of the wetland, weeds were growing within the wetland area and there were a few isolated areas where there was no vegetation. Three sites were described and sampled and their locations are shown in Figure 5-1.

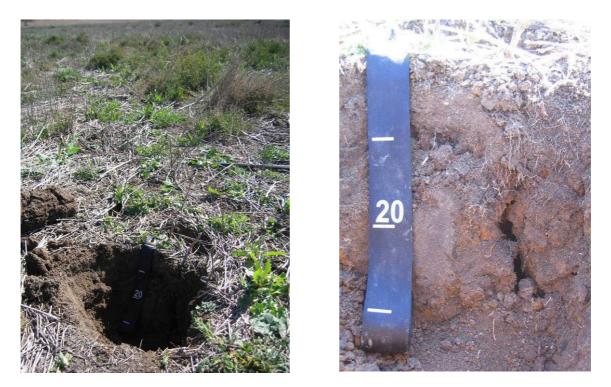
Figure 5-4. Photographs of site WEA3, showing the site location where established grasses and weeds were growing, and the soil profile with cracking clay upper layers.

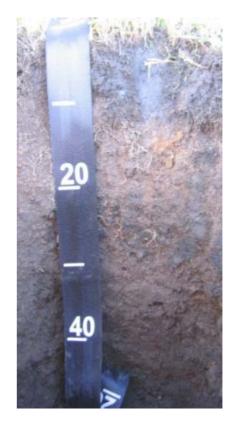
Figure 6-2. Photographs of site WMA1, showing the landscape of levelled land with the levee bank in the background and the soil profile of black 10cm topsoil over yellowish brown, clay.

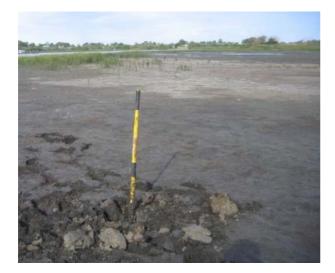
Site WMA3 (Figure 6-4) occurred in a low area of the wetland where the mud island area was just above the marina water at the house end of the wetland. The soil consisted of a thin, black aggregated clay, over a grey clay with buried reed material and below 20 cm a light grey, very soft clay.

Figure 6-4. Photographs of site WMA3, showing the landscape of a mud island that occurred in the marina waters, and the soil profile of grey clay with brown mottling.

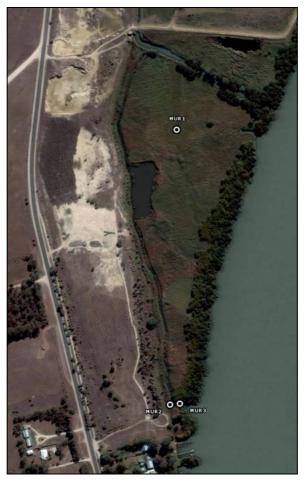
Figure 7-1. Wellington North (Murrundi) Wetland and sample site locations.

This wetland was studied in 2007/08 as part of a separate monitoring investigation of acid sulfate soils, the work and data was presented in the report 'Acid sulfate soils in subaqueous, waterlogged and drained soil environments of nine wetlands below Blanchetown (Lock 1), South Australia: properties, genesis, risks and management' (Fitzpatrick, Shand, Thomas, Merry, Raven and Simpson, November 2008. Report prepared for South Australian Murray-Darling Basin Natural Resources Management Board. CSIRO Land and Water Science Report 42/08). Readers are referred to this report for detailed information, and here a summary of the findings are presented. Three sites were sampled (MUR1, MUR2, and MUR3) and their locations are shown in Figure 7-1. A follow-up survey was conducted in August 2009 to observe the condition of the wetland.

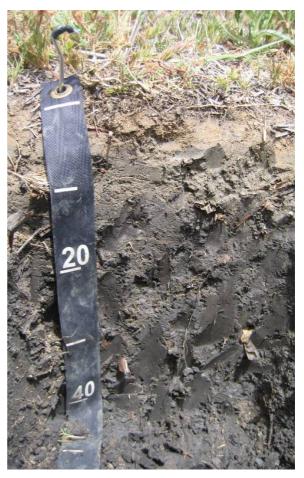
Figure 8-2. Photographs of site FLA5, showing the site landscape with grasses growing and the area bounded by willows to the west and a steep cliff to the east, and the soil profile of firm clay.

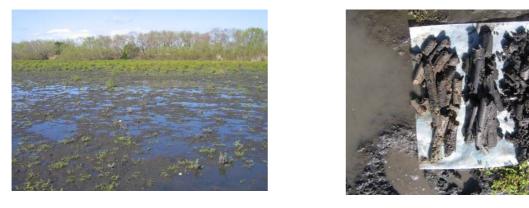
Figure 9-2. Photographs of site TBD1, showing the landscape with surface water, and the soil profile core with the upper horizon on the left and lower clay subsoil on the right.

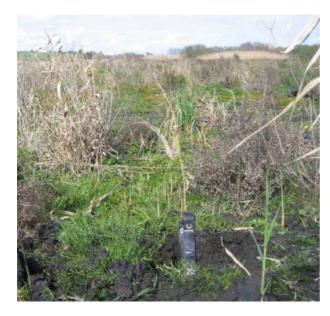
Site MRK1 (Figure 10-2) occurred in *Phragmites australis* (Common Reed) that fringe the bare surface areas around the wetland margins, the water table was at 25 cm depth. The soil consisted of grey, soft, clay, and at depth below 50 centimetres there was plant material buried with olive grey, firm, clay.

Figure 10-2. Photographs of site MRK1, showing the fringing vegetation on the hillside of the wetland, and the soil profile of structured clay surface layer with water table at approximately 25 cm.

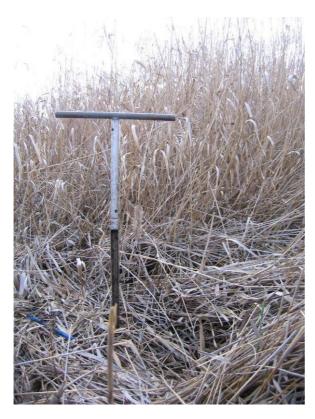
Site TOB1 (Figure 11-2) occurred in thick reeds that occurred throughout this area of the wetland. The soil consisted of brown peaty, friable, clay, over a grey brown, very firm, clay.

Figure 11-2. Photographs of site TOB1, showing the site location with thick reeds growing.

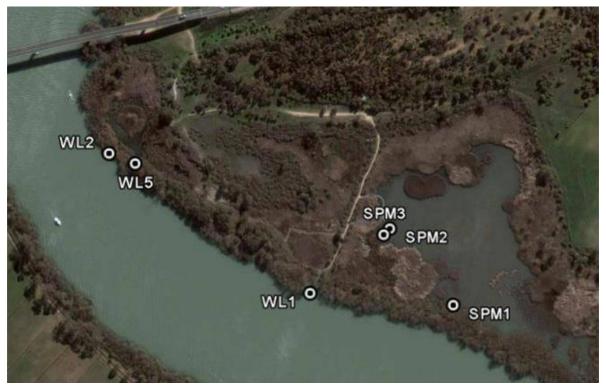
Figure 12-1. Swanport Wetland and sample site locations.

At the time of field sampling the wetland was dry. Six sites were sampled (WL1, WL2, WL5, SPM1, SPM2 and SPM3) and their locations are shown in Figure 12-1.

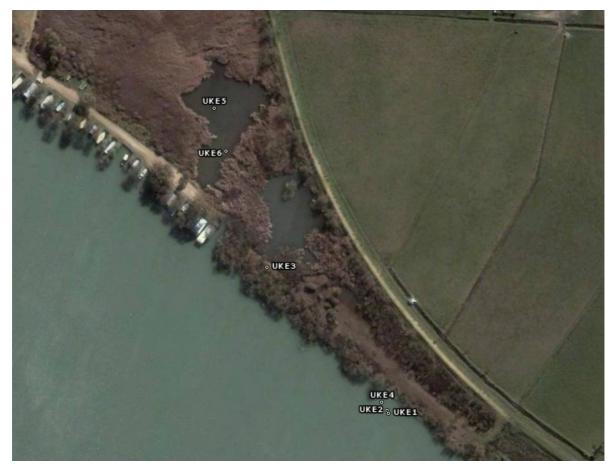
Figure 13-1. Ukee Boat Club Wetland and sample site locations.

At the time of field sampling the wetland was dry, three sites were sampled in the wetland (UKE3, UKE5, and UKE6) and three sites (UKE1, UKE2 and UKE4) were located in the river channel, and their locations are shown in Figure 13-1.

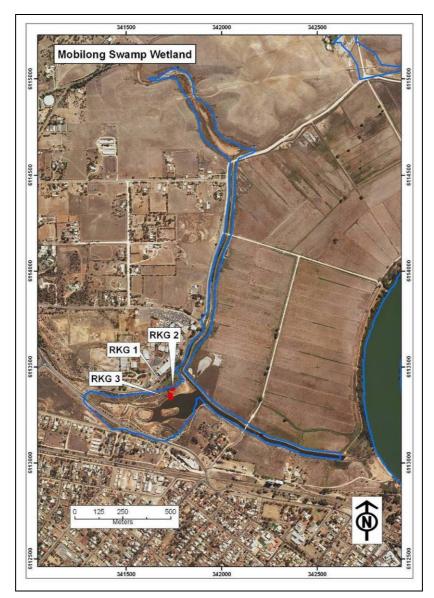
Figure 14-1. Mobilong Swamp (Rocky Gully) Wetland and sample site locations.

Mobilong Swamp (Rocky Gully) Wetland (Wetland ID. 12708) is situated on the western side of the River Murray, up river and adjacent to the town of Murray Bridge. The wetland is geomorphically categorised as a Murray Gorge basin (Pressey 1986) and is irregular in shape, with a total surface area of 28 hectares. The wetland is situated away from the river beyond farmland behind a levee bank along the river. There was an up-stream water connection channel and a major outlet channel to the river. The wetland receives surface water from stormwater in the surrounding area that includes dairy farms, an abattoir, and residential housing. Water is held in the wetland by a structure in the outlet channel and water can become extremely saline during the summer months. Additionally nutrients from run off may also deteriorate water quality. At the time when the soil survey was conducted in October 2008, the wetland had surface water in the centre and along the channels. On the wetland margins at a slightly higher elevation *Typha latifolia* (Bulrush) and *Phragmites australis* (Common Reed) were growing. Three sites were described and sampled and their locations are shown in Figure 14-1.

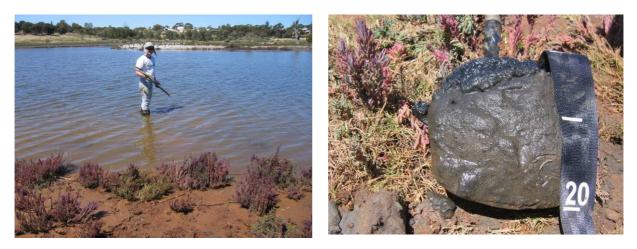
Figure 14-4. Photographs of site RKG3, showing the site location (marked by the person) in shallow surface water, and the soil profile of the upper layers of black monosulfidic material over sandy clay.

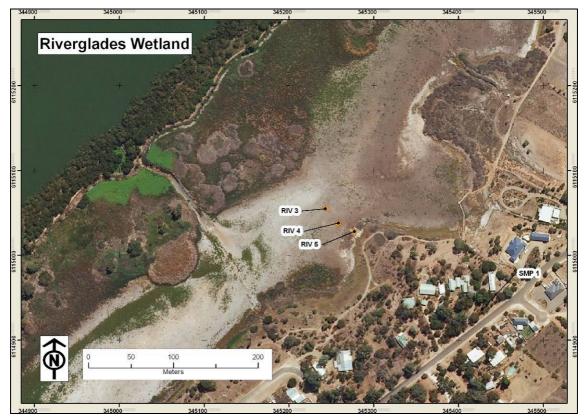
Figure 15-1. Riverglades wetland and site locations.

Three survey sites along one transect were located in the northern lagoon (Sites RIV 3, 4 and 5). The cross section spanned the deepest area of the wetland (RIV 3), mid (RIV4), and near the high water mark (RIV 5). The wetland and sample site locations are shown in Figure 15-1.

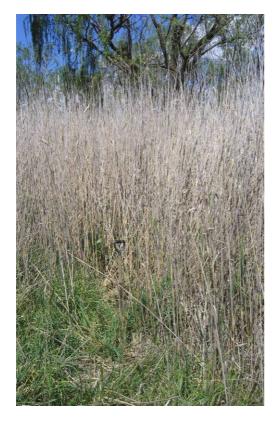
Site TLE1 (Figure 17-2) occurred in the low elevation area of the wetland where tall and thick reeds and sedges were growing. The soil consisted of dark brown, clay, over a black, very hard, clay that was too difficult to dig.

Figure 17-2. Photograph of site TLE1, showing the site location (marked by the shovel handle) amongst tall and thick *Phragmites australis* (Common Reed) vegetation.

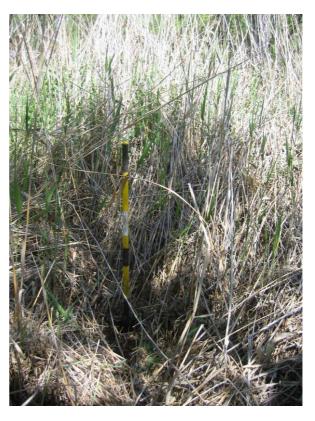
Site TLE2 (Figure 17-3) occurred where there were reeds growing on slightly elevated areas. The soil consisted of a dark brown, clayey peat, over grey, very firm, clay.

Figure 17-3. Photograph of site TLE2, showing the site location (marked by yellow shovel handle) amongst tall *Phragmites australis* (Common Reed) vegetation.

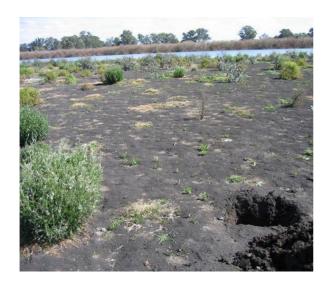
Site SDO1 (Figure 18-2) occurred in an area that had no vegetation growing and a few mussel shells on the black crusted surface that possibly was dry monosulfidic material, and the soil consisted of black, firm, clay with orange mottles along root channels between 5 and 70 centimetres in depth, over an olive grey, soft, clay.

Figure 18-2. Photographs of site SDO1, showing the site location where the surface was black and friable, and the soil profile that was firm clay with bright orange mottles in root channels.

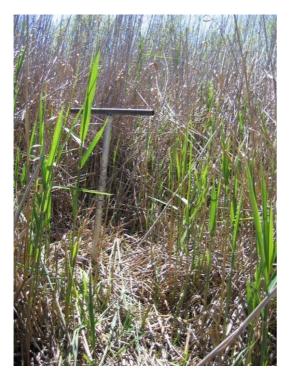
Site MLE2 (Figure 19-3) occurred where reeds were growing. The soil consisted of redbrown, friable, clayey peat, over a dark grey, very firm, clay.

Figure 19-3. Photographs of site MLE2, showing the site location (marked by the auger) amongst *Phragmites australis* (Common Reed) vegetation.

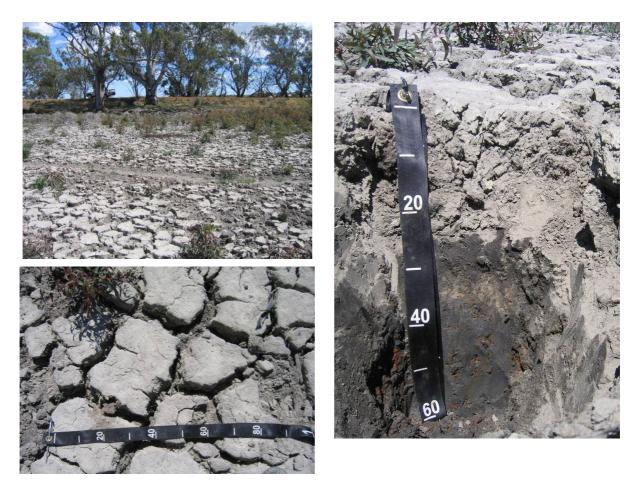
Figure 19-4. Photographs of site MLE3, showing the site landscape where there were few plants growing and the hard cracking clay surface, and the soil profile of blocky clay at the surface over clay with isolated red mottles in the soil matrix.

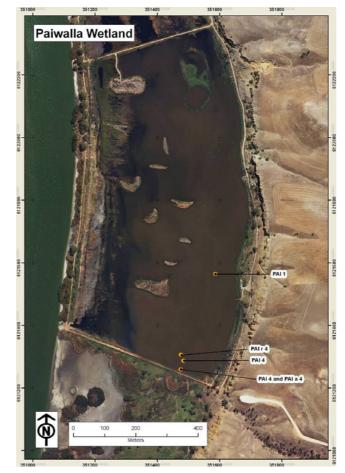
Figure 20-1. Sunnyside - Paiwalla Managed Wetland and sample site locations.

Two locations were sampled PAI 1 and the collection of sites that are associated with PAI 4. The sites sampled and their location is shown in Figure 20-1.
