**APPENDIX B3 – WETLAND DESCRIPTIONS FOR ASSESSMENT OF ACID
SULFATE SOIL MATERIALS IN THE LOCK 1 TO WELLINGTON
REGION OF THE MURRAY-DARLING BASIN**

41 TEAL FLAT (UPSTREAM) WETLAND (WETLAND ID. 12005)

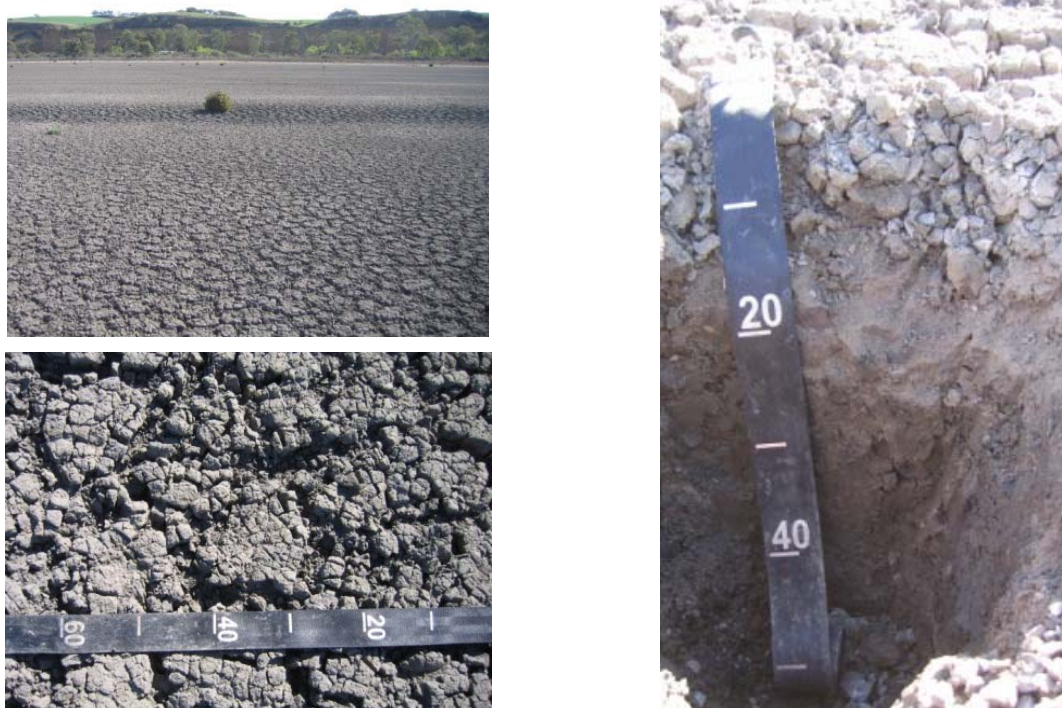
Site TFL1 (Figure 41-2) occurred in the bare cracking clay surface area. The soil consisted of dark grey to black, very firm, clay that was too rigid to dig below 50 centimetres.

Figure 41-2. Photographs of site TFL1, showing the landscape across the wetland to the river in the background and the cracking clay surface that was breaking down into aggregates, and the soil profile of crumbling surface aggregates over a very firm clay.

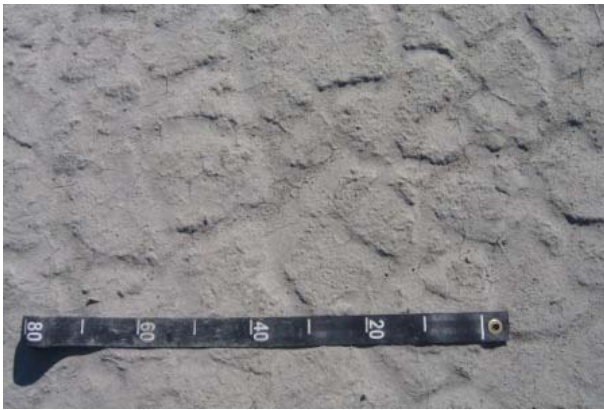
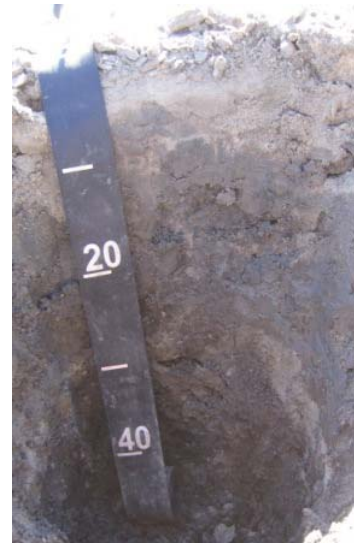
Site TFL2 (Figure 41-3) occurred in the bare cracking clay surface area where the cracks had been filled with sand to form a sealed surface. The soil consisted of dark grey, firm, clay that was too rigid to dig below 70 centimetres.

Figure 41-3. Photographs of site TFL2, showing the soil cracks filled by windblown sand, and the soil profile with the sand filling cracks between the firm clay columns.

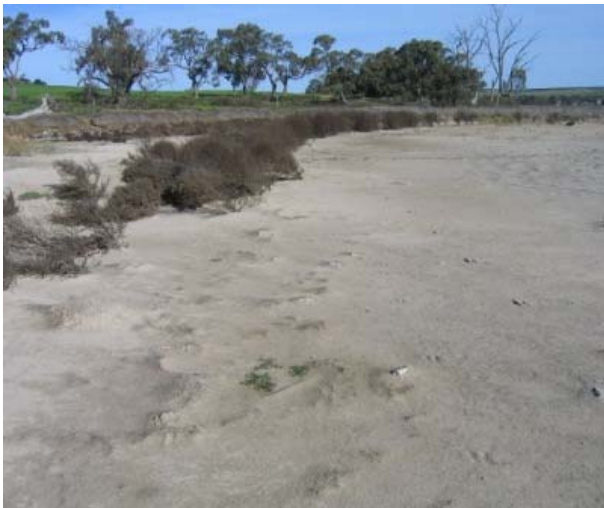
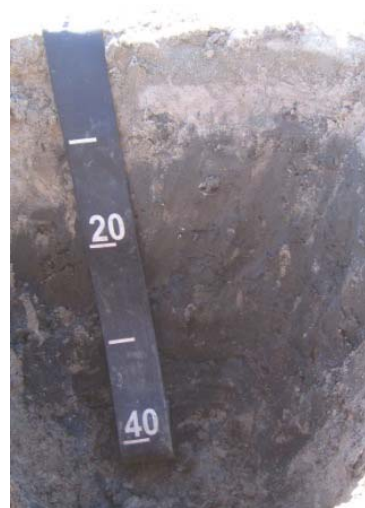
Site TFL3 (Figure 41-4) occurred near the edge of the wetland where sand was encroaching over the surface and *Phragmites australis* (Common Reed) were growing, the surface was bare with loose sand. The soil consisted of pale brown loose sand over black very firm clay.

Figure 41-4. Photographs of site TFL3, showing the landscape along the wetland margin with sand encroaching onto the wetland surface, and the soil profile of loose sand over very firm clay.

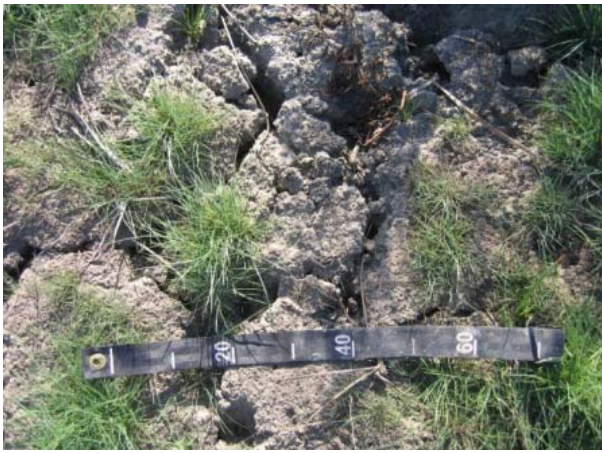
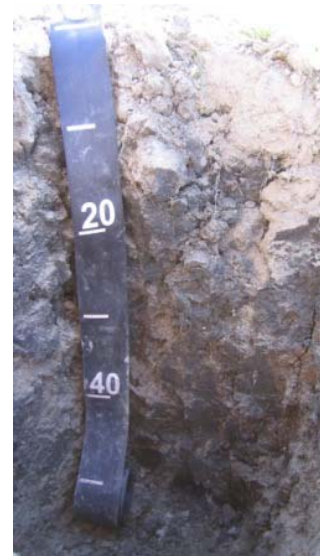
Site CLG1 (Figure 42-2) occurred on the river side of the wetland in the cracking clay area that had some plant growth that was at a high elevation grading up to the river bank. The soil consisted of black, slightly rigid clay over clay too hard to dig.

Figure 42-2. Photographs of site CLG1, showing the cracking soil surface and vegetation growing on the surface, and the soil profile of black, slightly rigid clay.

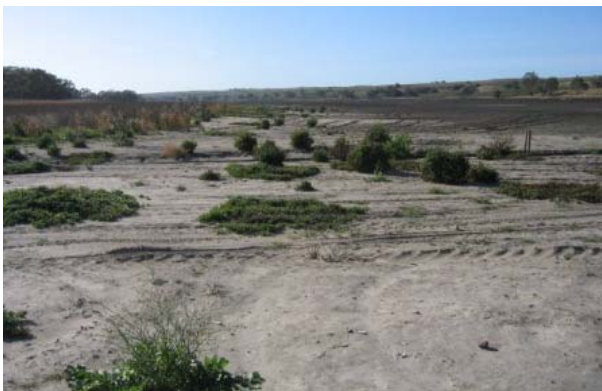
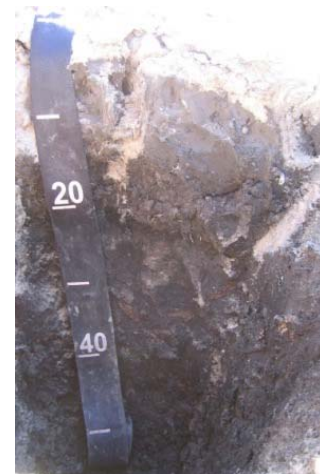
Site CLG2 (Figure 42-3) occurred mid elevation where there was a loose sandy surface with some plants growing. The soil consisted of a black, very firm, clay.

Figure 42-3. Photographs of site CLG2, showing the wetland margin with sand encroaching onto the wetland surface, and the soil profile of black, very firm, clay.

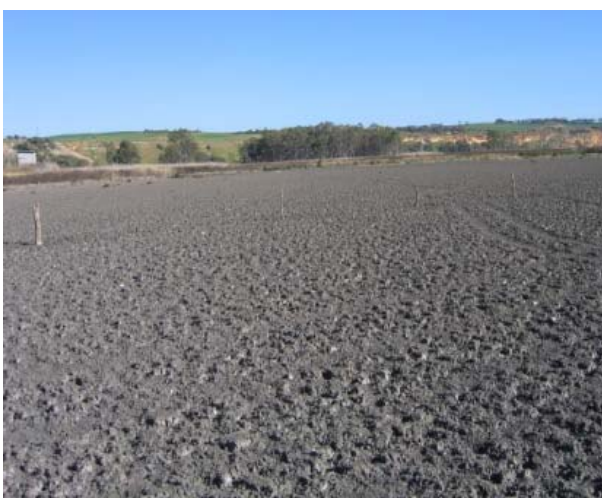
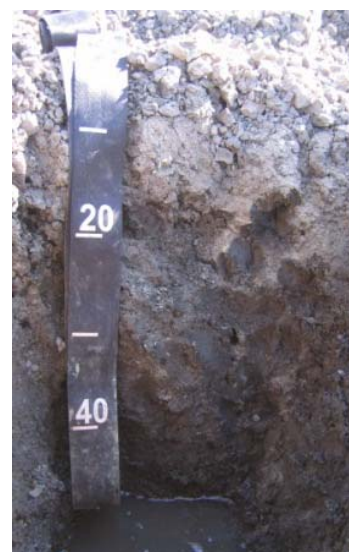
Site CLG3 (Figure 42-4) occurred in a bare area where the columns from the cracking clay had broken down into aggregates. The soil consisted of black, very firm, clay.

Figure 42-4. Photographs of site CLG3, showing the main wetland area that had no vegetation growing on it and the breaking down of the surface layer into aggregates, and the soil profile of firm clay with the cracks filled with surface aggregates.

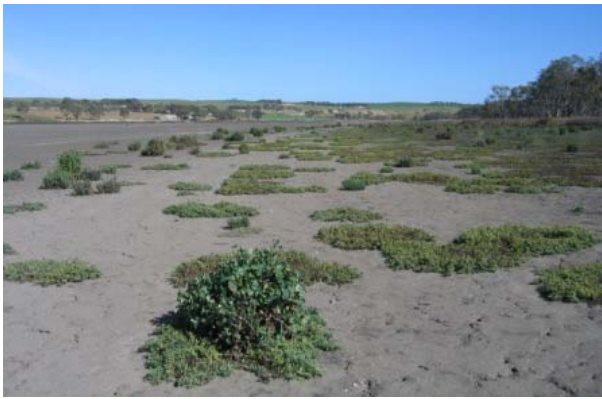
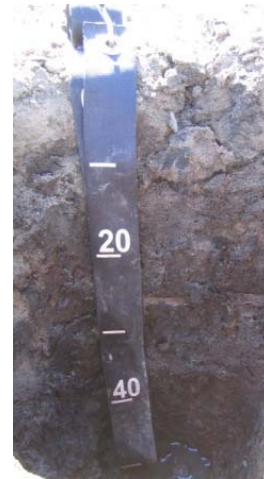
Figure 42-5. Photographs of site CLG4, showing the crusted surface of the wetland margin near the raised terrace adjacent to the river, and the soil profile of black firm clay.

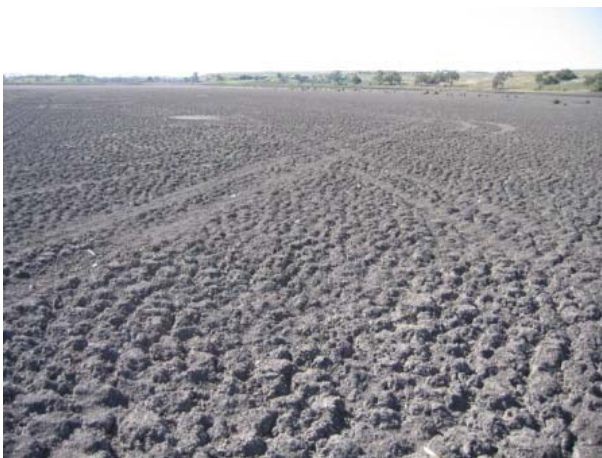
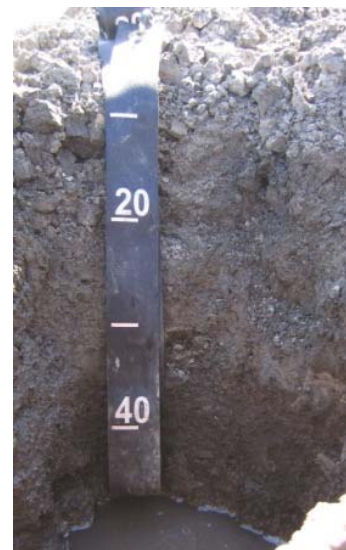
Site CLG5 (Figure 42-6) occurred in the lowest area of the wetland where the surface was bare with loose aggregates from the broken columns formed when the surface cracked open. The soil consisted of a black, very firm clay.

Figure 42-6. Photographs of site CLG5, showing the main wetland area with columns breaking down into aggregates filling the cracks, and the soil profile of very firm clay.

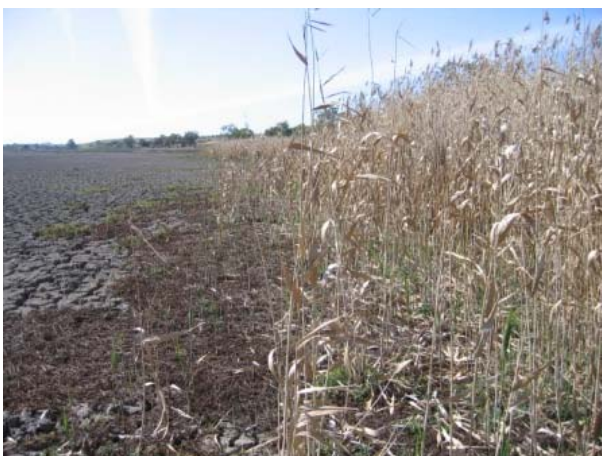
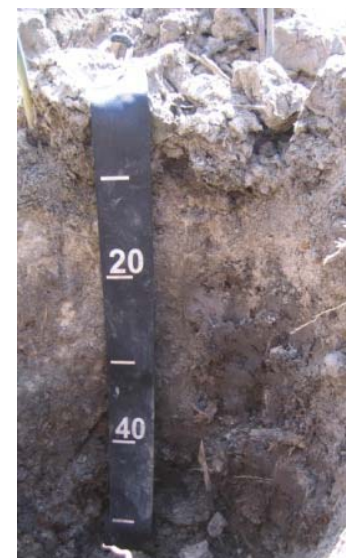
Figure 42-7. Photographs of site CLG6, showing the landscape of the wetland margin where *Phragmites australis* (Common Reed) was growing, and the soil profile of dark grey, very firm clay.

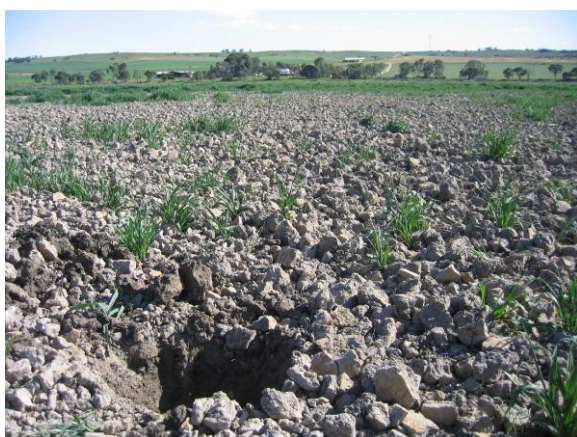
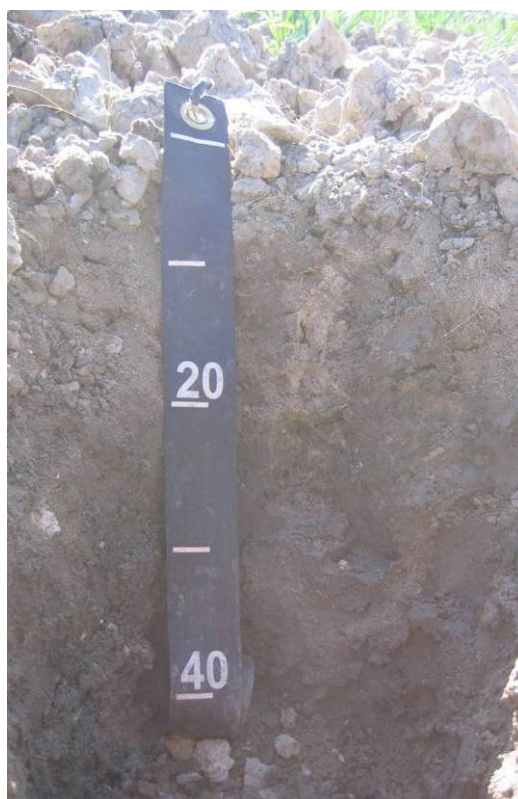
Site MDT1 (Figure 43-2) occurred at the low elevation area that dominated the main area of the wetland where the cereal crop was growing. The soil consisted of grey, very firm, clay over clay that became too hard to dig.

Figure 43-2. Photographs of site MDT1, showing the cultivated cloddy surface of the main wetland area, and the soil profile of rigid, cloddy, clay over very firm, clay.

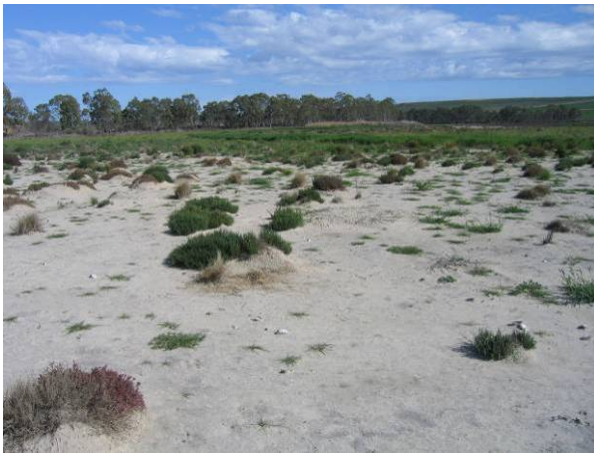
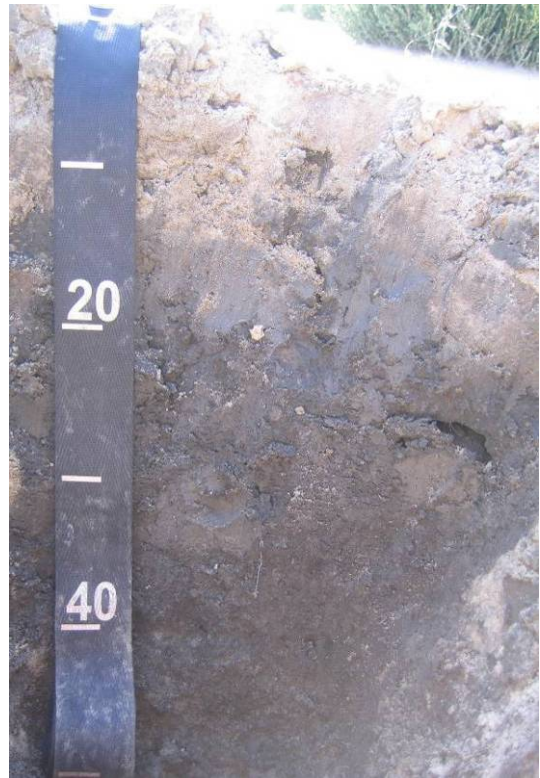
Figure 43-3. Photographs of site MDT2, showing sandy surface at mid elevation, and the soil profile of friable, sandy loam, over firm clay.

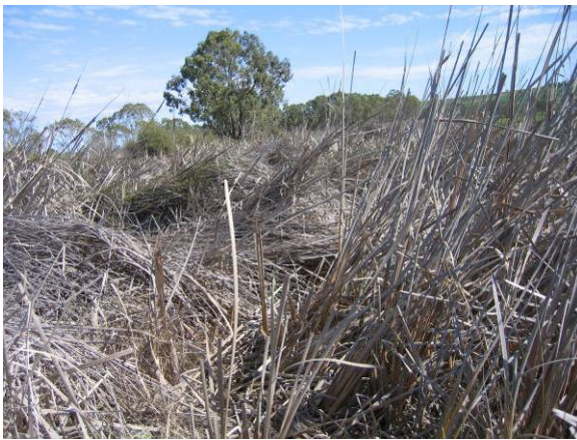
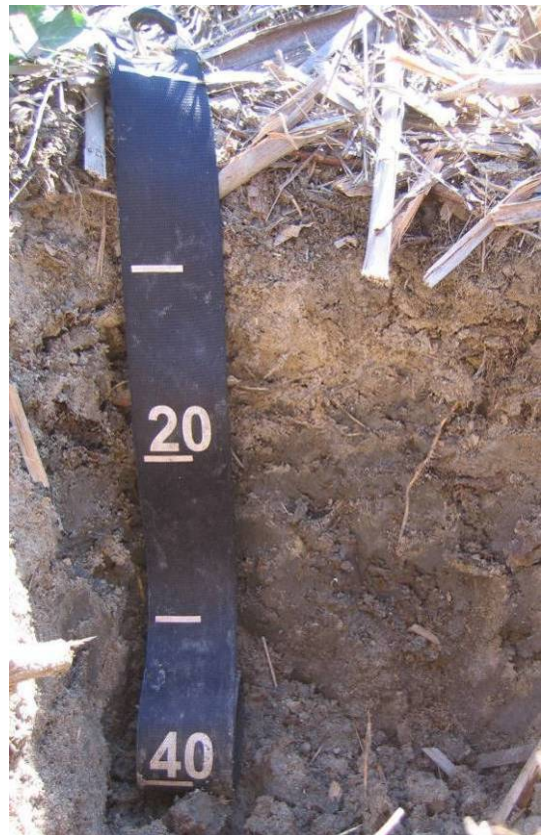
Site MDT3 (Figure 43-4) occurred at a higher elevation on the wetland margin where *Typha latifolia* (Bulrush) was growing. The soil consisted of pale brown, loose, loamy sand, over grey, firm, clay.

Figure 43-4. Photographs of site MDT3, showing the wetland margin where reeds were growing, and the soil profile of loose sand, over firm clay.

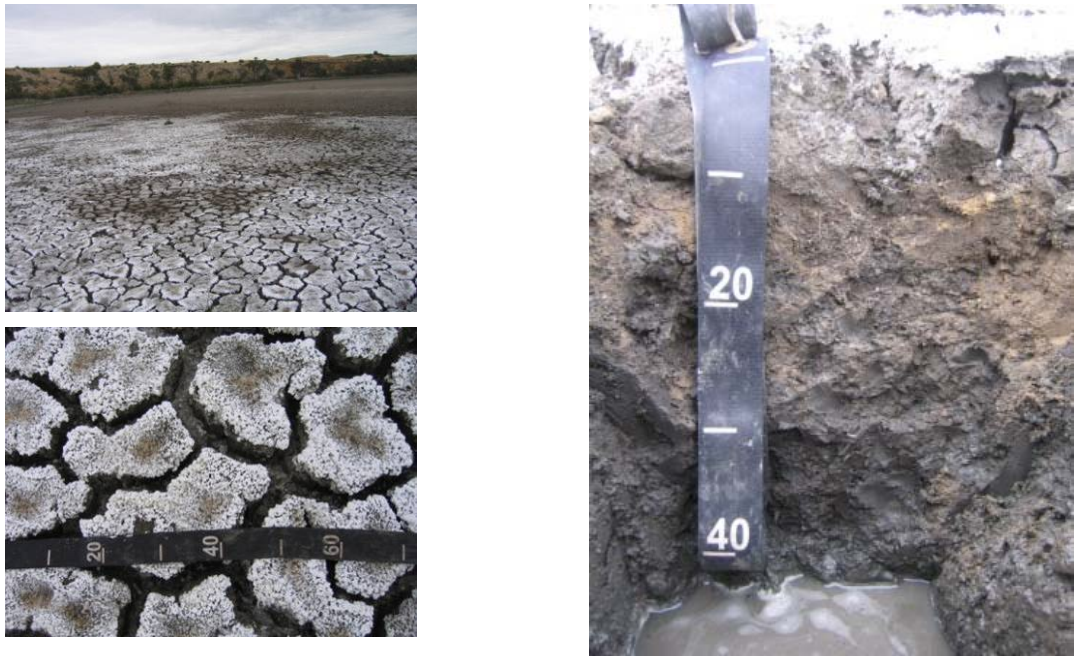
Figure 44-2. Photographs of site BWH1, showing the salt crust on the cracking clay surface, and the soil profile with the water table at about 45 cm.

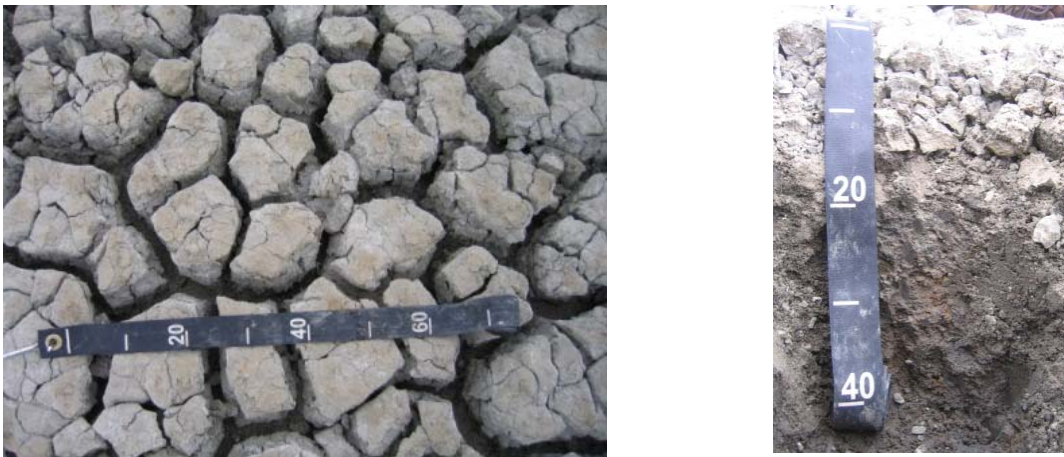
Site BWH2 (Figure 44-3) occurred in the low centre area of the wetland that was bare with large columns forming deep cracks extending into the subsoil. The soil consisted of light grey, extremely hard, clay with salts on the column faces, over black, firm, clay with red mottles in the soil matrix.

Figure 44-3. Photographs of site BWH2, showing the very hard clay surface with deep cracks, and the soil profile with a surface layer of extremely hard clay aggregates over a very firm clay.

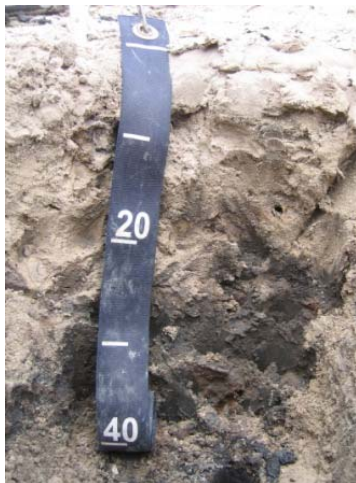
Site BWH3 (Figure 44-4) occurred where *Typha latifolia* (Bulrush) was growing on the higher elevation side of the wetland margin. The soil consisted of brown, loose, sand, over black, very firm, clay with red mottles on ped faces.

Figure 44-4. Photograph of site BWH3, showing the soil profile of the encroaching surface sand over very firm clay.

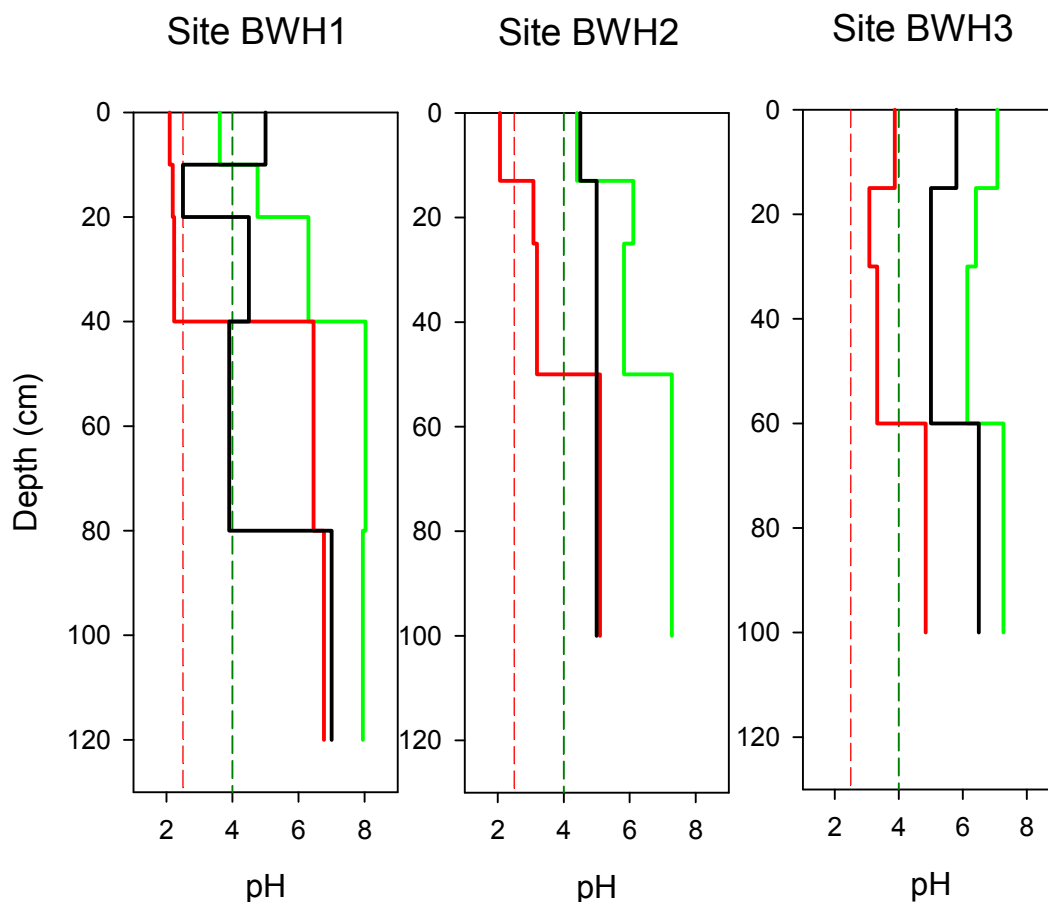
The pH_{OX} data for the surface layers of profiles BWH1 and BWH2 identified samples below the critical value of $pH_{OX} < 2.5$, the threshold value normally used to indicate a high likelihood of sulfuric material forming.

Figure 44-5. Depth profiles of soil pH for Bow Hill wetland, showing soil pH (pH_W as green line), and peroxide treated pH (pH_{OX} as red line) and ageing pH (pH_{INC} after 28 weeks as black line). Critical pH_W and pH_{INC} value of 4 (black dashed line) and critical pH_{OX} value of 2.5 (red dashed line).

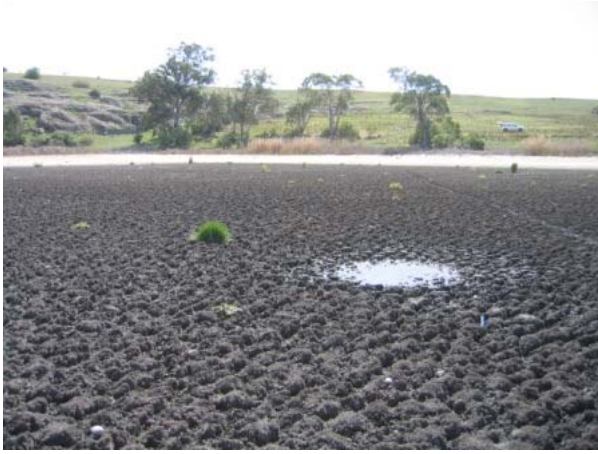
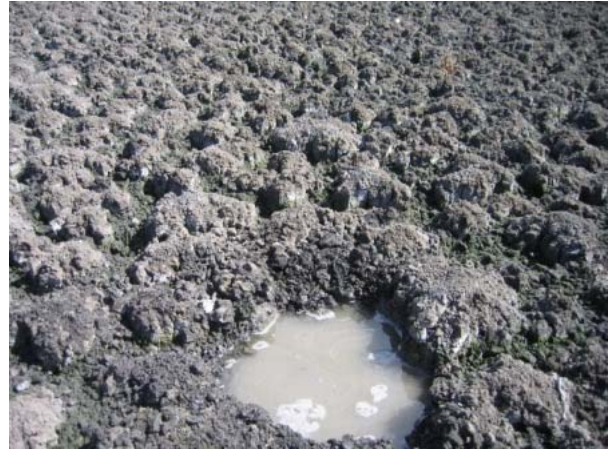
Figure 45-2. Photographs of site CNK1, showing the main wetland area with the tops of the soil columns breaking down and the aggregates filling cracks, and the soil profile with the water level near the surface.

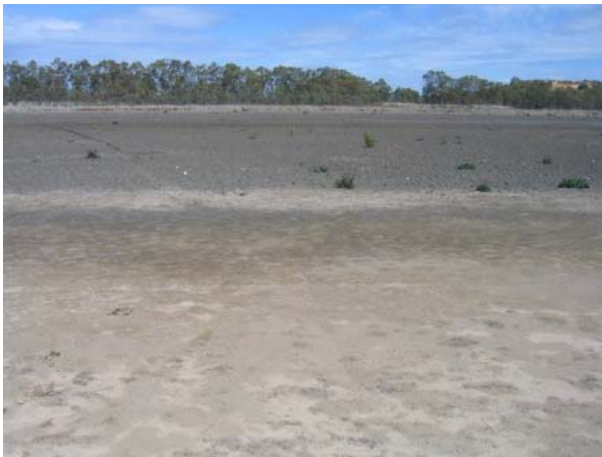
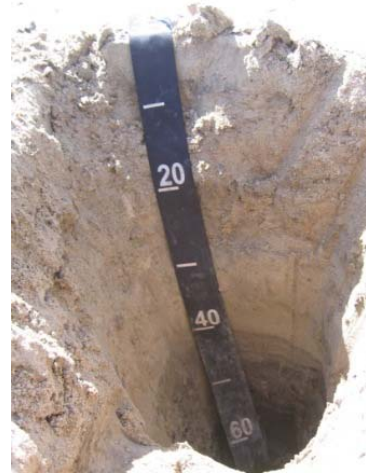
Figure 45-3. Photographs of site CNK2, showing the sand encroaching from the margins over the cracking clay soils of the wetland, and the soil profile of deep loose sand.

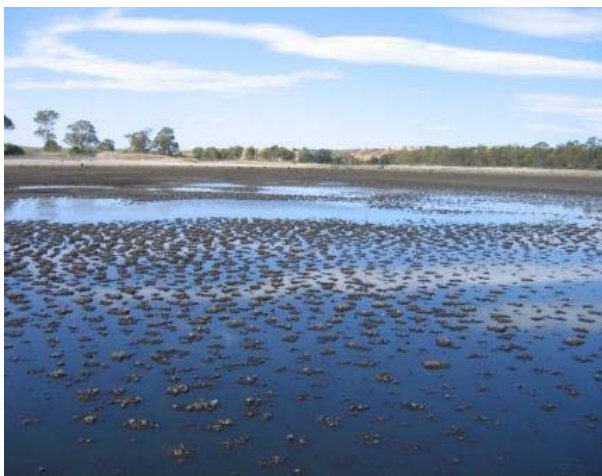
Figure 45-4. Photograph of site CNK3, showing the shallow surface water probably from upwelling of ground water seep.

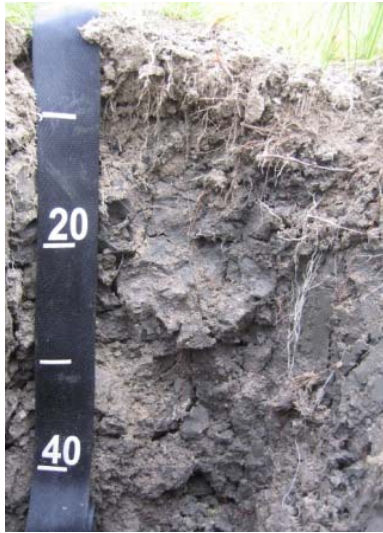
Figure 46-2. Photograph of site SBF1, showing the soil profile of a well structured firm clay soil.

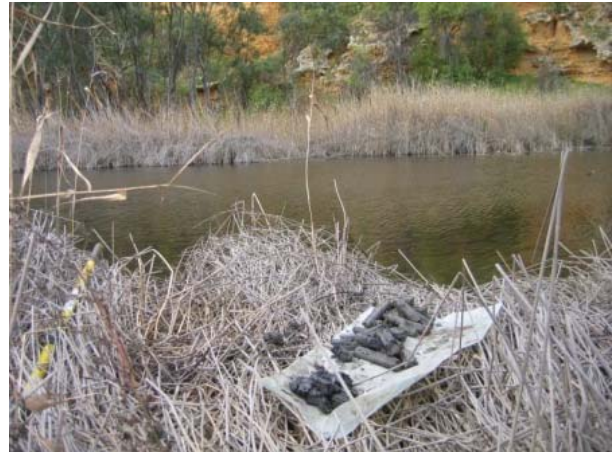
Site SBF2 (Figure 46-3) occurred in a water pond at the base of the cliff, surrounded by *Phragmites australis* (Common Reed) and was part of the narrow channel to the downstream outlet, the water was probably from a spring or seepage from the cliffs, the water was about 10 centimetres deep, and the soil consisted of black, soft peaty clay over olive grey, firm clay.

Figure 46-3. Photograph of site SBF2, showing surface water near the base of the cliff.

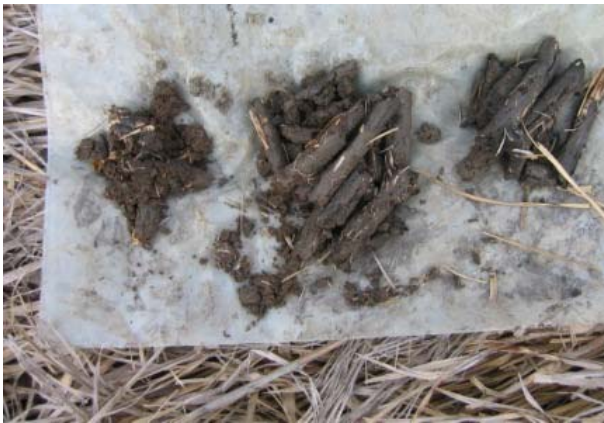
Site SBF3 (Figure 46-4) occurred in the mid to high elevation near the river and on the side of an inlet which had dense growth of *Phragmites australis* (Common Reed). The soil consisted of dark brown friable clay, over grey firm clay.

Figure 46-4. Photograph of site SBF3, showing the soil profile core with upper soil of brown friable clay on the left and grey firm clay on the right.

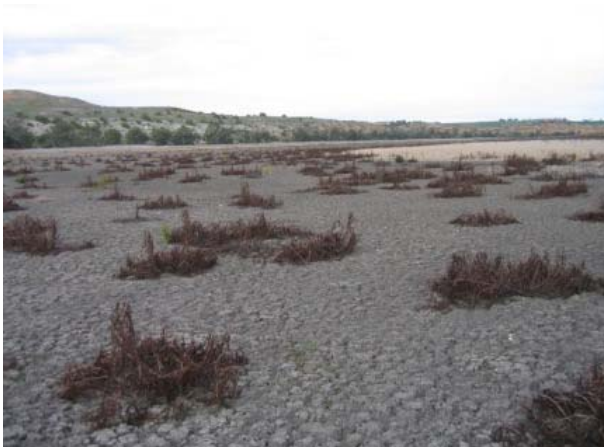
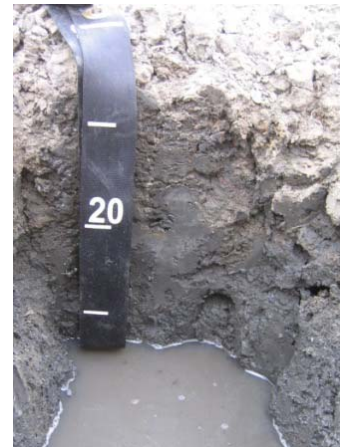
Figure 46-5. Photographs of site SBF4, showing the main wetland landscape of cracking clay surface, and the soil profile of friable, grey clay and the water table at about 35 cm.

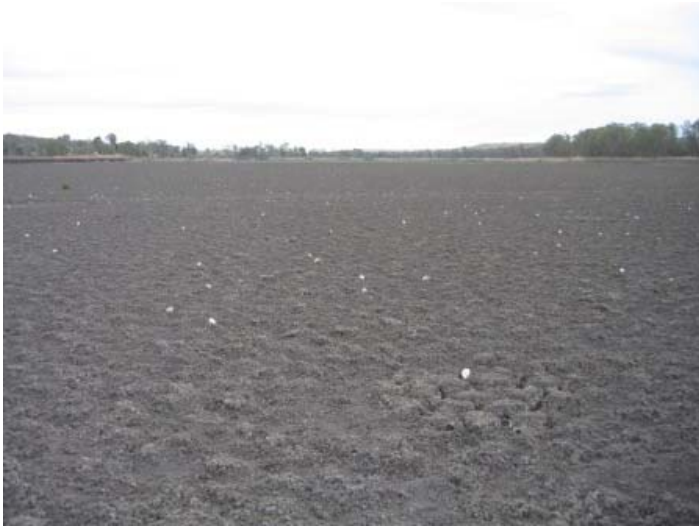
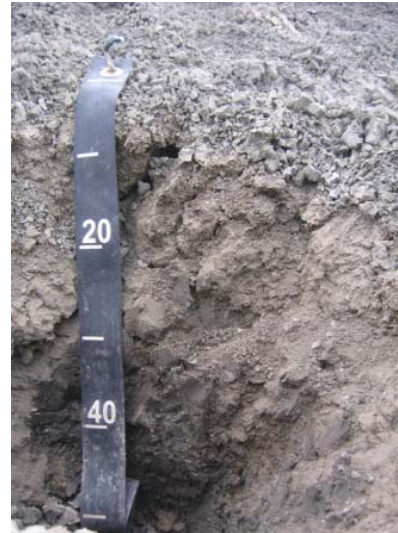
Figure 47-2: Photographs of site CMT1, showing the wetland landscape to the northwest from the profile location with broken surface aggregates that filled the cracking clay surface, and the soil profile with very hard grey clay below about 30cm.

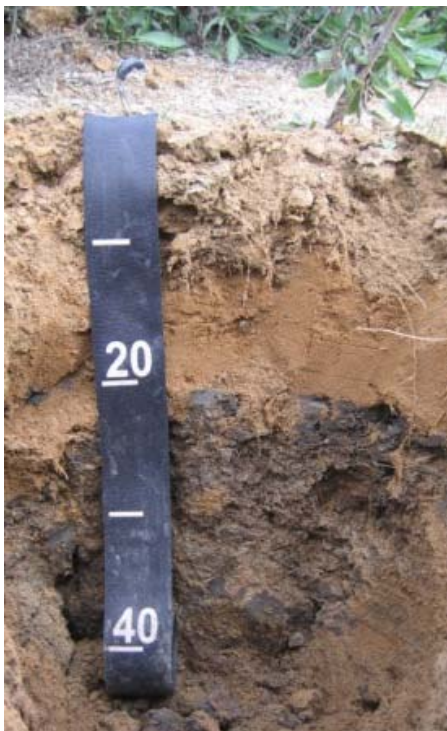
Figure 47-3. Photograph of profile CMT2, showing the soil profile with loose sand to about 15 cm over the grey clay.

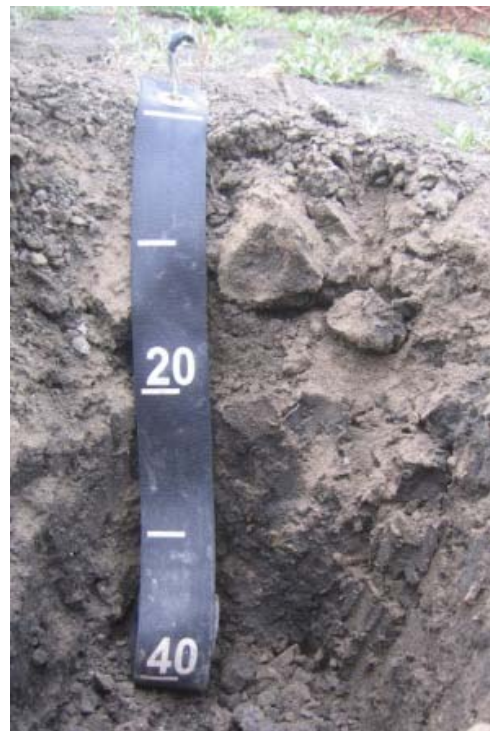
Figure 47-4. Photograph of profile CMT3, showing the soil profile with aggregates in-filling the surface cracks and subsoil of rigid clay that was too hard to dig below 40 cm.

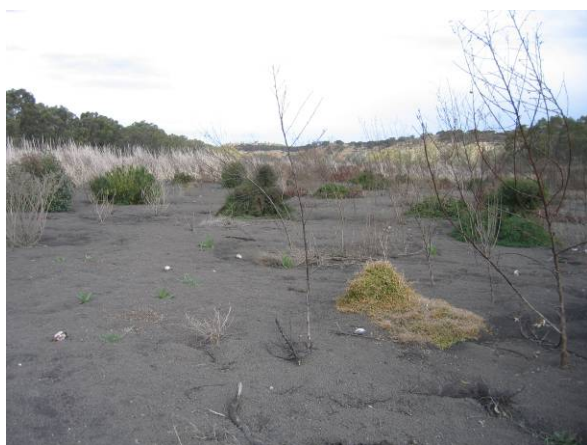
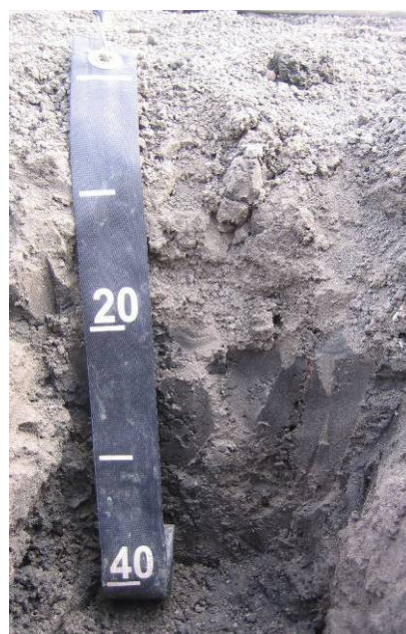
Figure 49-2. Photographs of site NCT1, showing the site location where the surface was bare, and the soil profile of black, slightly rigid, clay.

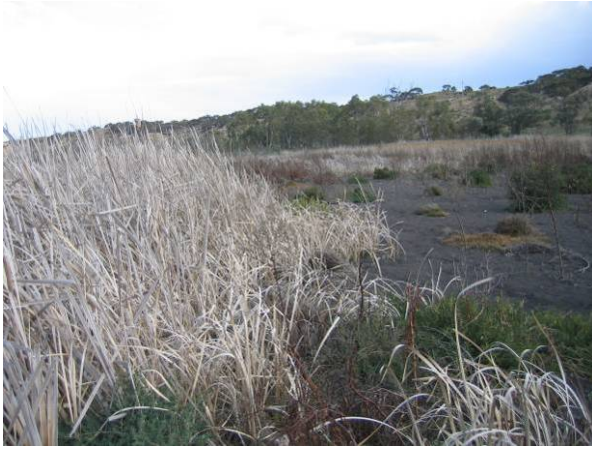
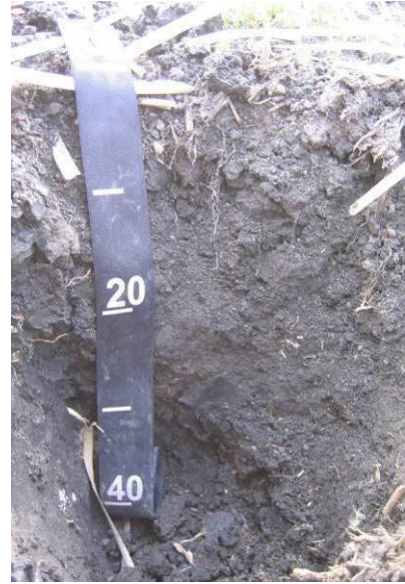
Site NCT2 (Figure 49-3) occurred on the wetland margin where *Typha latifolia* (Bulrush) was growing. The soil consisted of black, very firm, clay, over clay that was too hard to dig.

Figure 49-3. Photographs of site NCT2, showing the wetland margin where bulrushes were growing, and the soil profile of black, very firm, clay.

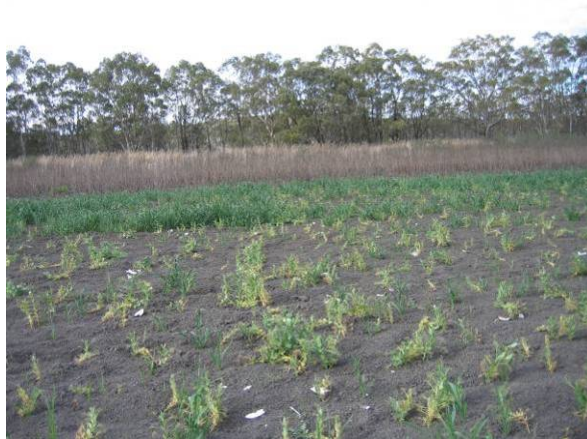
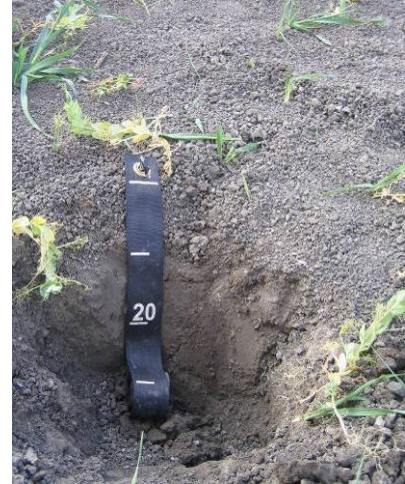
Site NCT3 (Figure 49-4) occurred in the low elevation area of the wetland that was characteristic of a large portion of the wetland. A cereal crop was growing on the cracking clay surface that had been tilled into large clods. The soil consisted of black, rigid, clay, over clay that was too hard to dig.

Figure 49-4. Photographs of site NCT3, showing the main wetland area where cereal crop was growing in the cloddy surface, and the soil profile of black, rigid, clay.

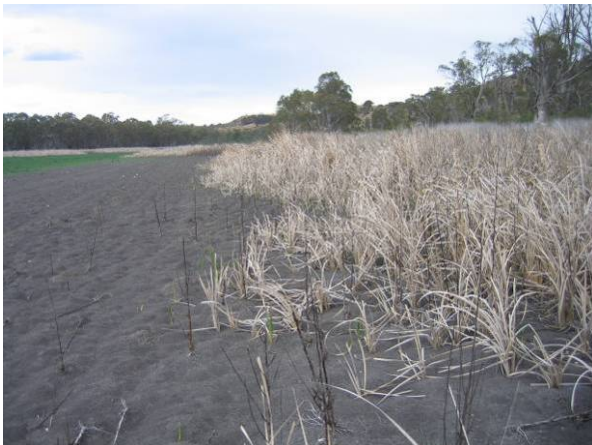
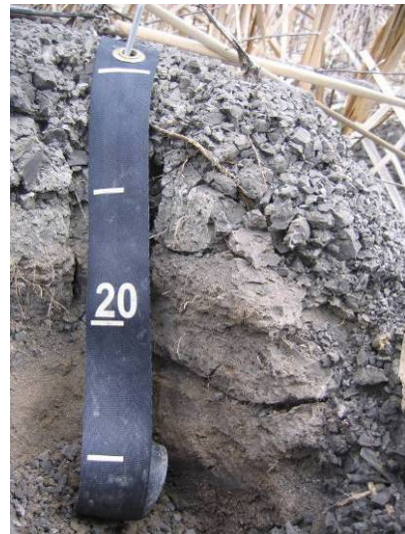
Site NCT4 (Figure 49-5) occurred at a higher elevation where *Typha latifolia* (Bulrush) was growing on the wetland margins. The soil consisted of dark grey, rigid, clay, over clay that was too hard to dig.

Figure 49-5. Photographs of site NCT4, showing the wetland margin, and the soil profile of rigid, clay.

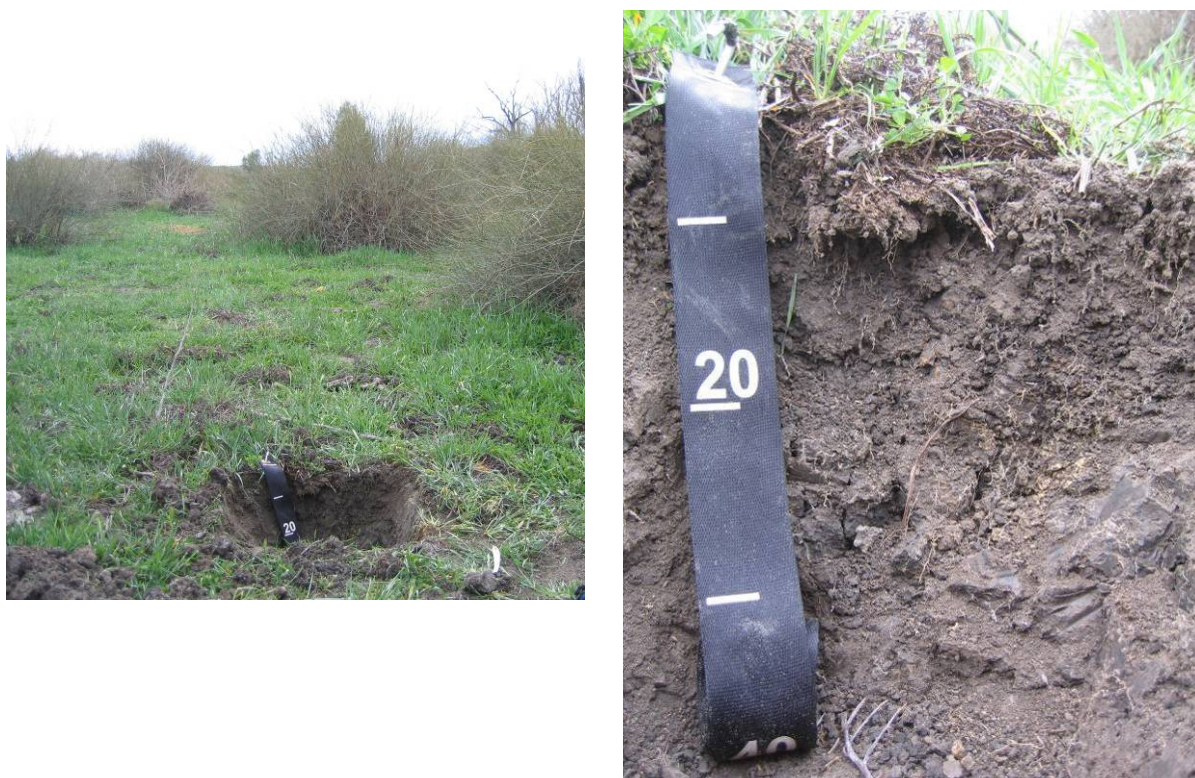
Site SCF1 (Figure 50-2) occurred in a low elevation channel depression, and the soil consisted of black, slightly rigid, clay, over clay that became too hard to dig below 30 centimetres depth.

Figure 50-2. Photographs of site SCF1, showing the site location in an area with grasses and *Muehlenbeckia florulenta* (*Lignum*) growing, and the soil profile of very hard, blocky structured, clay.

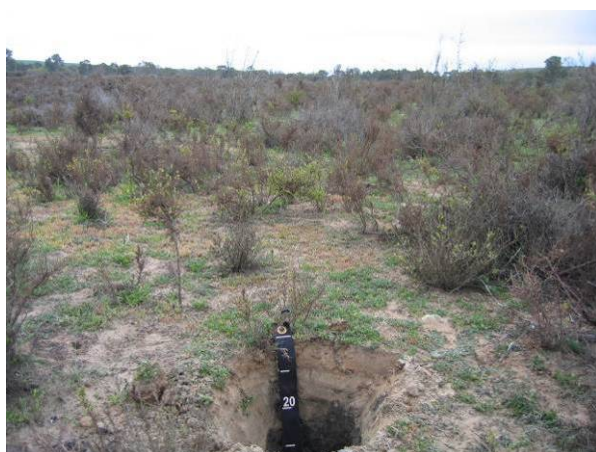
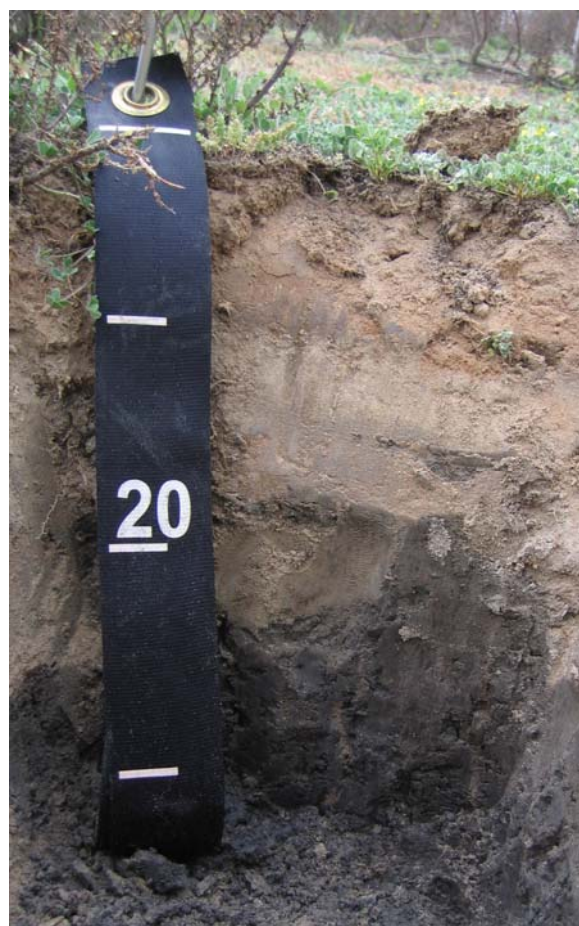
Figure 51-2. Photographs of site SCF2, showing the sandy surface and *Muehlenbeckia florulenta* (Lignum) growing, and the soil profile of loose sand over extremely hard clay below approximately 20 centimetres depth.

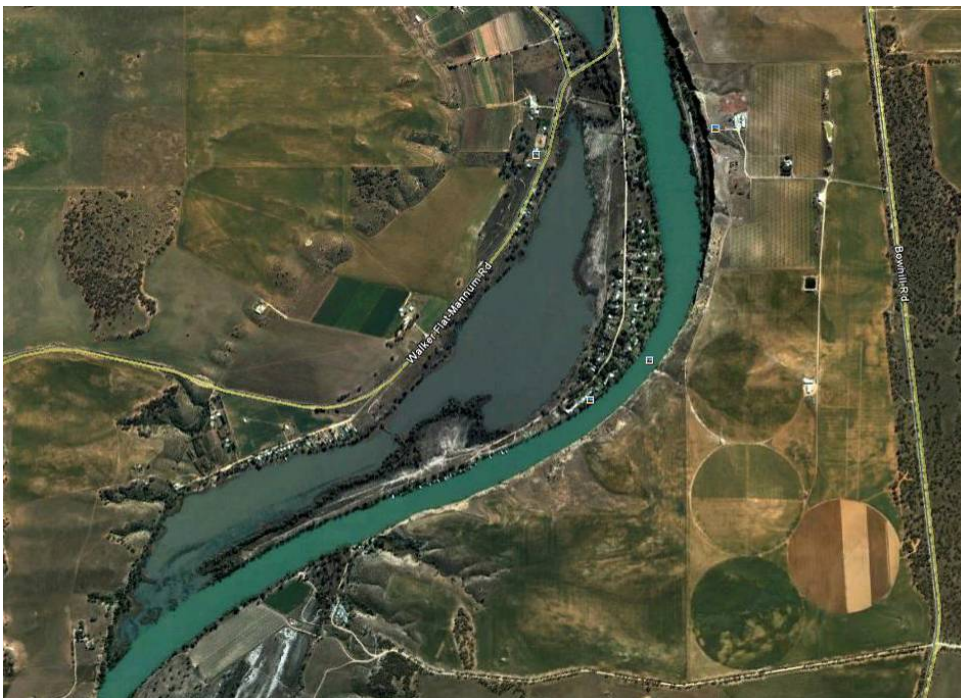
Figure 52-1. Walker Flat South Lagoon Wetland.

At the time of field sampling the wetland had some surface water and the sites were located near the wetland margin. Two sites were sampled (Sites WL8 and WL9) and the wetland is shown in Figure 52-1.

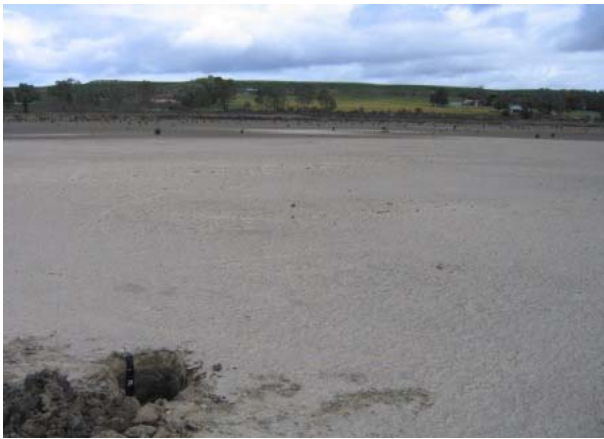
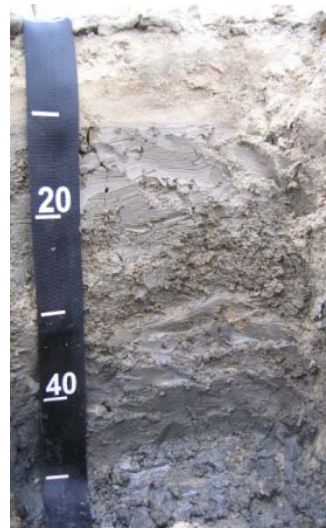
Figure 53-2. Photographs of site LBY1, showing the wind blown sand encroaching onto the wetland surface, and the soil profile of sand over clay.

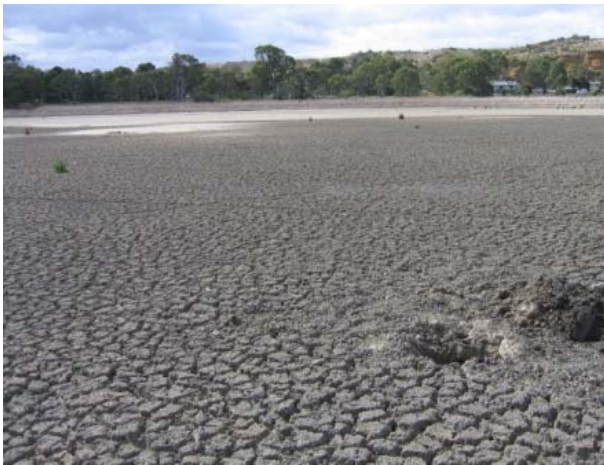
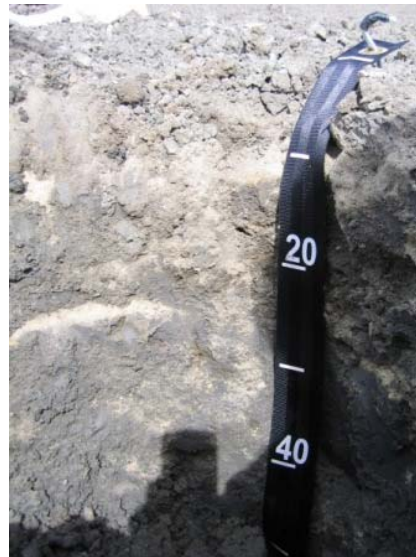
Figure 53-3. Photographs of site LBY2, showing the cracking clay surface with the windblown sand on the wetland surface in the background, and the soil profile of firm clay.

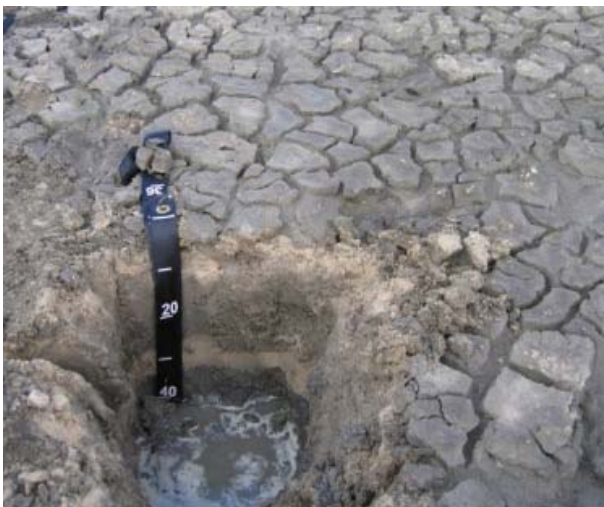
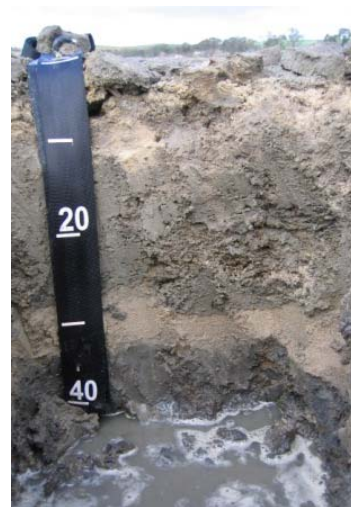
Figure 53-4. Photographs of site LBY3, showing the cracking clay surface, and the soil profile with the water table at about 50 cm.

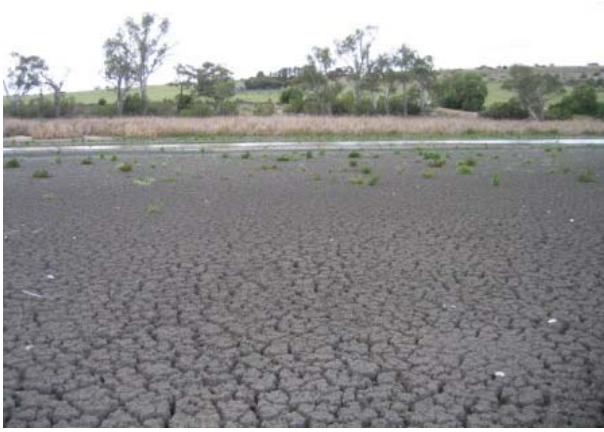
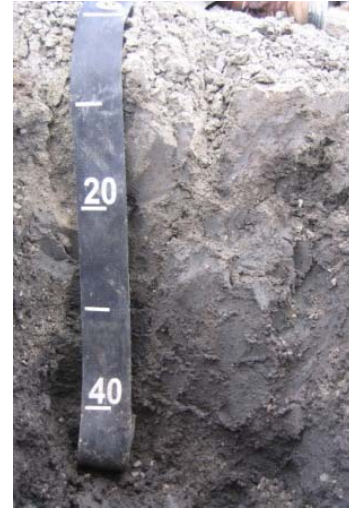
Figure 54-2. Photographs of site FRL1, showing the cracking clay surface of the main wetland area, and the soil profile of very firm clay.

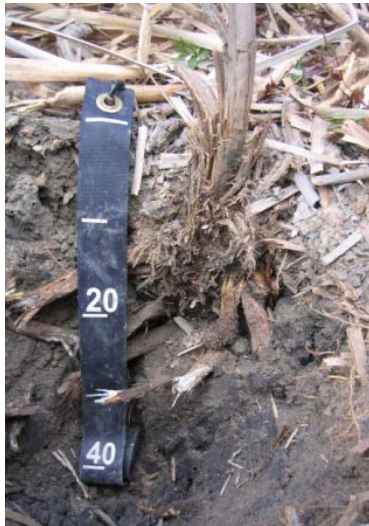
Figure 54-3. Photograph of site FRL2, showing the soil profile of rigid clay and *Phragmites australis* (Common Reed) roots.

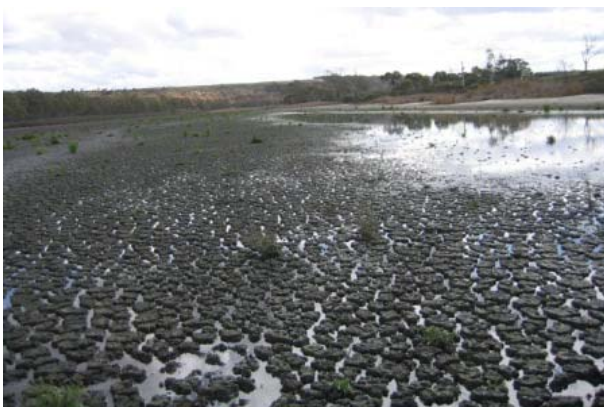
Figure 54-4. Photograph of site FRL3, showing the shallow surface water in soil cracks and the low depression located near the hill slope.

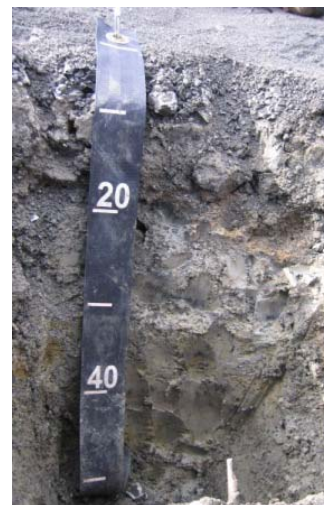
Figure 54-5. Photograph of site FRL4, showing the soil profile of friable clay aggregates to about 20 cm over a firm clay.

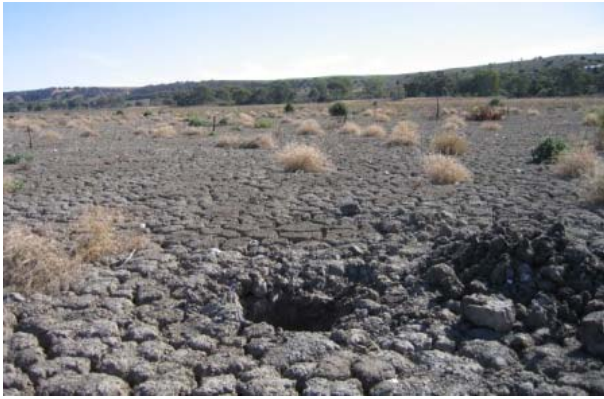
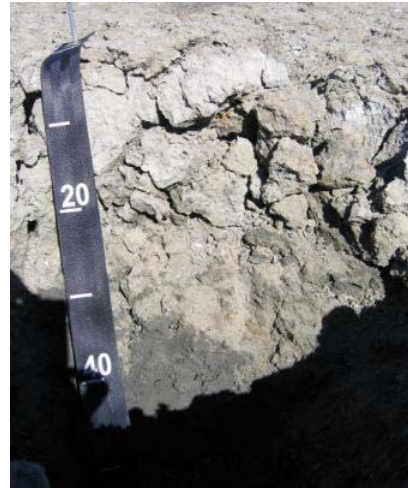
Figure 55-2. Photographs of site WON1, showing the main wetland area of cracking clay soils, and the soil profile of very firm clay.

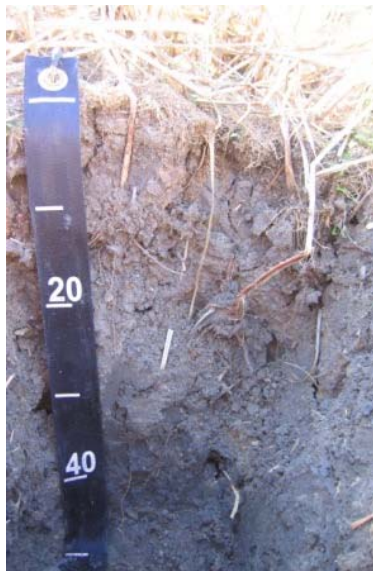
Figure 55-3. Photograph of site WON2, showing the soil profile of grey clay and *Phragmites australis* (Common Reed) roots.
