**APPENDIX B3 – WETLAND DESCRIPTIONS FOR ASSESSMENT OF ACID
SULFATE SOIL MATERIALS IN THE LOCK 1 TO WELLINGTON
REGION OF THE MURRAY-DARLING BASIN**

41 TEAL FLAT (UPSTREAM) WETLAND (WETLAND ID. 12005)

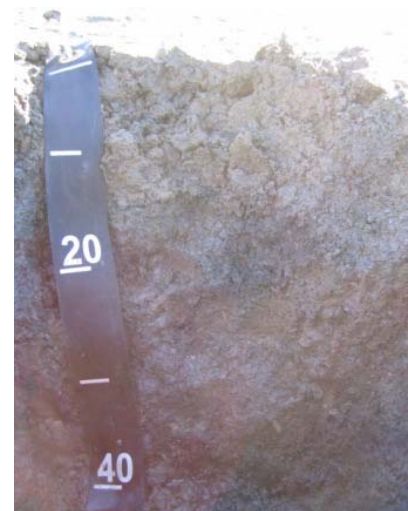
Site WON3 (Figure 55-4) occurred near the down river channel and close to where water was on the surface in a depression. The soil consisted of a thin grey, soft clay over a black, firm, and at depth, olive grey, firm clay.

Figure 55-4. Photographs of site WON3, showing the soft clay surface, and the soil profile of olive grey clay.

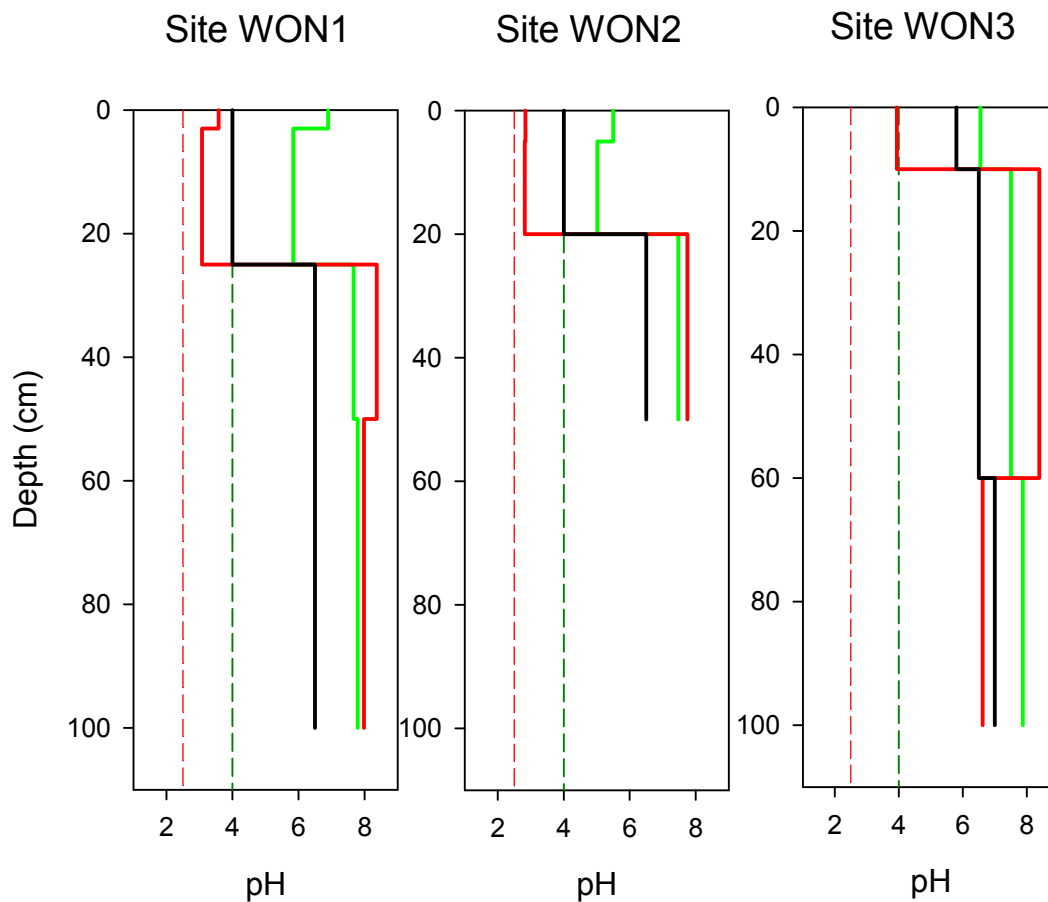
Figure 55-5. Depth profiles of soil pH for Wongulla Lagoon Wetland, showing soil pH (pH_W as green line), peroxide treated pH (pH_{OX} as red line) and ageing pH (pH_{INC} after 28 weeks as black line). Critical pH_W and pH_{INC} value of 4 (black dashed line) and critical pH_{OX} value of 2.5 (red dashed line).

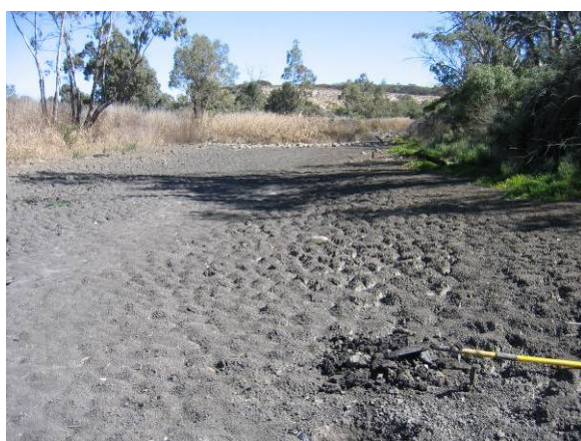
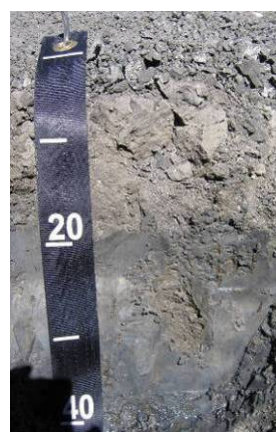
Site MMO1 (Figure 57-2) occurred near the middle of the wetland where it connects with the river, there was no vegetation growing and the surface had crumbled into aggregates. The soil consisted of a thin surface layer of slightly rigid, blocky aggregates, over dark grey, soft, clay, over a brown to black, soft, peaty clay, and at depth olive grey, soft, peaty clay.

Figure 57-2. Photographs of site MMO1, showing the main wetland area in the channel with no vegetation growing, and the soil profile of a thin layer of slightly rigid, clay aggregates over soft clay.

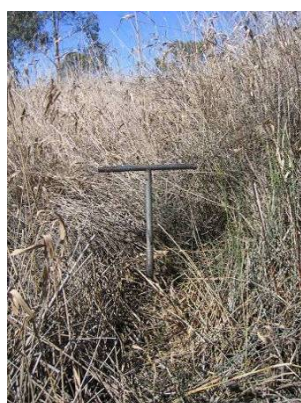
Site MMO2 (Figure 57-3) occurred amongst *Phragmites australis* (Common Reed) at a higher elevation on the wetland margin. The soil consisted of grey, friable, peaty clay over very firm, clay with many plant roots.

Figure 57-3. Photograph of site MMO2, showing the site location on the wetland margin marked by auger handle amongst tall *Phragmites australis* (Common Reed).

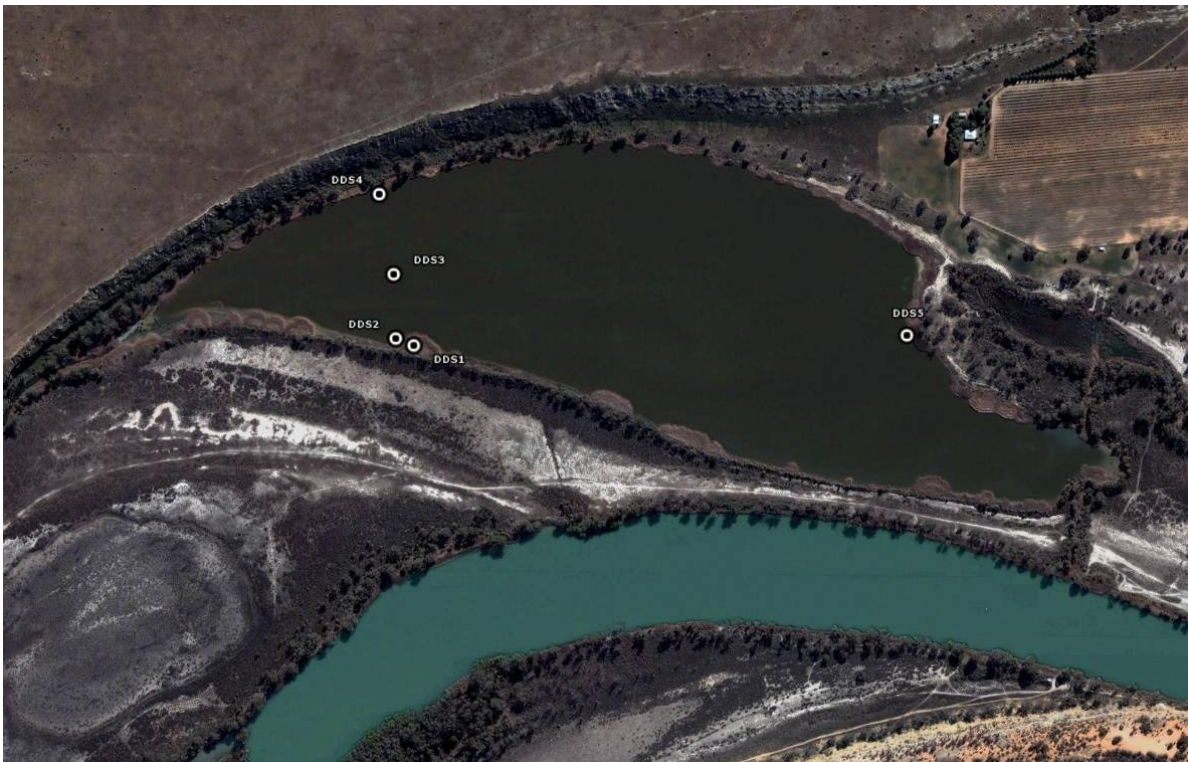
At the time of field sampling the wetland was dry. Sites were located along one transect across the wetland (Sites DD51, DD52, DD53 and DD54) and at the eastern margin (Site DD55). Five sites were sampled and their locations are shown in Figure 58-1.

Figure 58-1. Devon Downs South Wetland and sample site locations.
