Assessment of Acid Sulfate Soil Materials in the Victorian Northern Flowing Rivers Region of the Murray-Darling Basin

Phase 1 Inland Acid Sulfate Soil Detailed Assessment within the Victorian Northern Flowing Rivers Region

For: Murray Darling Basin Authority

OCTOBER, 2010

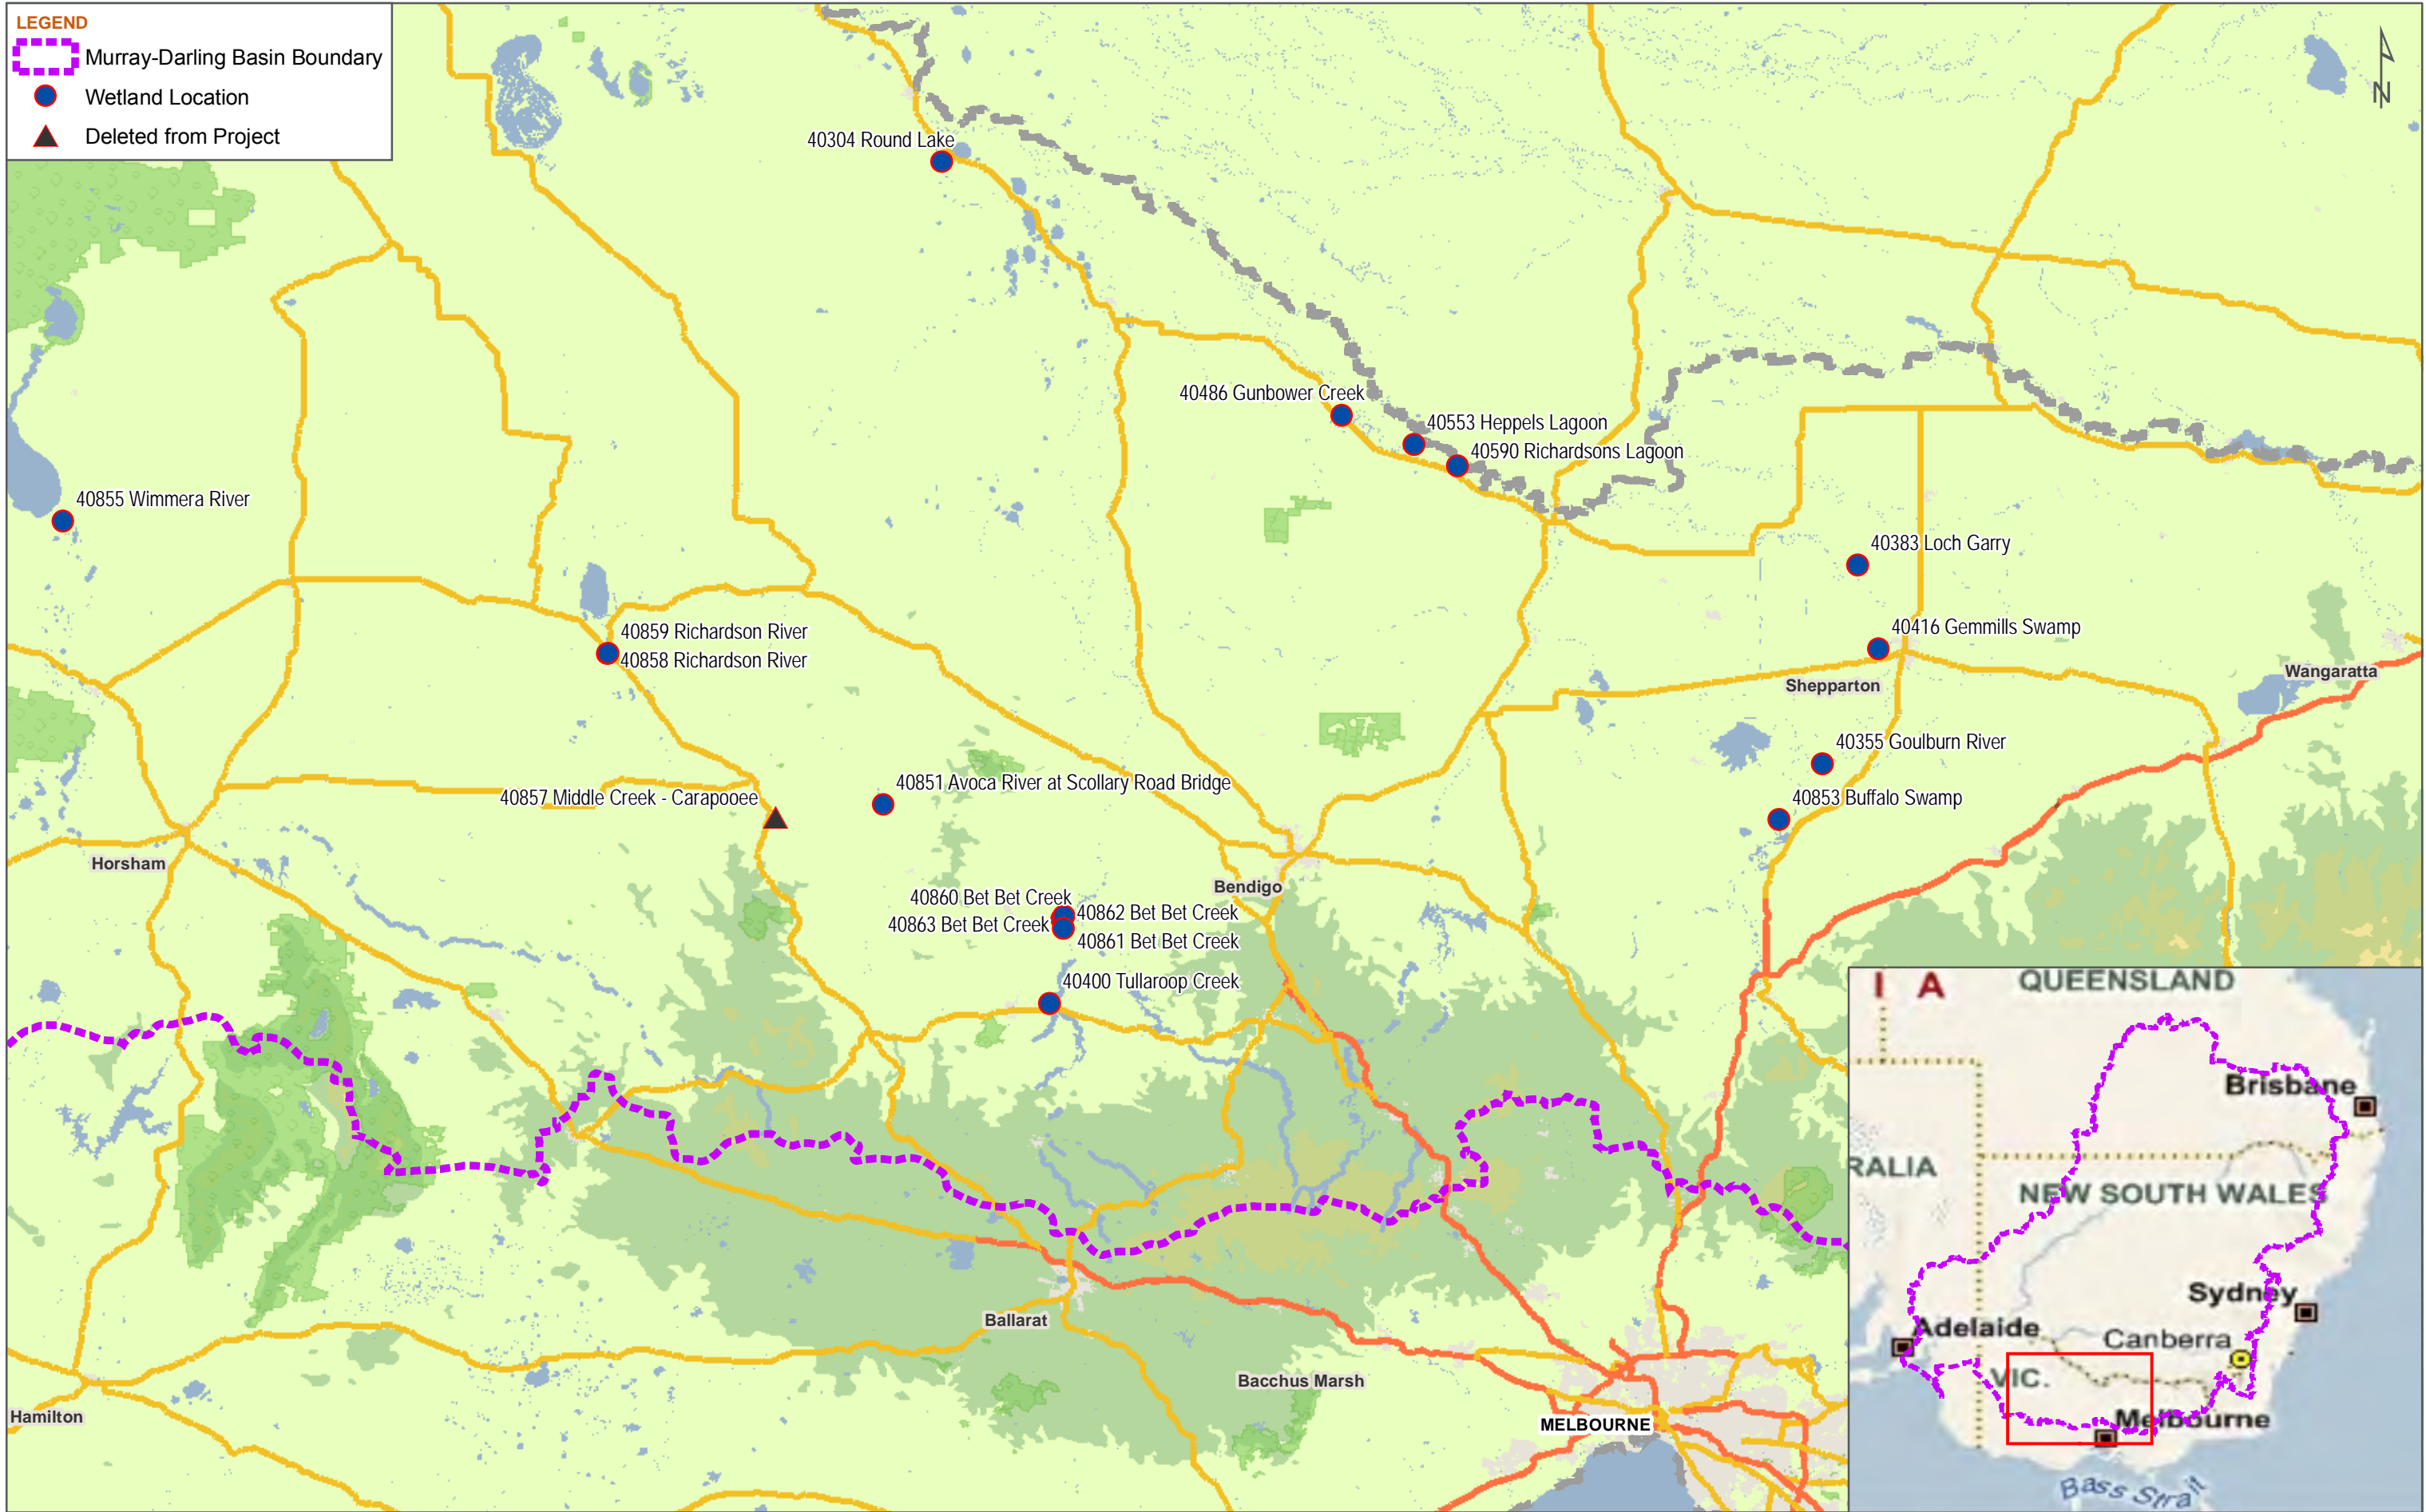
FIG NO. 1 **PROJECT TITLE** Detailed Assessment of Acid Sulfate Soils: MD1513-17 Wetlands within the Victorian Northern Flowing Rivers Regions
PROJECT NO. 3001801 **FIGURE TITLE** Priority Region Map - Overview

Figure 1 – Map showing priority wetlands surveyed in the Murray-Darling Basin (source: MDBA, 2010).

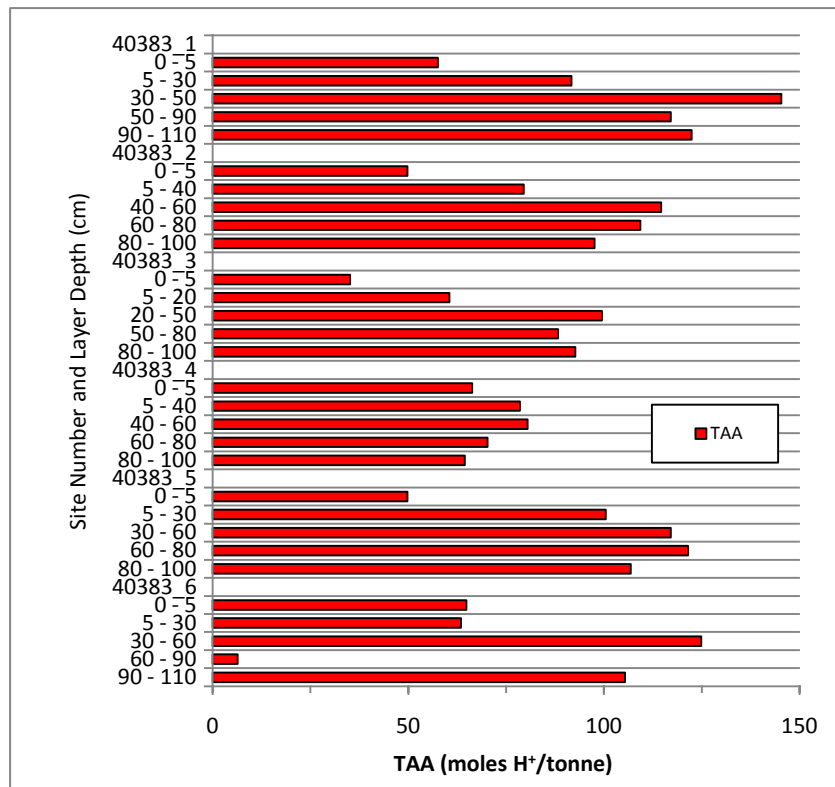
Figure 4 – Variation in TAA (mole H⁺/tonne) with depth at sites 40383_1 – 40383_6 (Loch Garry).

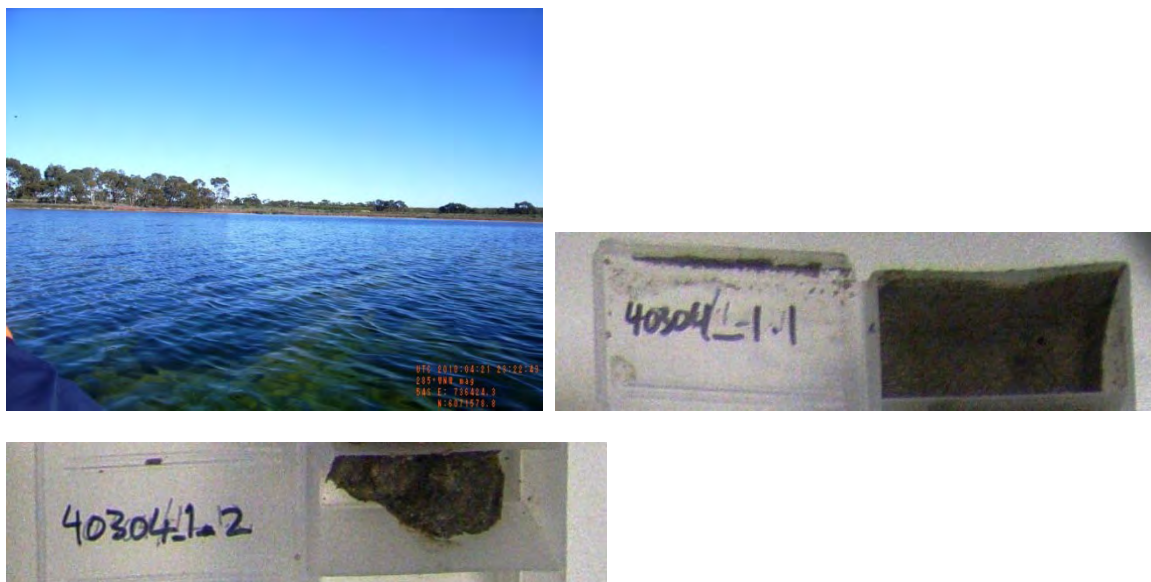
Figure 3 – Photographs of site 40304_1, showing the water surface (water column of 2.30m), and the chip tray soil profile of dark grey wet soft clayey sand.

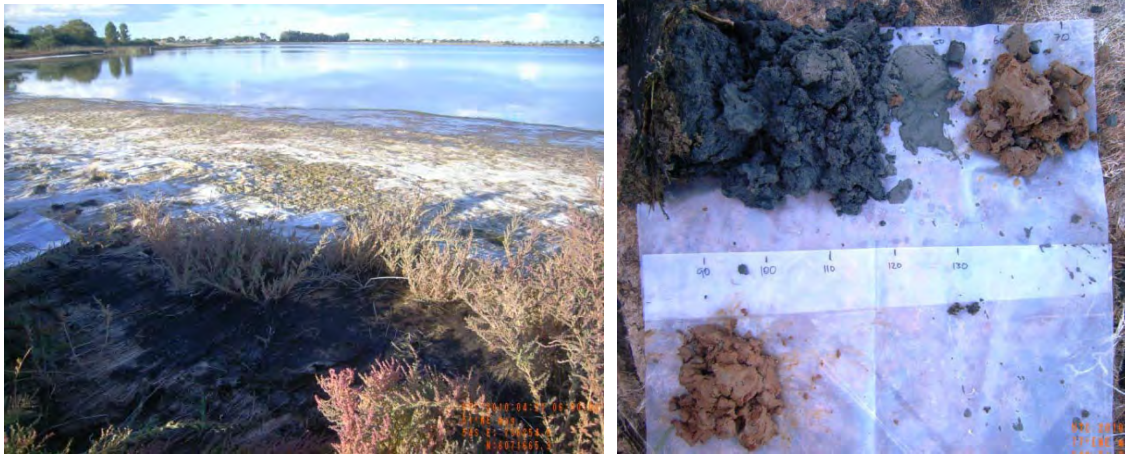
Figure 4 – Photographs of site 40304_2, showing the edge of water surface condition and the laid out soil profile of grey to dark grey soft loamy clayey sand overlying reddish brown soft clayey sand.

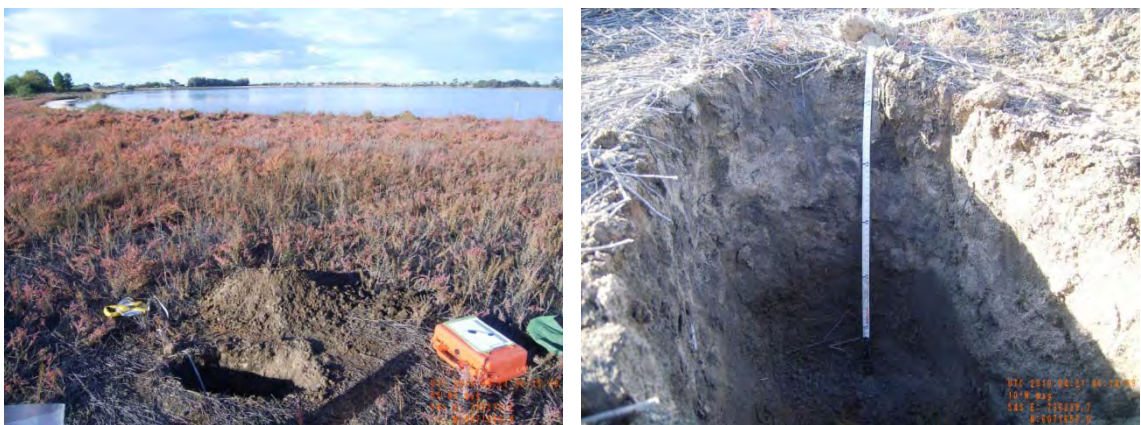
Figure 5 – Photographs of site 40304_3, showing the surface condition and the soil profile of grey loose loamy sand overlying reddish brown very weak clayey sand.

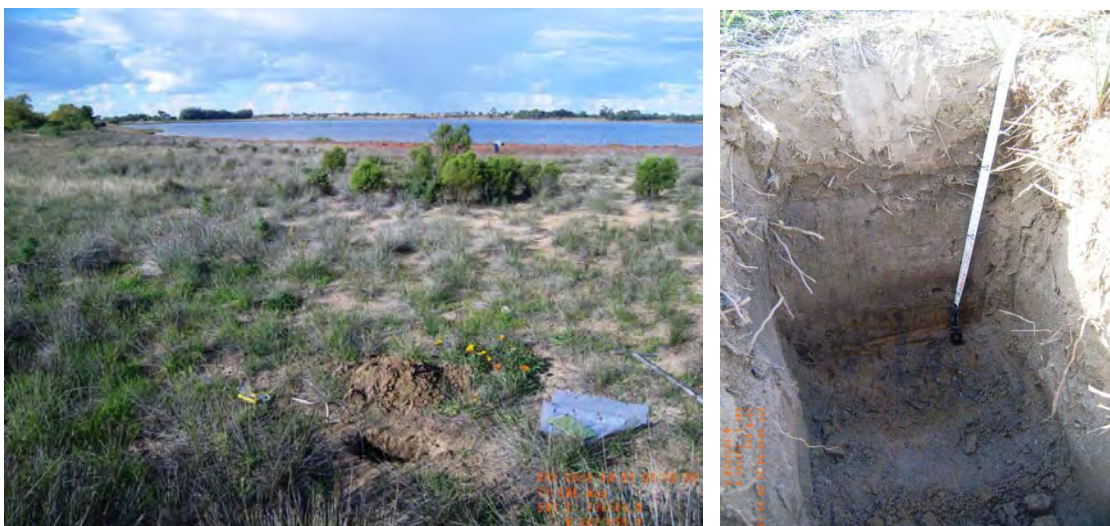
Figure 6 – Photographs of site 40304_4, showing the surface condition and the soil profile of dark greyish brown loose loamy sand overlying reddish brown very weak clayey sand.

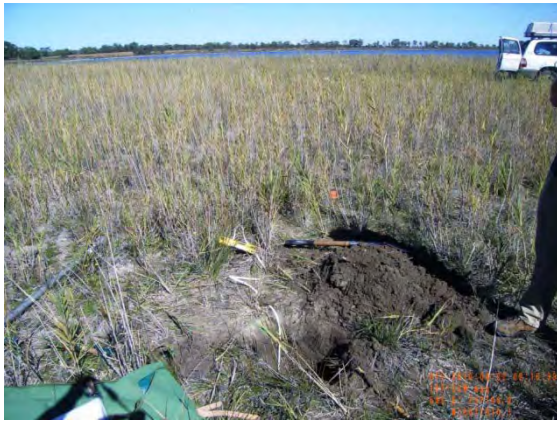
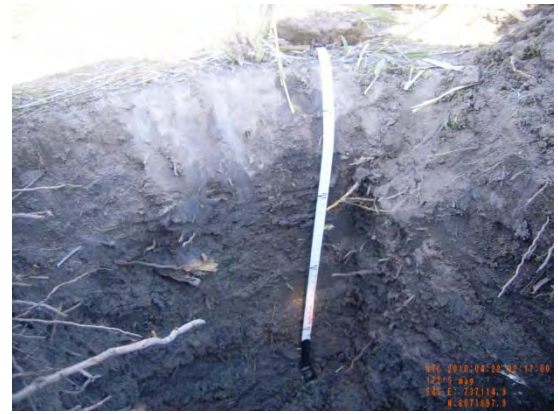
Figure 7 – Photographs of site 40304_5, showing the surface condition and the soil profile of dark greyish brown loose loamy sand overlying reddish brown very weak clayey sand.

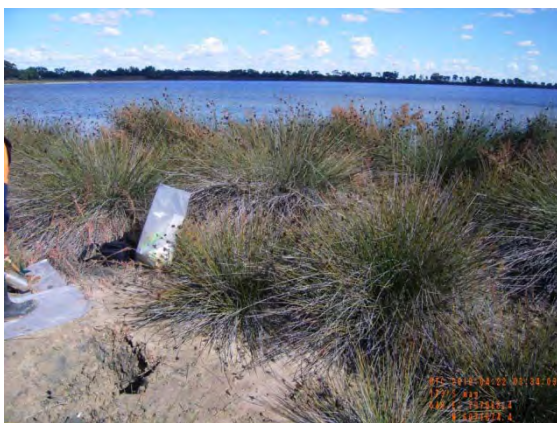
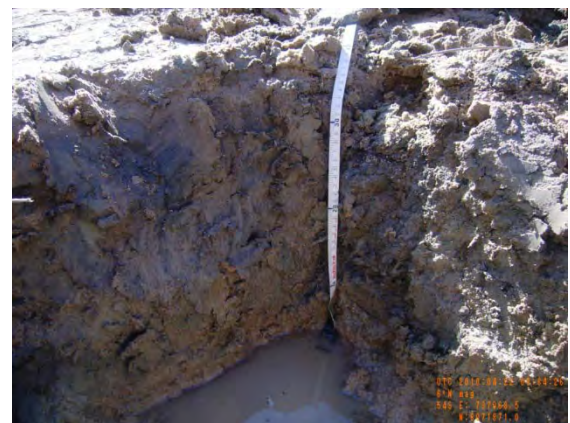
Figure 8 – Photographs of site 40304_6, showing the surface condition and the soil profile of dark greyish brown loose and very weak clayey sand.

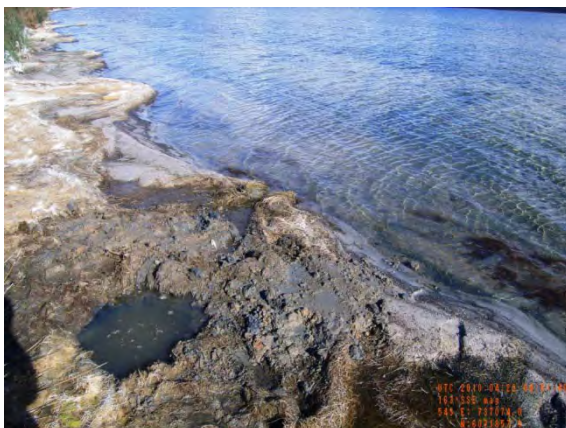
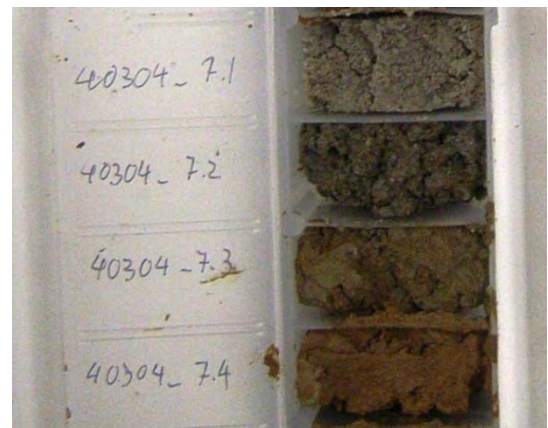
Figure 9 – Photographs of site 40304_7, showing the edge of water surface condition and the chip tray soil profile grey to dark grey soft clayey sand overlying reddish brown soft sandy clay.

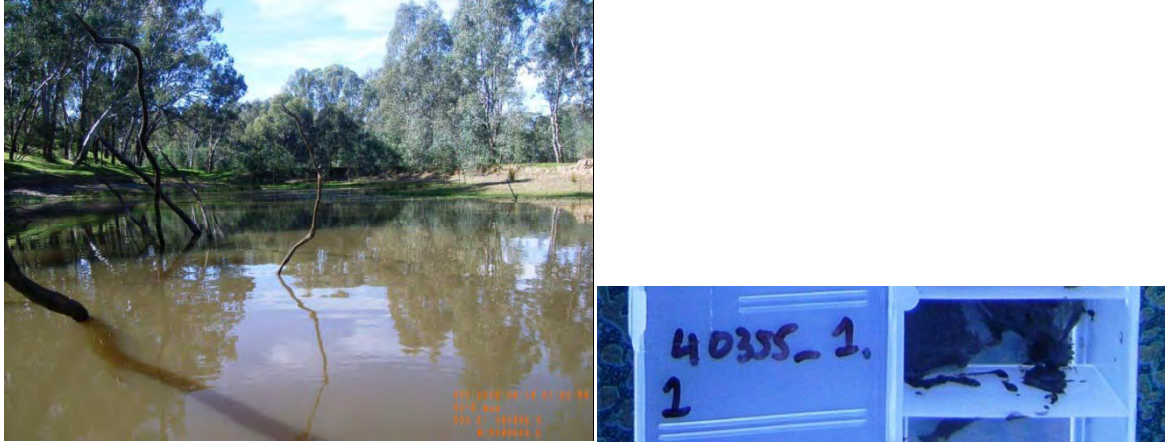
Figure 3 - Photographs of site 40355_1, showing the water surface (water column of 1.20m), and the chip tray soil profile of dark grey soft, decomposed organics, soft silty clay collected with small sediment grabber

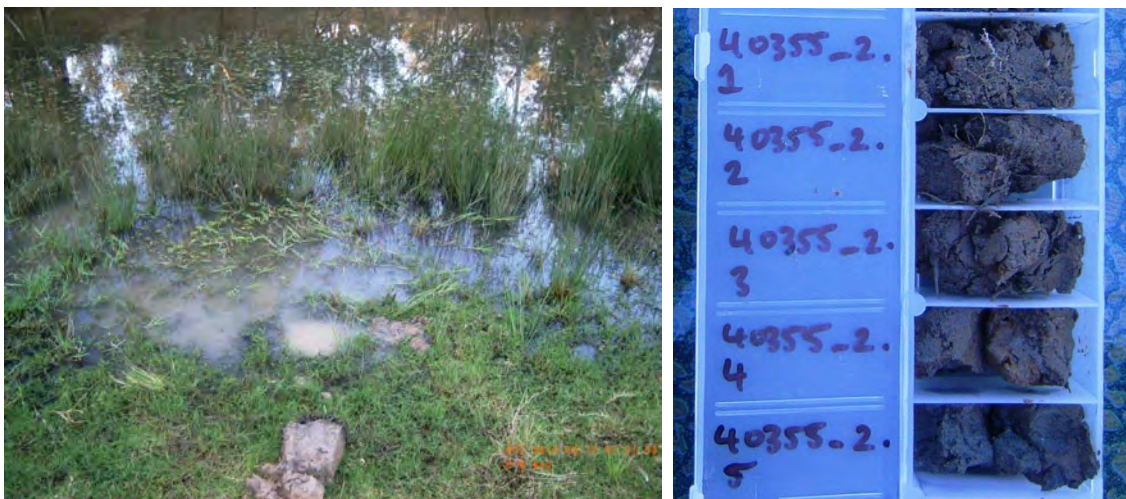
Figure 4 – Photographs of site 40355_2, showing the edge of waterline, and the chip tray soft soil profile of silty clay loam overlying very dark grey silty clay loam.

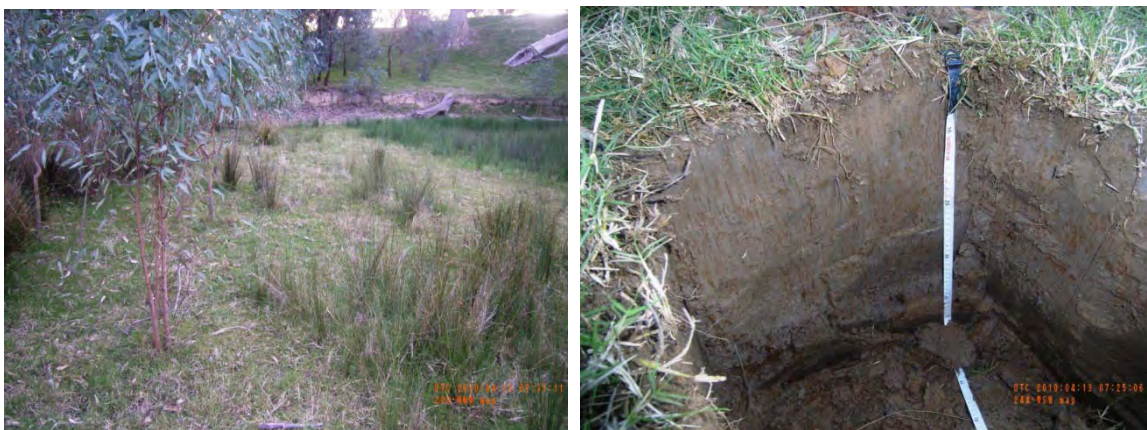
Figure 5 – Photographs of site 40355_3, showing the high point firm vegetated surface, and the shallow (0 – 50cm) soil profile of dark yellowish brown, silty clay loam overlying very dark grey silty clay loam.

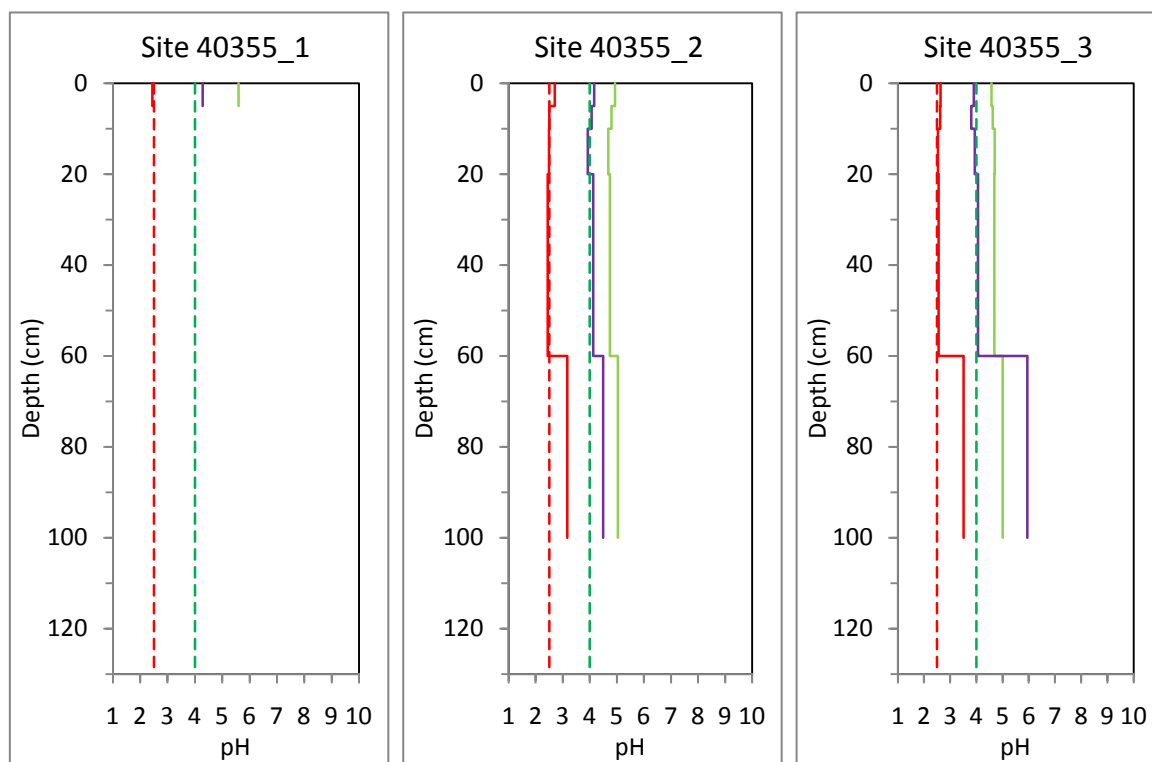
Figure 6 – Depth profiles of soil pH for Goulburn River, showing soil pH (pH_w as green line), peroxide treated pH (pH_{peroxide} as red line) and ageing pH ($pH_{\text{incubation}}$ after 8 weeks as purple line). Critical pH_w and $pH_{\text{incubation}}$ value of 4.0 (green dashed line) and critical pH_{peroxide} value of 2.5 (red dashed line).

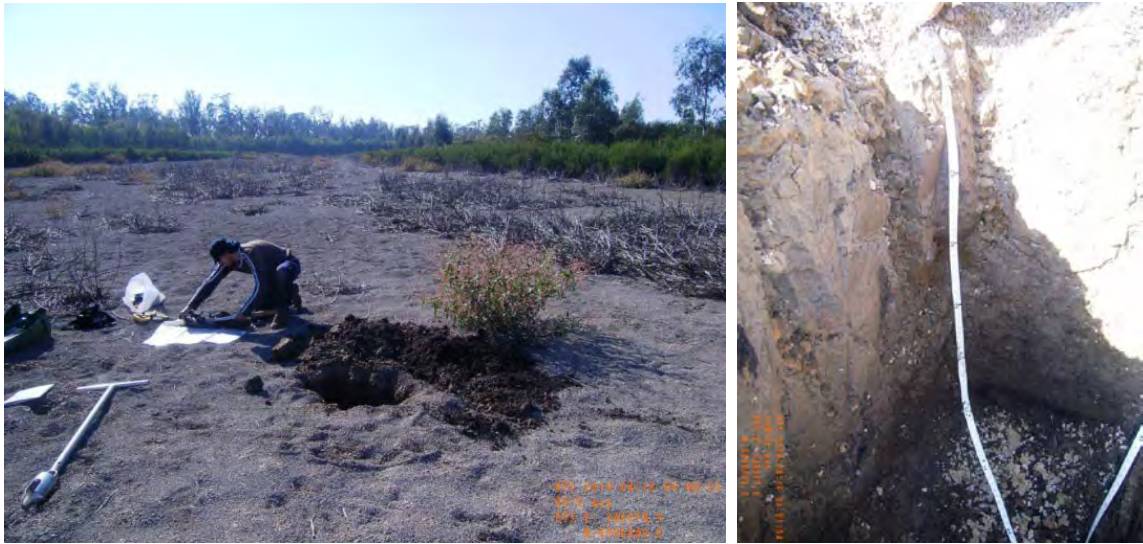
Figure 3 - Photographs of site 40383_1, showing the mid stream channel surface condition and the shallow soil profile of very dark brown, strong, silty clay loam and clay.

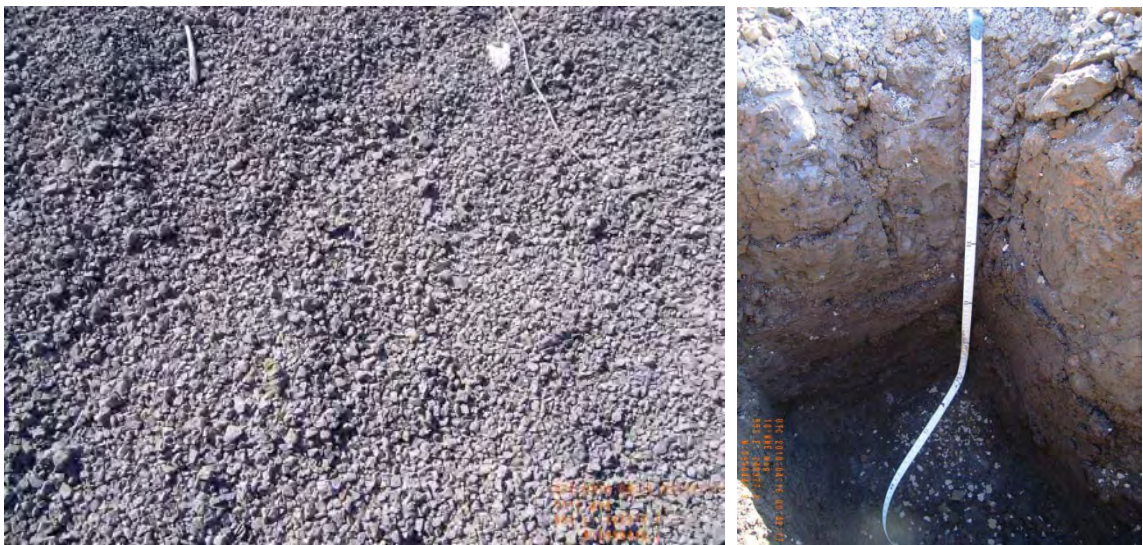
Figure 4 – Photographs of site 40383_2, showing the stream channel surface condition and the shallow soil profile of very dark brown, strong, silty clay loam and clay.

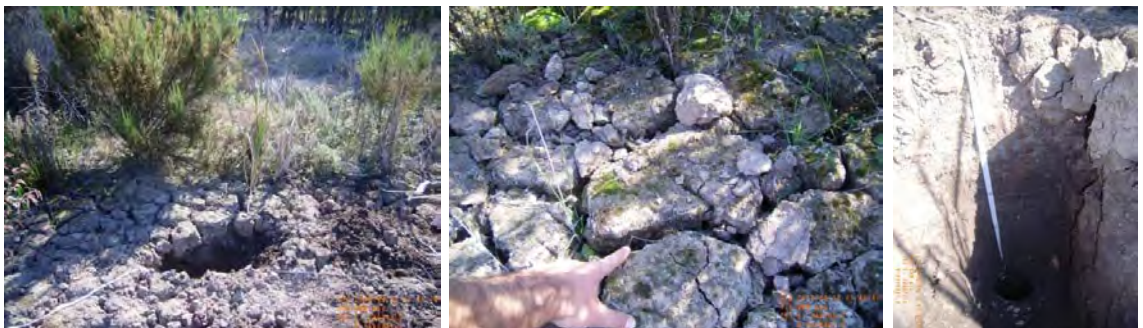
Figure 5 – Photographs of site 40383_3, showing the stream channel surface condition, cracking surface and the shallow soil profile of reddish brown, strong, silty clay loam and clay.

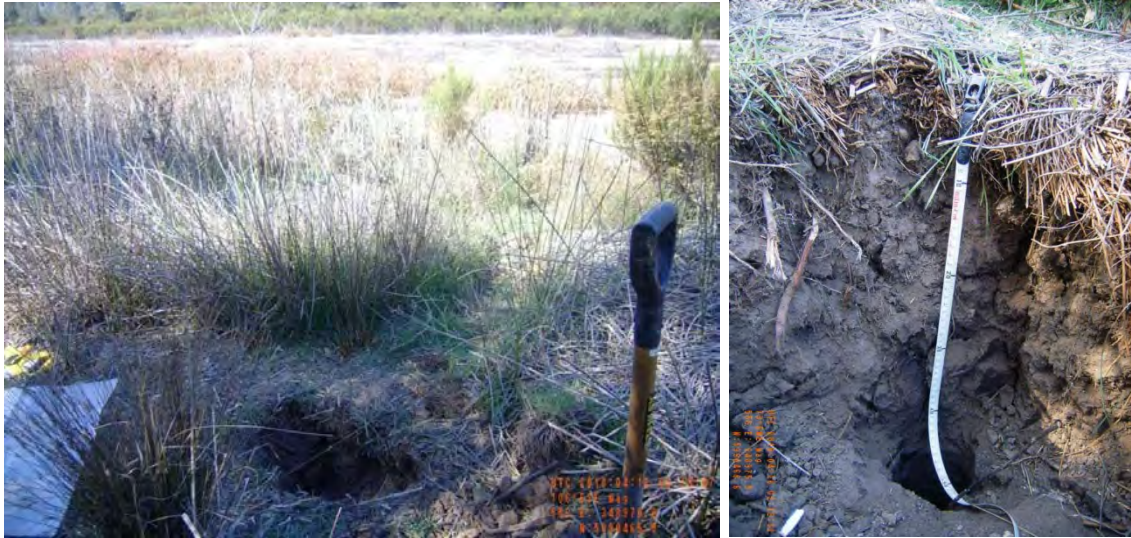
Figure 6 – Photographs of site 40383_4, showing the upper edge of stream channel surface condition and the shallow soil profile of very dark brown, strong, silty clay loam and clay.

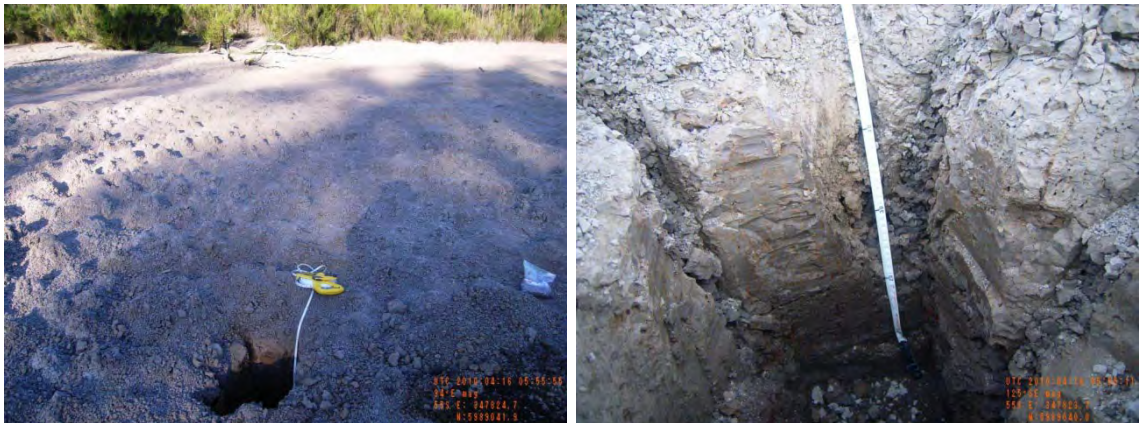
Figure 7 – Photographs of site 40383_5, showing the mid stream channel surface condition and the shallow soil profile of very dark brown, strong, silty clay loam and clay.

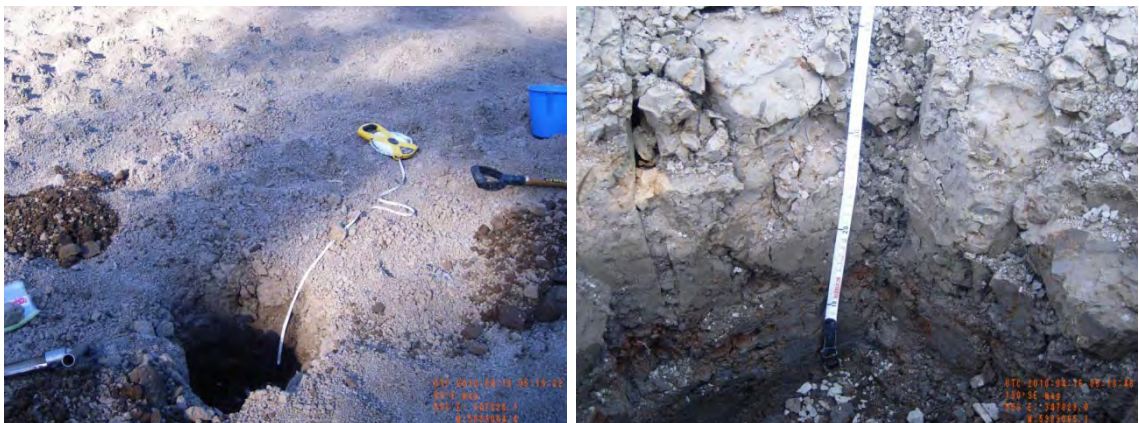
Figure 8 – Photographs of site 40383_6, showing the stream channel surface condition and the shallow soil profile of very dark brown, strong, silty clay loam and clay.

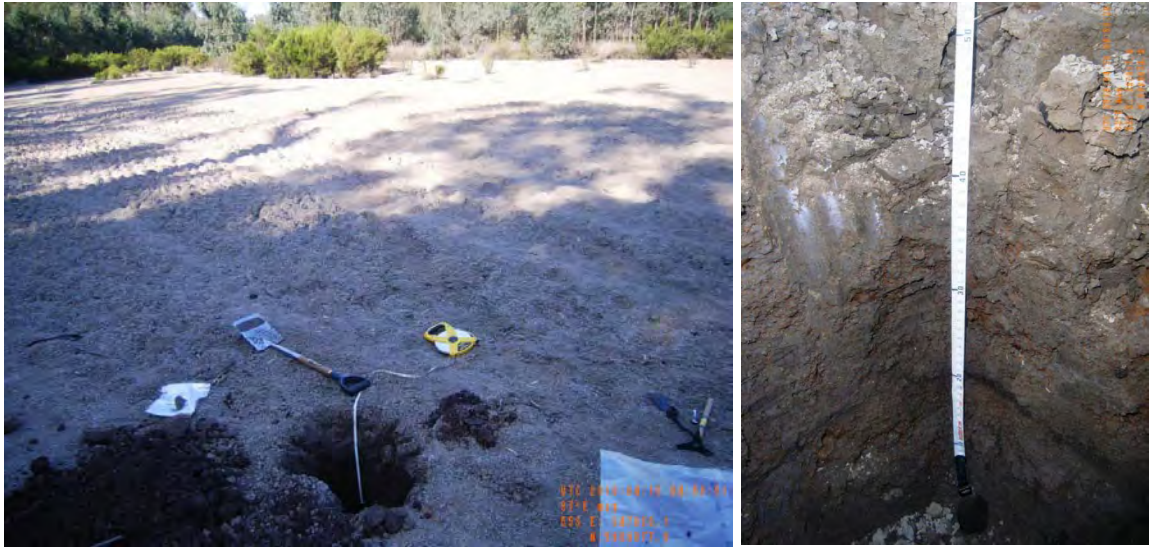
Figure 9 – Photographs of site 40383_7, showing the stream channel surface condition and the shallow soil profile reddish brown, strong, silty clay loam and clay.

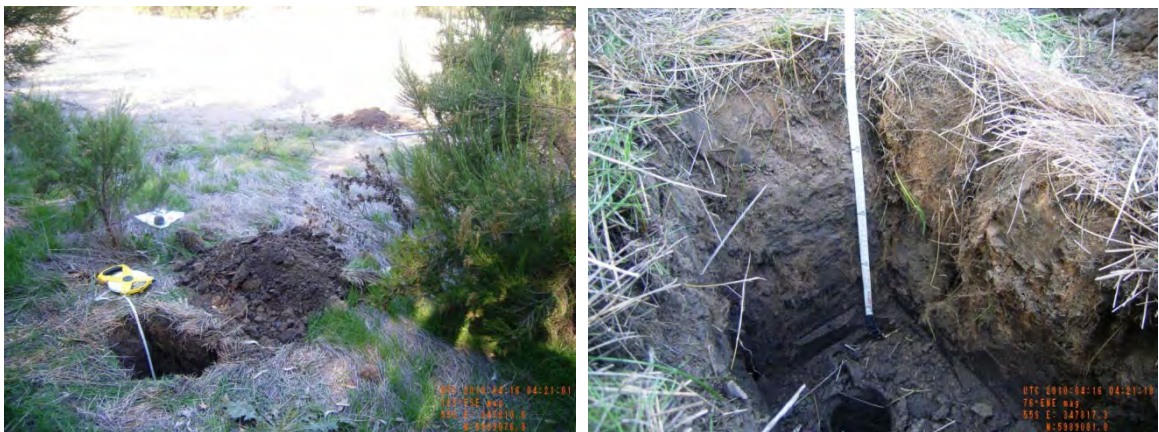
Figure 10 – Photographs of site 40383_8, showing the upper edge of stream channel surface condition and the shallow soil profile of very dark brown, strong, silty clay loam and clay.

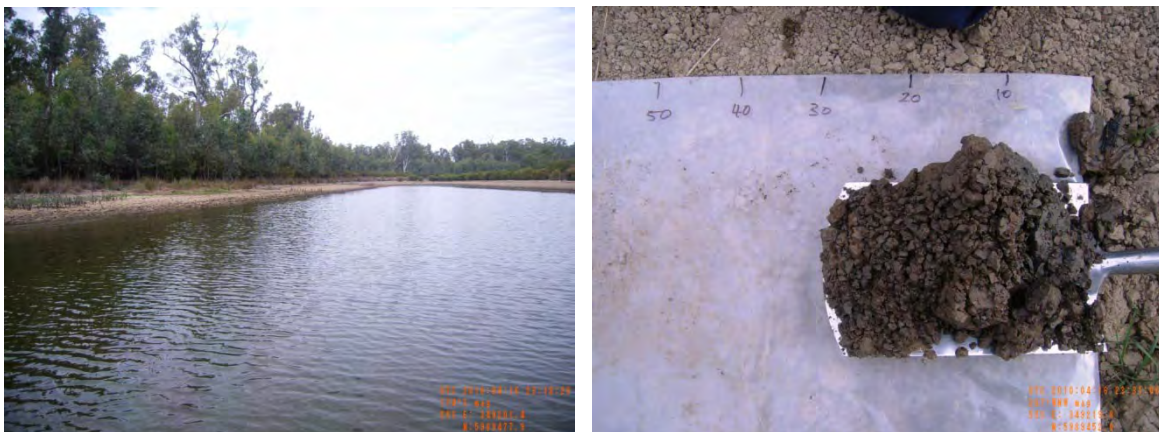
Figure 11 – Photographs of site 40383_9, showing the mid stream channel surface condition (water column of 33cm) and the shallow soil profile of light brownish grey, strong, wet, silty clay loam.

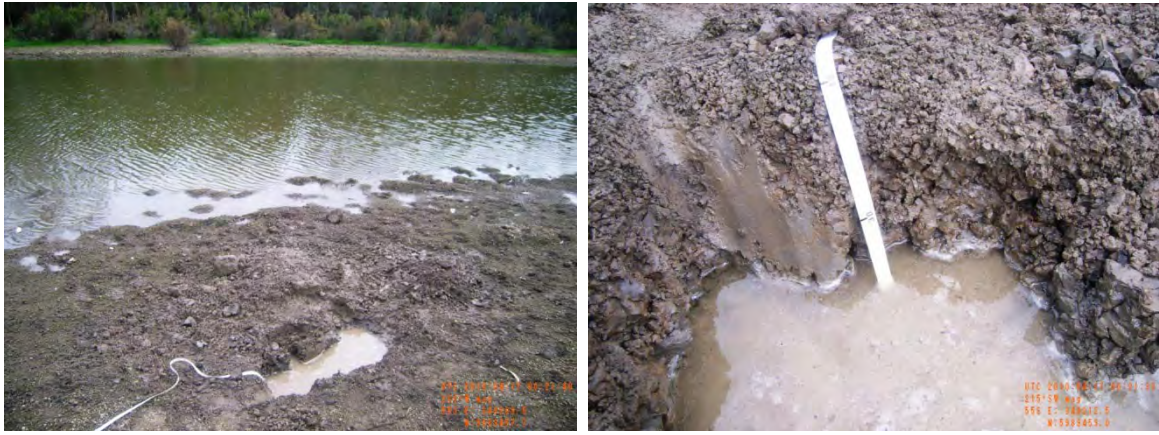
Figure 12 – Photographs of site 40383_10, showing the stream channel surface condition and the shallow soil profile of very dark brown, strong, silty clay loam and clay.

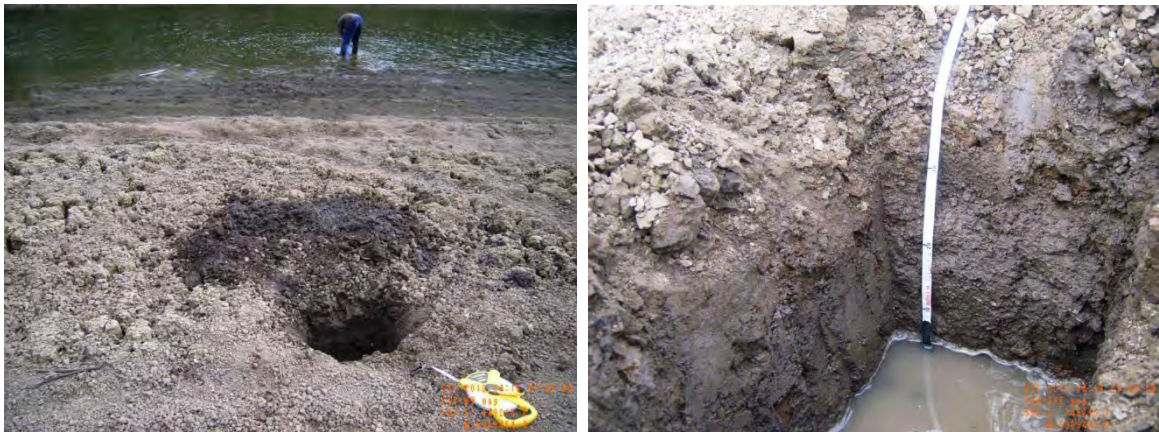
Figure 13 – Photographs of site 40383_11, showing the stream channel surface condition and the shallow soil profile of reddish brown, strong, silty clay loam and clay.

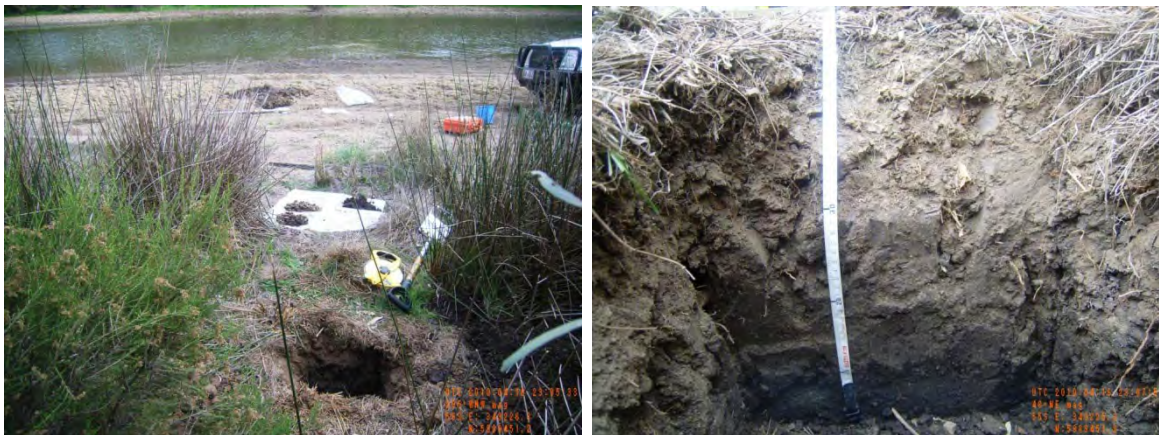
Figure 14 – Photographs of site 40383_12, showing the upper edge of stream channel surface condition and the shallow soil profile of very dark brown, strong, silty clay loam and clay.

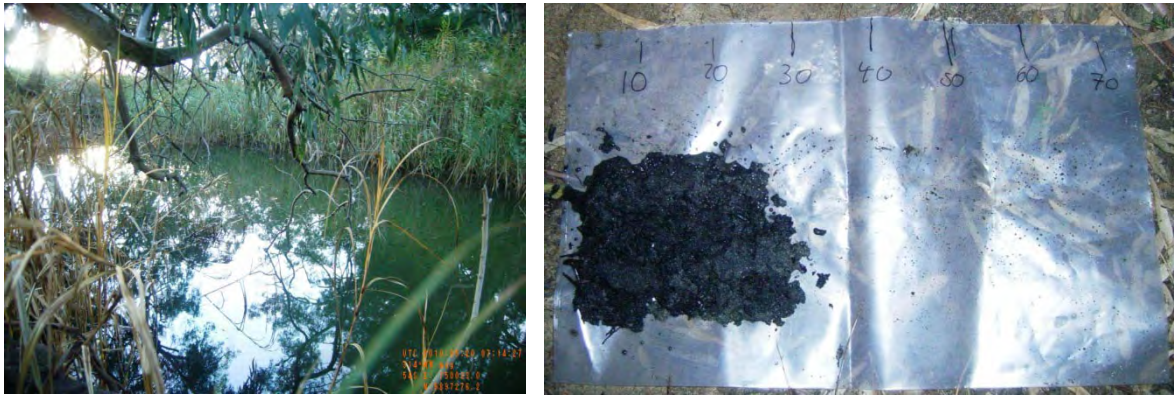
Figure 3 - Photographs of site 40400_1, showing the water surface (water column of >1.5m), and the laid out soil profile of very soft, very dark greenish grey, wet, sand.

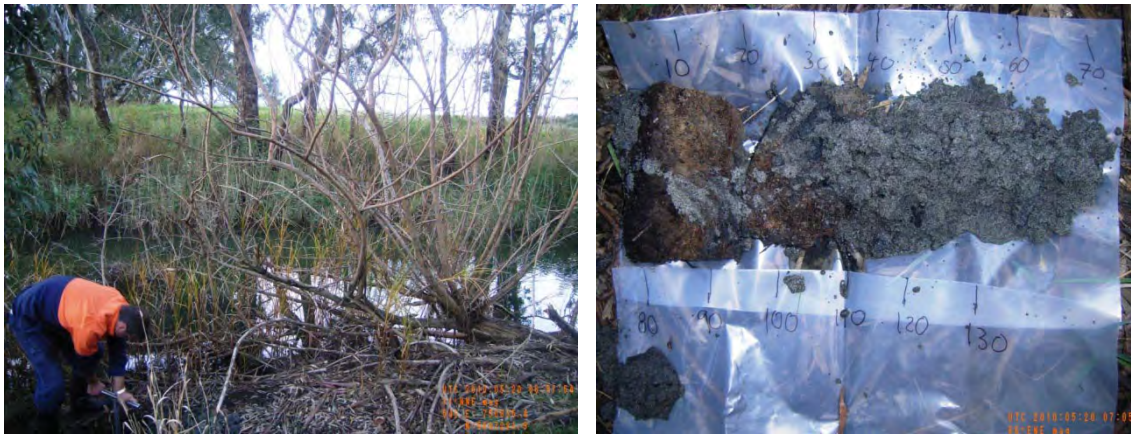
Figure 4 – Photographs of site 40400_2, showing the upper bank surface condition, and the laid out soil profile of dark yellowish brown, soft, clayey sand overlying very soft, greenish black sand.

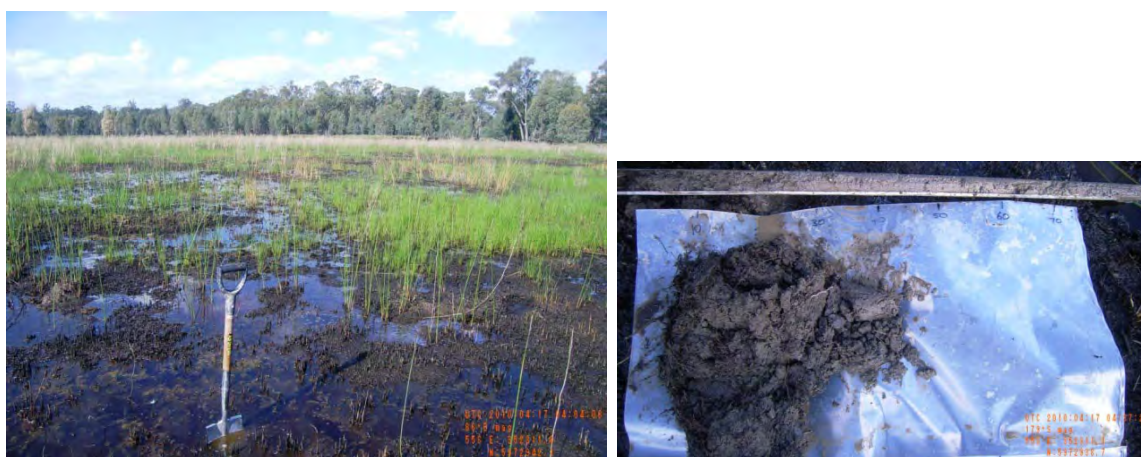
Figure 3 – Photographs of site 40416_1, showing the water logged surface (water column of 5cm) and the laid out soil profile of dark grey, very soft, silty clay loam overlying very dark grey, very soft, clay.

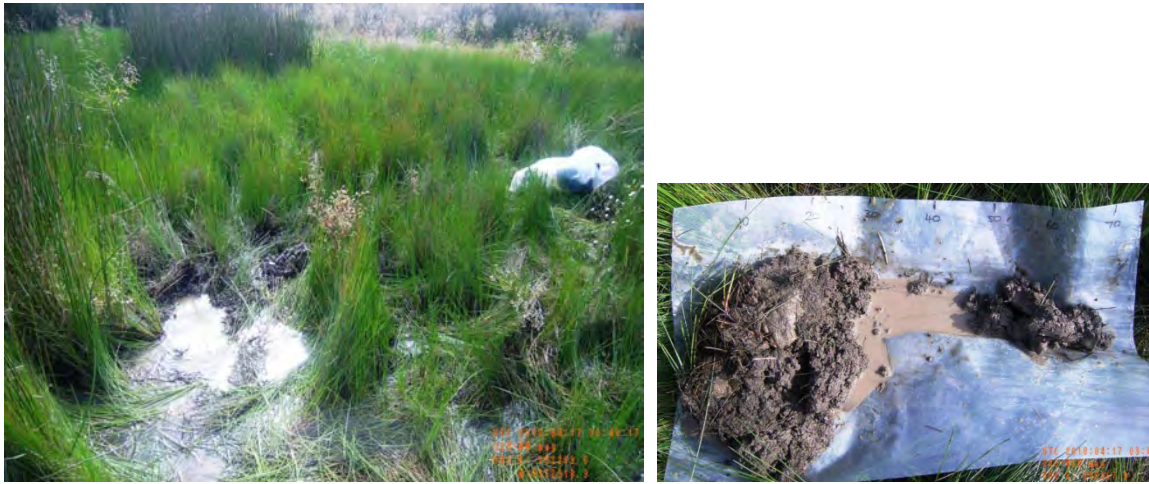
Figure 4 – Photographs of site 40416_2, showing the water logged surface (water column of 15cm) and the laid out soil profile of dark greyish brown, very soft, silty clay loam overlying dark greyish brown, very soft, clay.

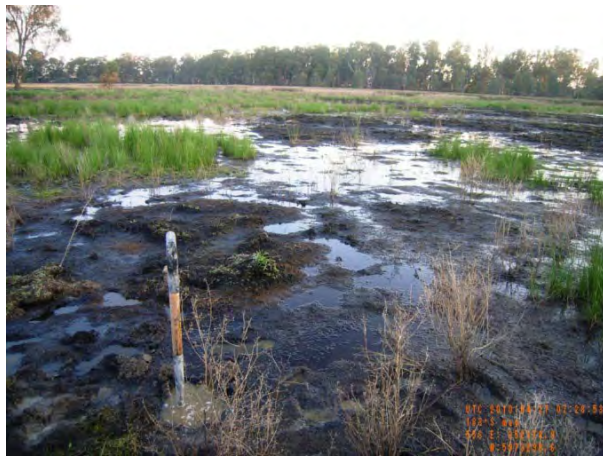
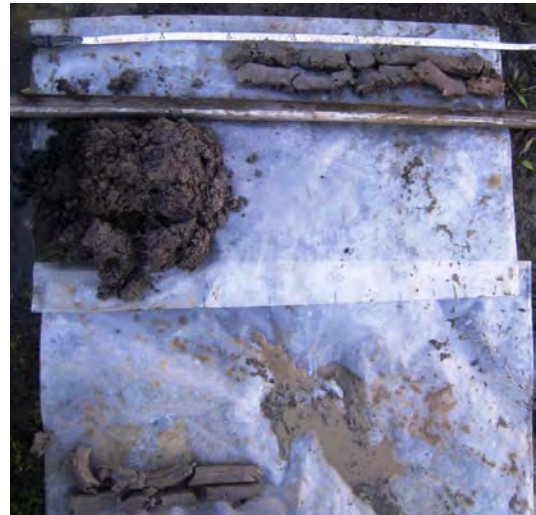
Figure 7 – Photographs of site 40416_5, showing the water logged surface (water column of 8cm) and the laid out soil profile of dark greyish brown, soft, loam overlying dark grey, very soft, clay.

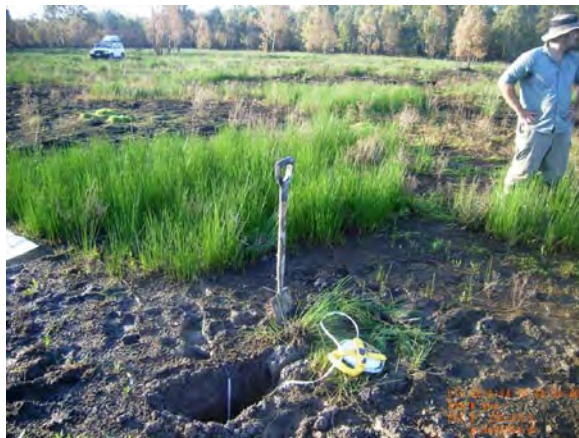
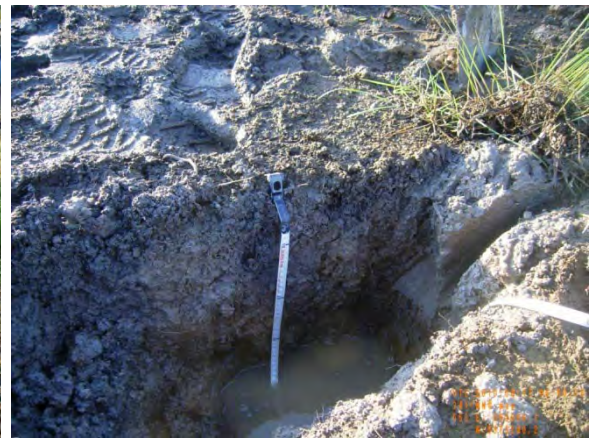
Figure 8 – Photographs of site 40416_6, showing the surface condition and soil profile of dark greyish brown, soft, clay overlying dark greyish brown, very soft, clay.

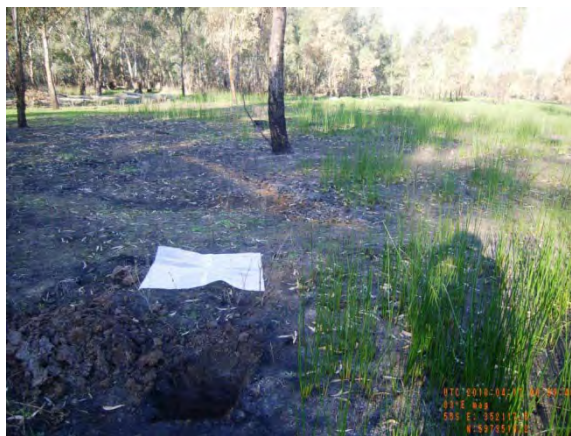
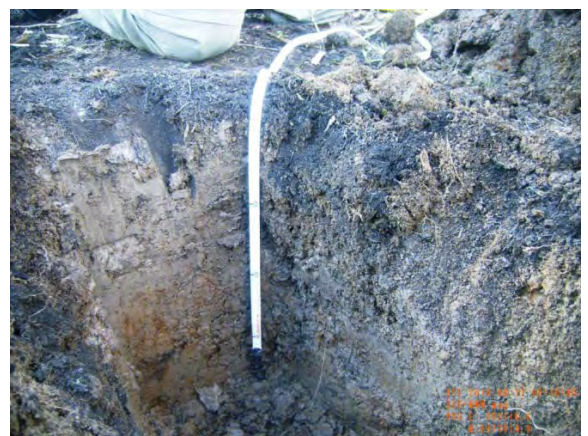
Figure 9 – Photographs of site 40416_7, showing the surface condition and soil profile of greyish brown, very weak, clay overlying dark greyish brown, weak, clay.

- 40416_7: all samples have $pH_w < 6.0$. Surface soils (0 - 30cm) have pH_w 4.22 – 4.95 with subsoils (30 – 110cm) ranging 5.39 – 5.57. Surface soils $pH_{incubation}$ ranged between 4.09 – 4.90 indicating hyposulfidic and other acidic conditions. Subsoils $pH_{incubation}$ ranged between 4.32 – 5.38 indicating hyposulfidic conditions.
- 40416_8: all samples have $pH_w < 6.0$. Surface soils (0 - 45cm) have pH_w 4.78 – 5.41 with subsoils (45 – 110cm) ranging 5.53 – 5.65. Surface soils $pH_{incubation}$ ranged between 4.38 – 4.63 indicating hyposulfidic and other acidic conditions. Subsoils $pH_{incubation}$ ranged between 4.83 – 4.91 indicating other acidic conditions.

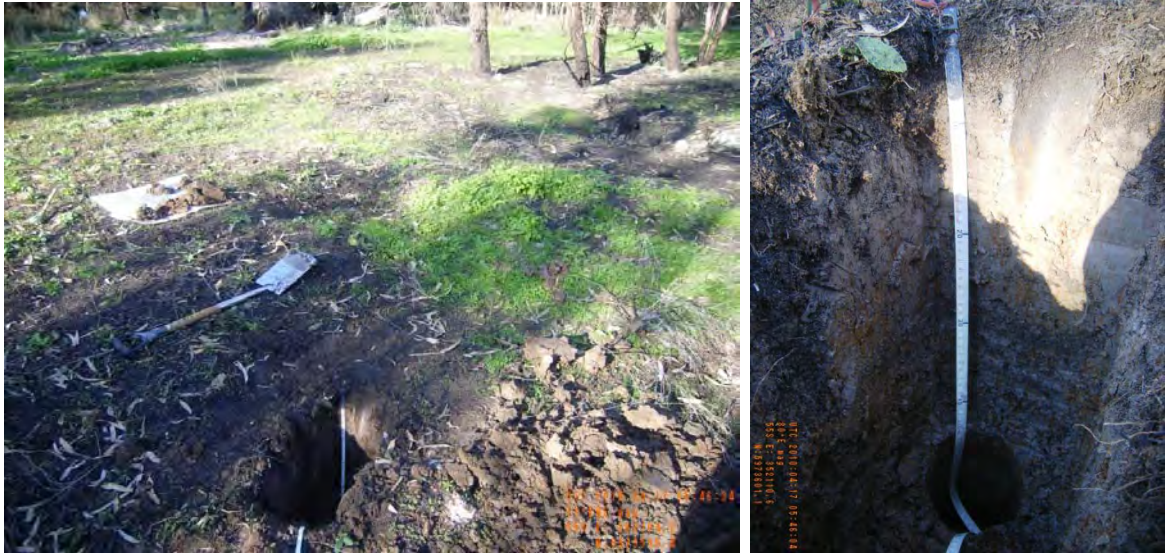
Figure 10 – Photographs of site 40416_8, showing the surface condition and soil profile of greyish brown, very weak, clay overlying dark greyish brown, weak, clay.
