Assessment of Acid Sulfate Soil Materials in the Victorian Northern Flowing Rivers Region of the Murray-Darling Basin

Phase 1 Inland Acid Sulfate Soil Detailed Assessment within the Victorian Northern Flowing Rivers Region

For: Murray Darling Basin Authority

OCTOBER, 2010

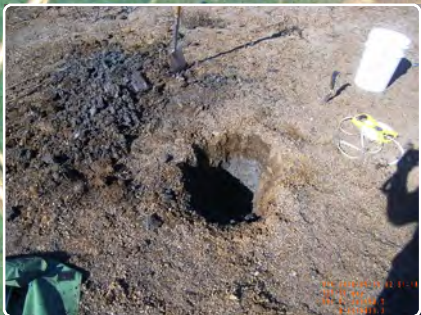
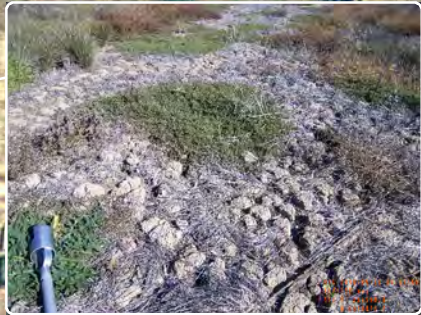
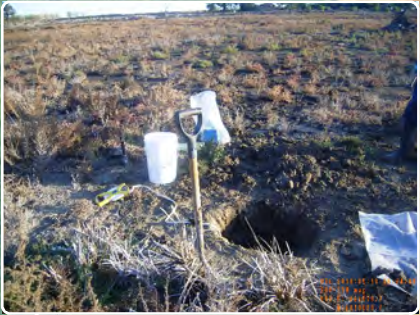
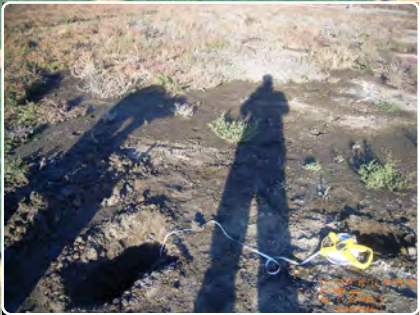
40486
13ha

Note: Inset Photos show Surface Condition of Site

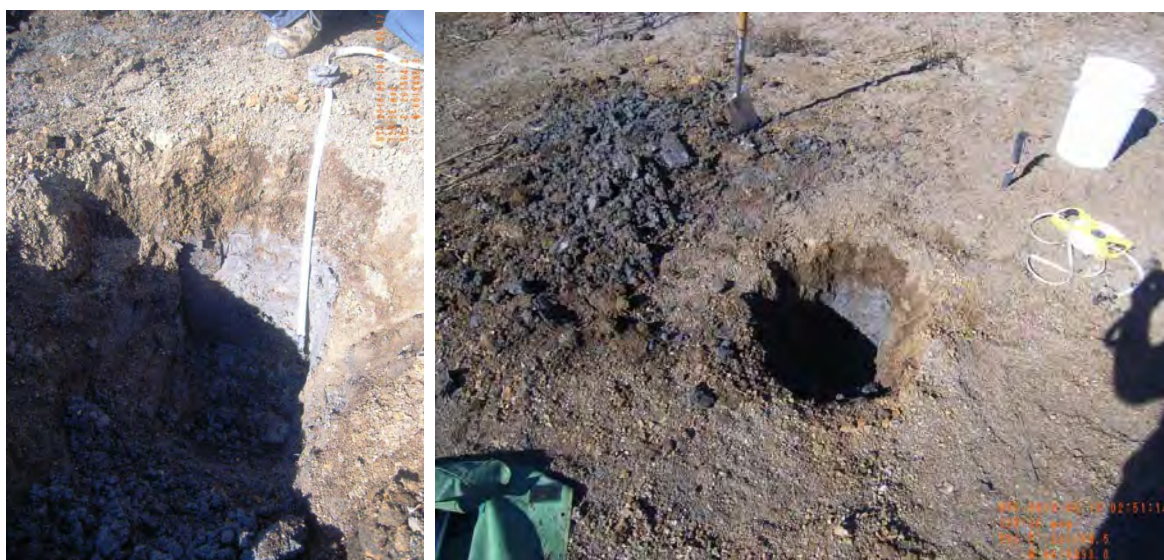
Figure 3 – Photographs of site 40486_1, showing the surface condition and the soil profile of weak, very dark greyish brown clay overlying very firm, dark greenish grey clay.

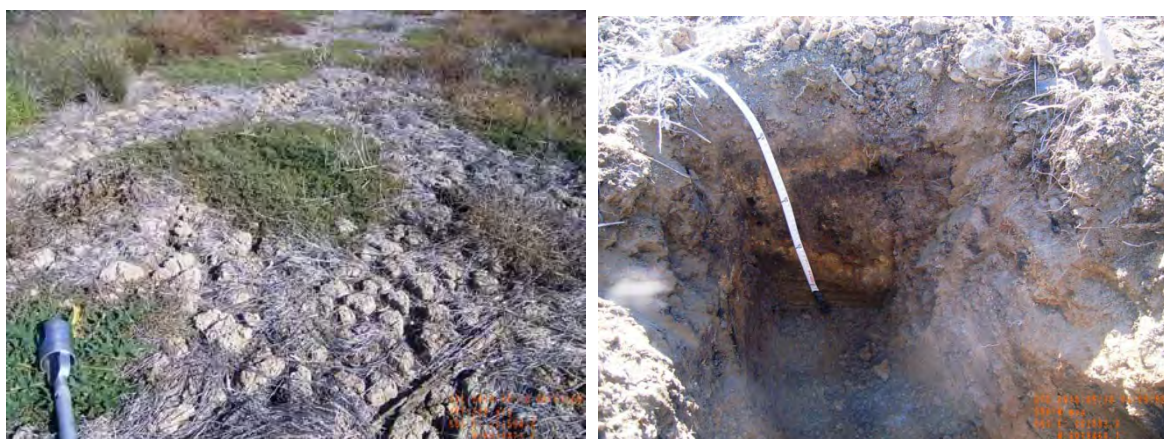
Figure 4 – Photographs of site 40486_2, showing the surface condition and the soil profile of weak, dark greyish brown clay loam overlying very firm, dark greyish brown clay.

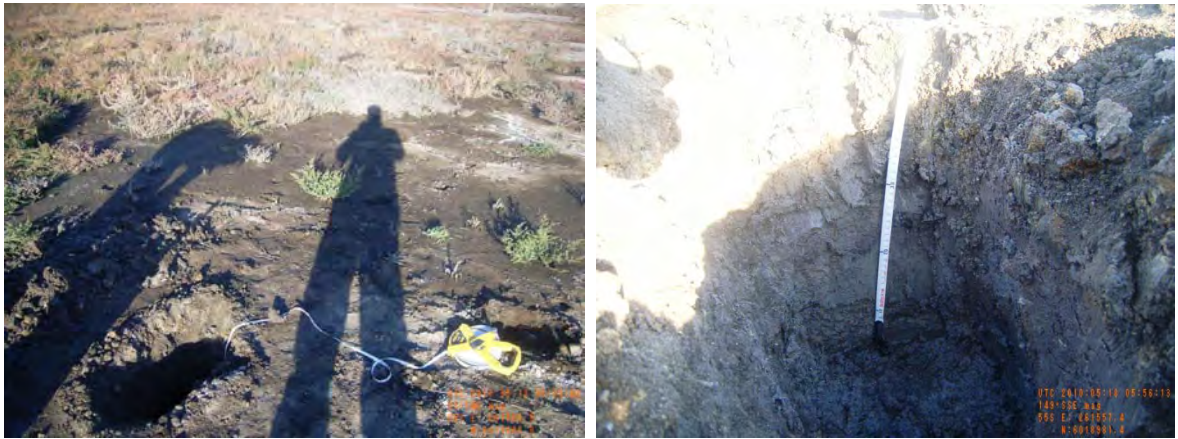
Figure 5 – Photographs of site 40486_3, showing the surface condition, surface salt crust and the soil profile of loose salt crust on surface, then weak, brown clay loam overlying very firm, dark grey clay.

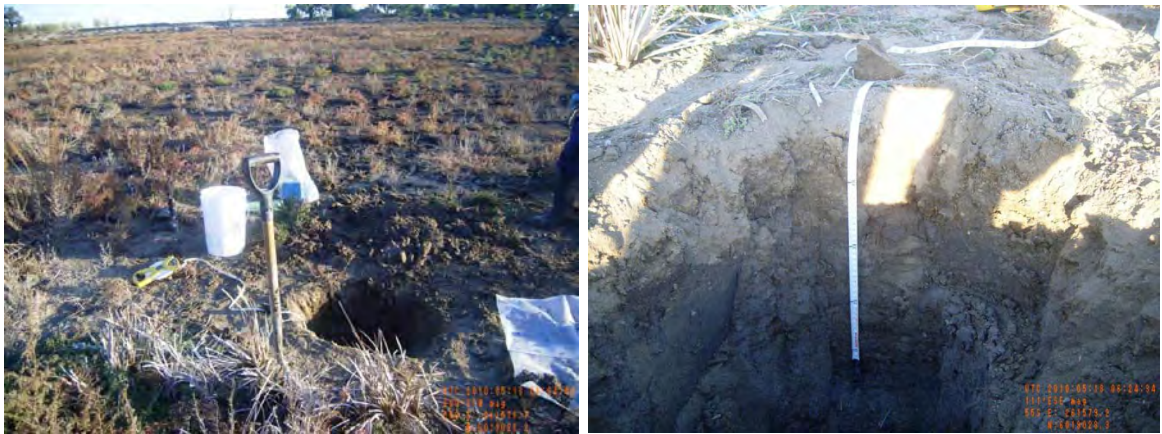
Figure 6 – Photographs of site 40486_4, showing the surface condition and the soil profile of weak, brown and dark brown clay loam overlying very firm, dark greyish brown clay loam sandy.

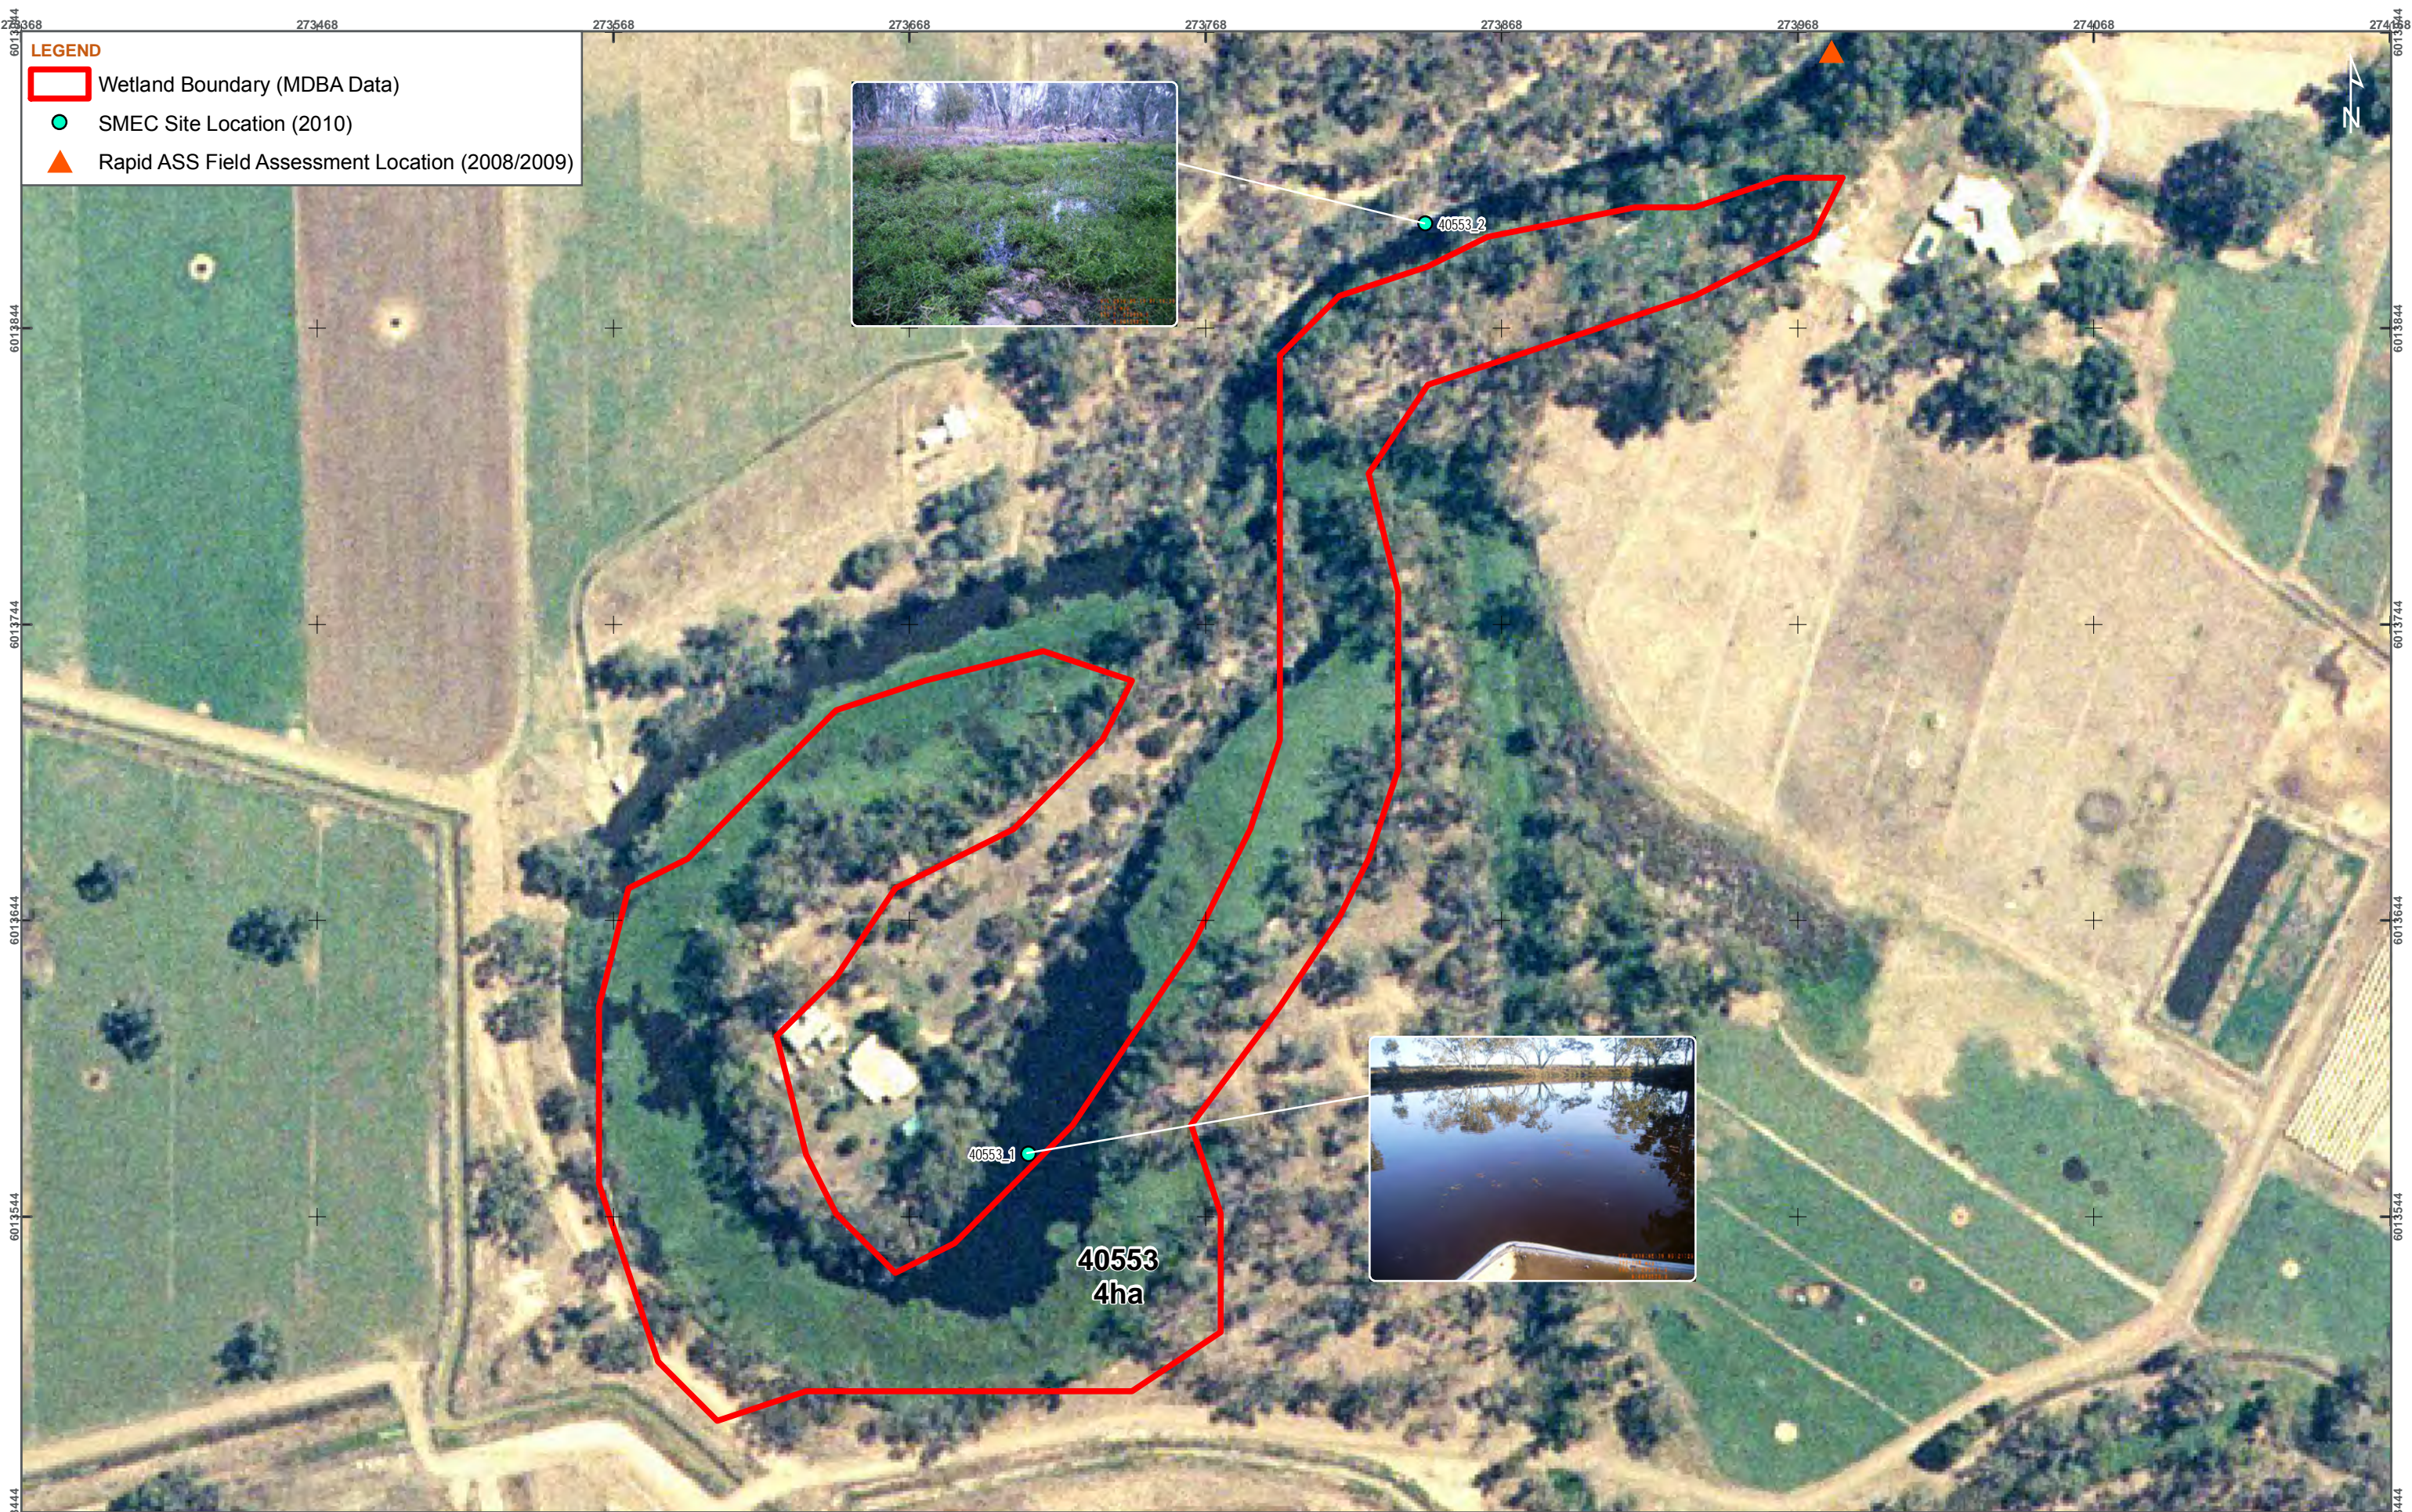
DATE 07/07/2010 SCALE 1:2,000

Note: Inset Photos show Surface Condition of Site

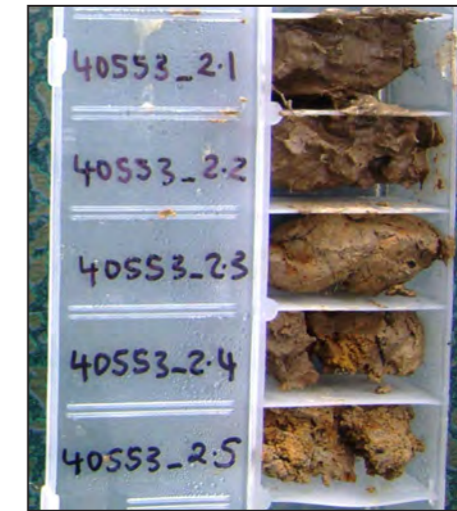
PROJECT NO. 3001801 **FIGURE TITLE** Conceptual Hydrotoposequence Cross Section, Heppels Lagoon 40553

40553_2

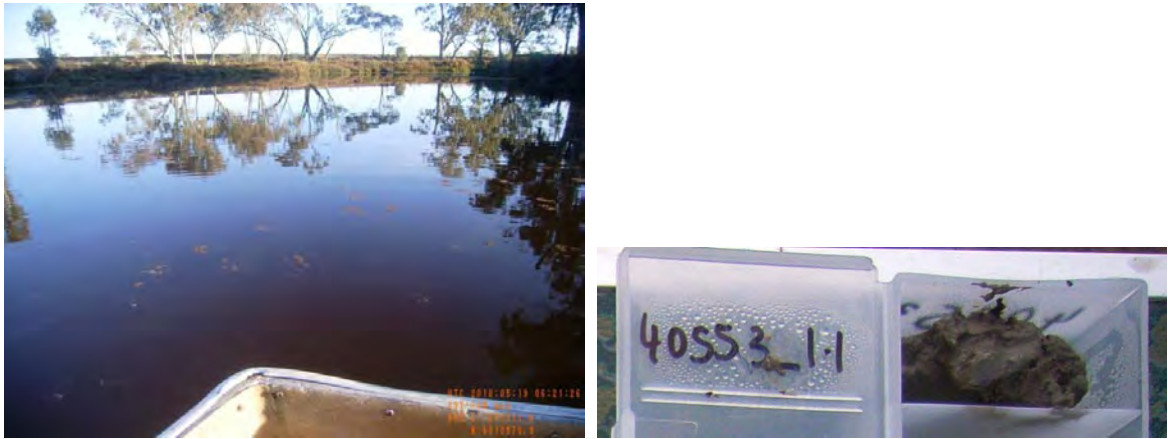
Figure 3 – Photographs of site 40553_1, showing the water surface (water column of 1.80m), and the chip tray soil profile of dark grey, very soft, wet, clay.

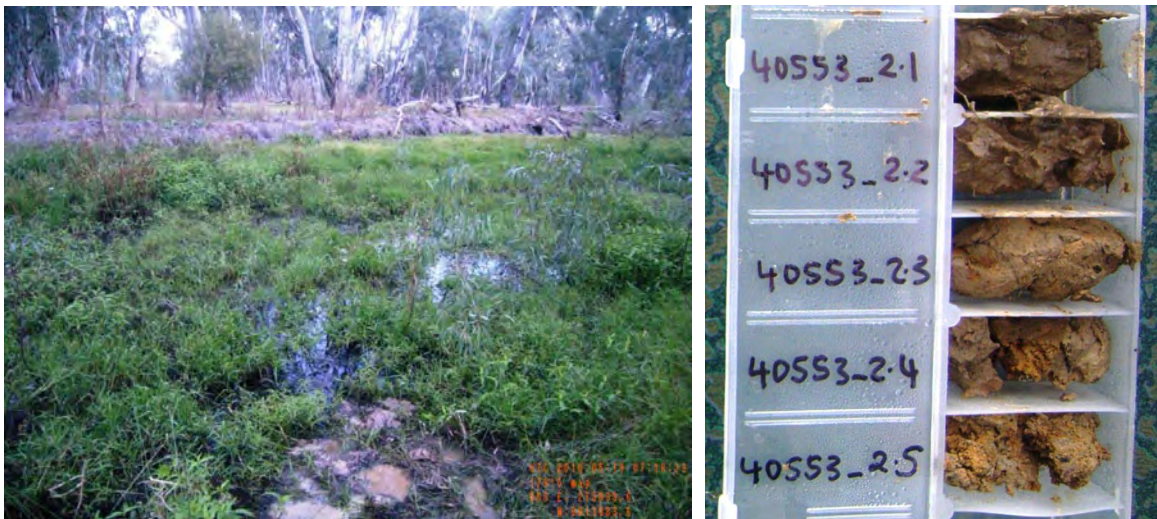
Figure 4 – Photographs of site 40553_2, showing the edge of water surface condition and the chip tray soil profile of brown, very soft, clay loam overlying dark yellowish brown, very soft clay.

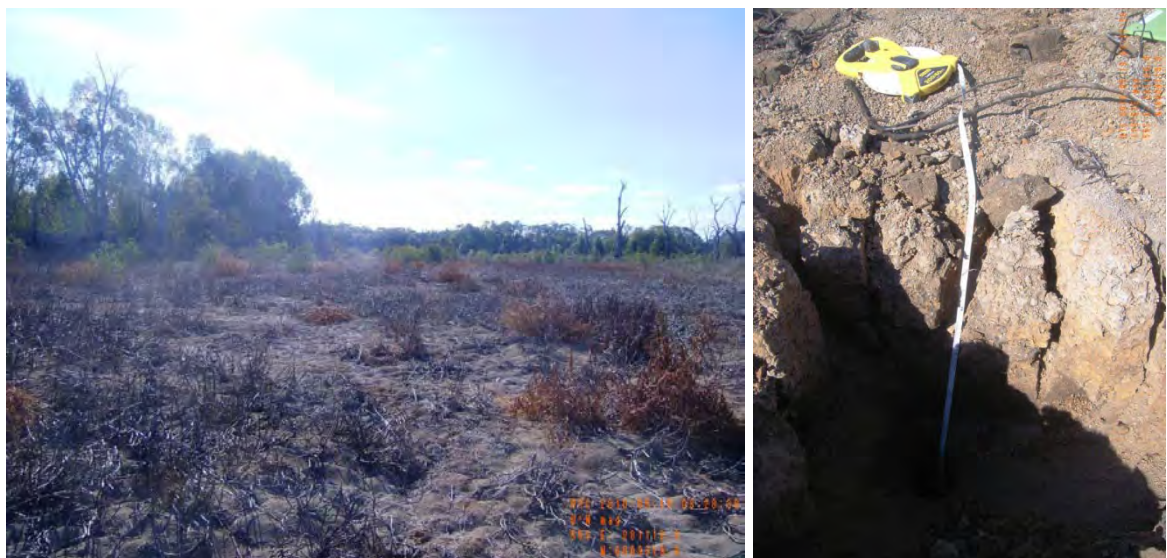
Figure 3 – Photographs of site 40590_1, showing the surface condition and the soil profile of strong, dark greyish brown clay overlying very firm, brown clay.

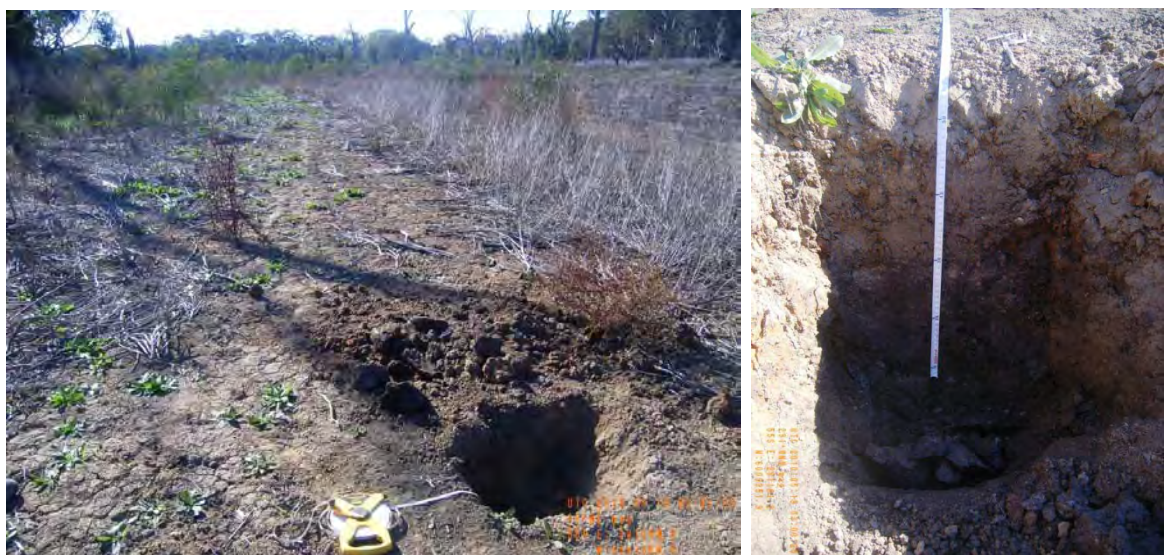
Figure 4 – Photographs of site 40590_2, showing the surface condition and the soil profile of strong, very dark greyish brown silty clay loam overlying very firm, dark greyish brown clay.

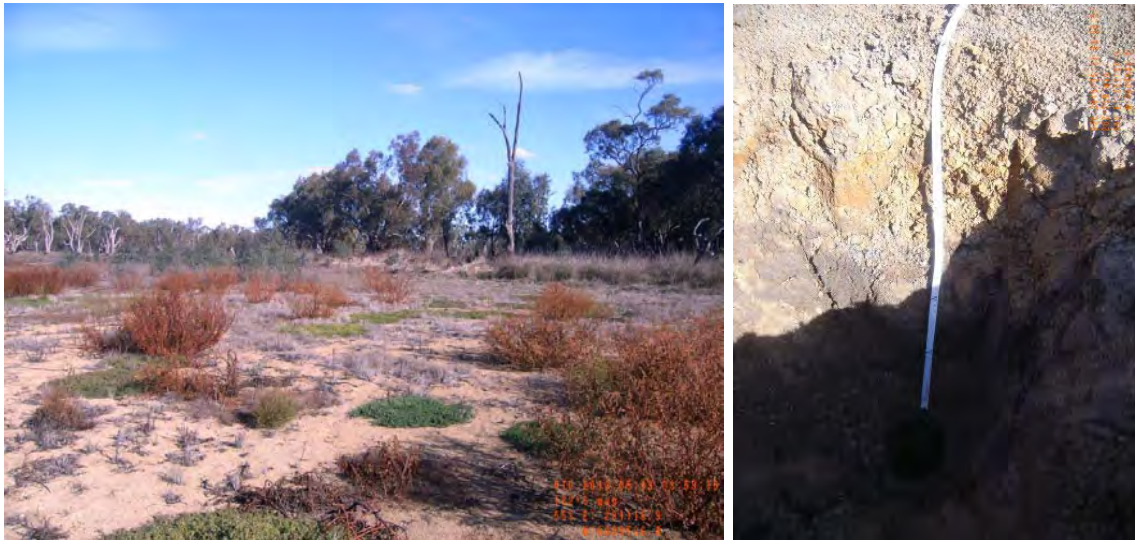
Figure 5 – Photographs of site 40590_3, showing the surface condition and the soil profile of strong, dark greyish brown clay overlying very firm, brown clay.

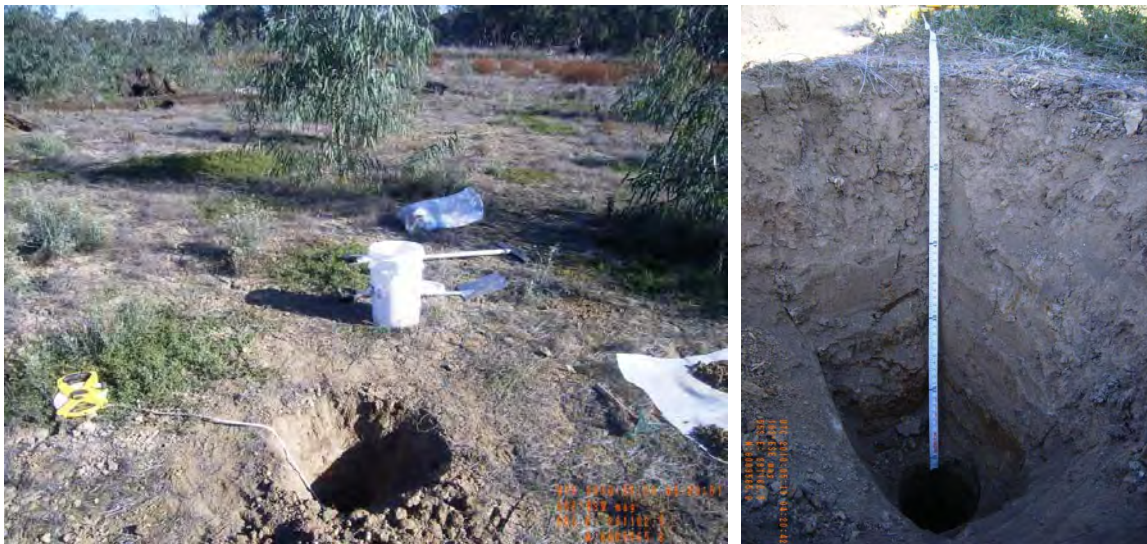
Figure 6 – Photographs of site 40590_4, showing the surface condition and the soil profile of strong, very dark greyish brown silty clay loam overlying very firm, dark greyish brown clay.

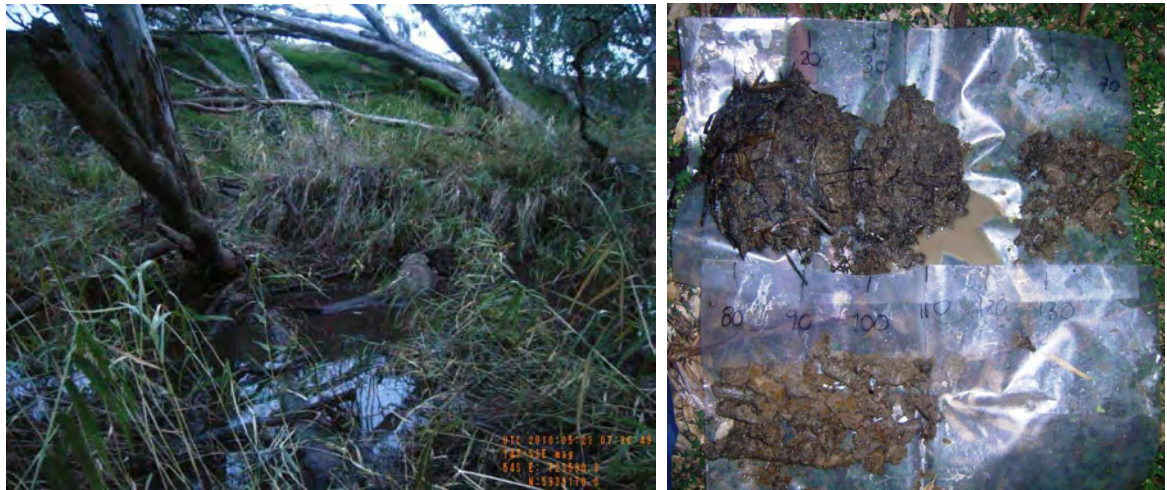
Figure 3 – Photographs of site 40851_1, showing the water surface (water column of 50cm), and the laid out soil profile of very soft, dark yellowish brown clay loam overlying very weak, dark greyish brown silty and sandy clay loam.

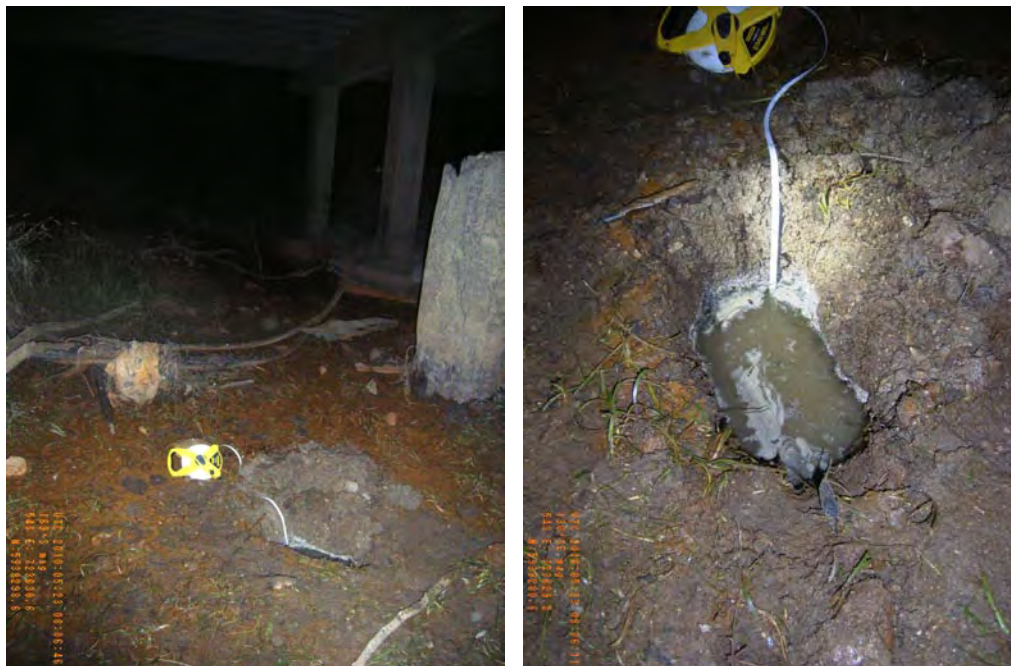
Figure 4 – Photographs of site 40851_2, showing the surface condition and the soil profile of very soft, dark yellowish brown sandy clay loam overlying very weak, dark greyish brown silty and clay loam sandy.

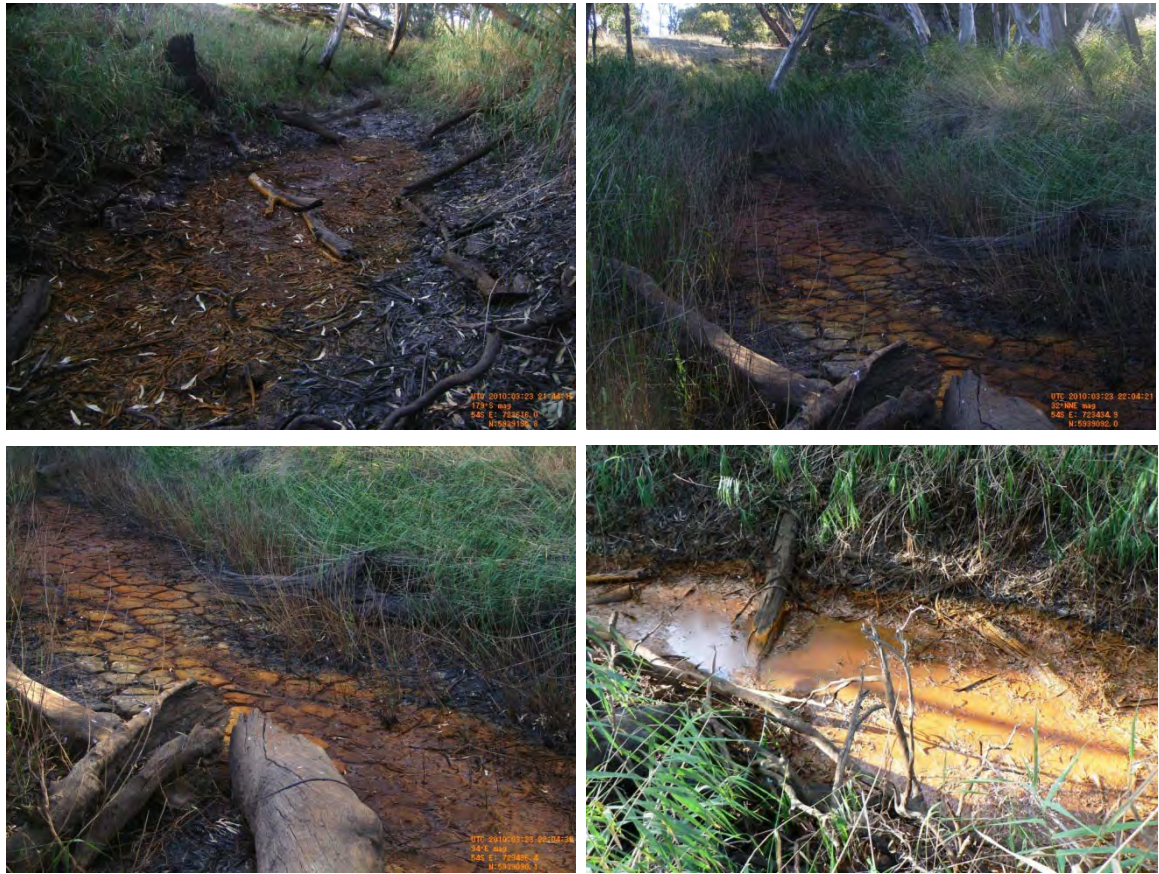
Figure 5 – Photographs of site 40851, showing wetland during a site visit by SMEC in March 2010. The photographs show the dryer state of the wetland channel and the iron and mineral surface deposits within the channel floor.

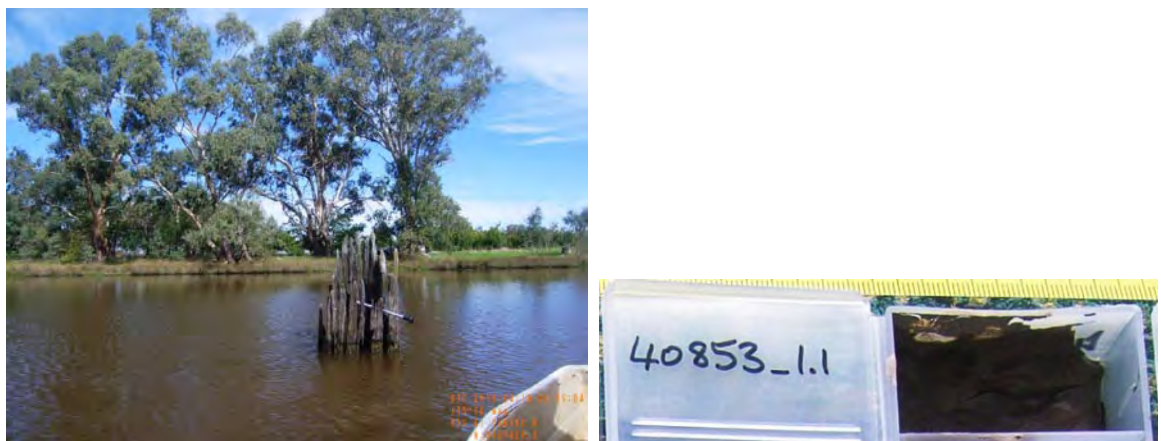
Figure 3 – Photographs of site 40853_1, showing the water surface (water column of 220cm), and the chip tray soil profile of very soft, dark greenish grey silty clay.

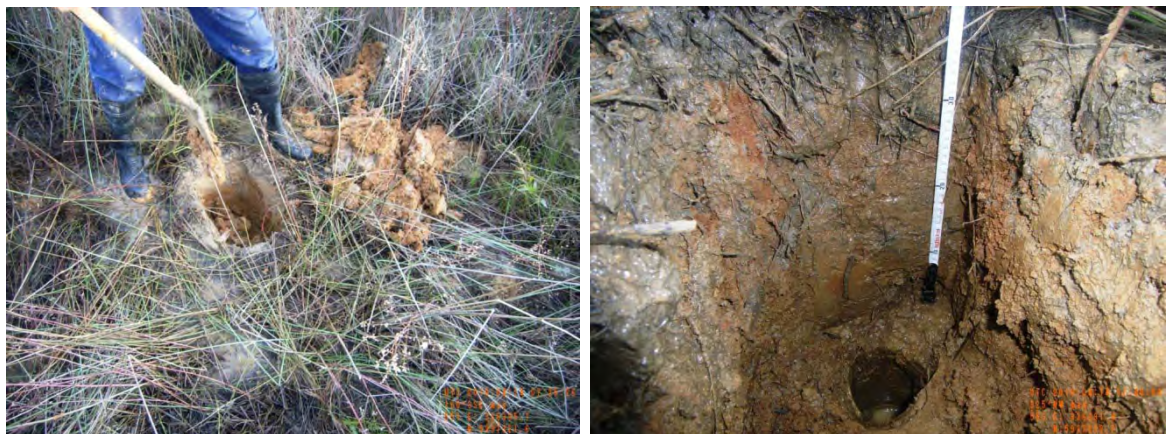
Figure 4 – Photographs of site 40853_2, showing the surface condition and the soil profile of soft, dark yellowish brown clay loam and clay overlying firm, yellowish brown clay.

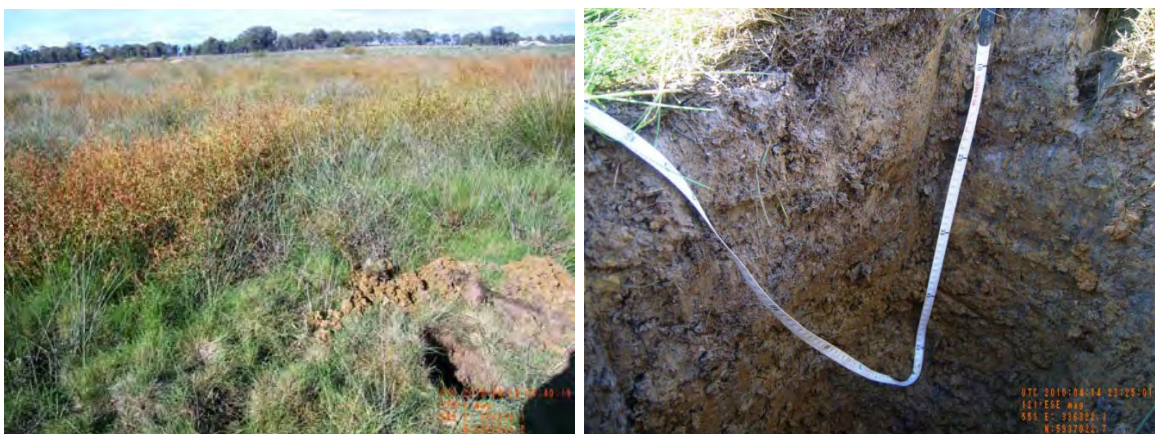
Figure 7 – Photographs of site 40853_5, showing the surface condition and the soil profile of weak, brown silty clay loam overlying firm, dark yellowish brown clay.

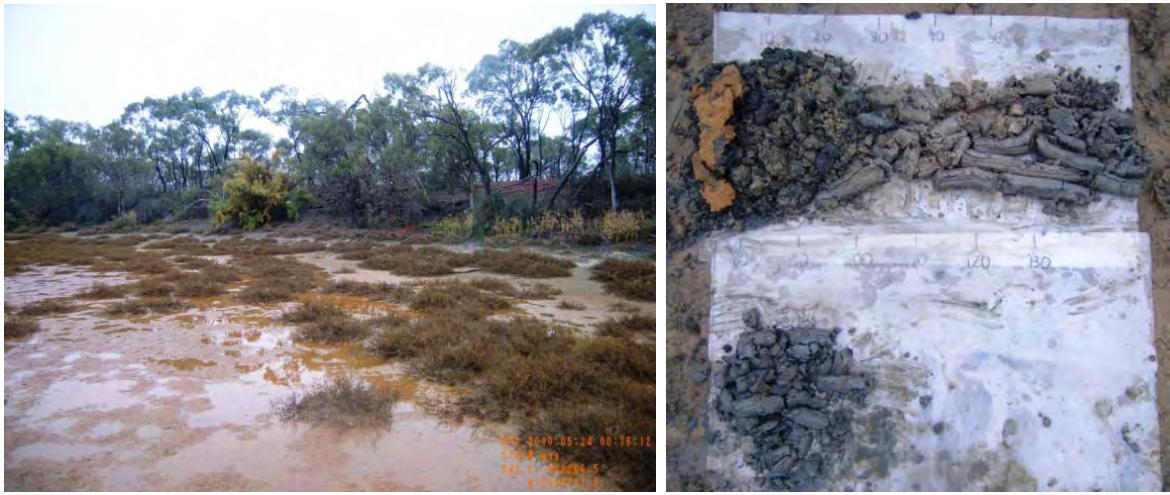
Figure 3 – Photographs of site 40855_1, showing the water surface (water column of 10cm), and the laid out soil profile of very soft, dark greyish brown silty clay loam overlying very weak, dark greyish brown and very dark greenish grey silty clay loam and clay.

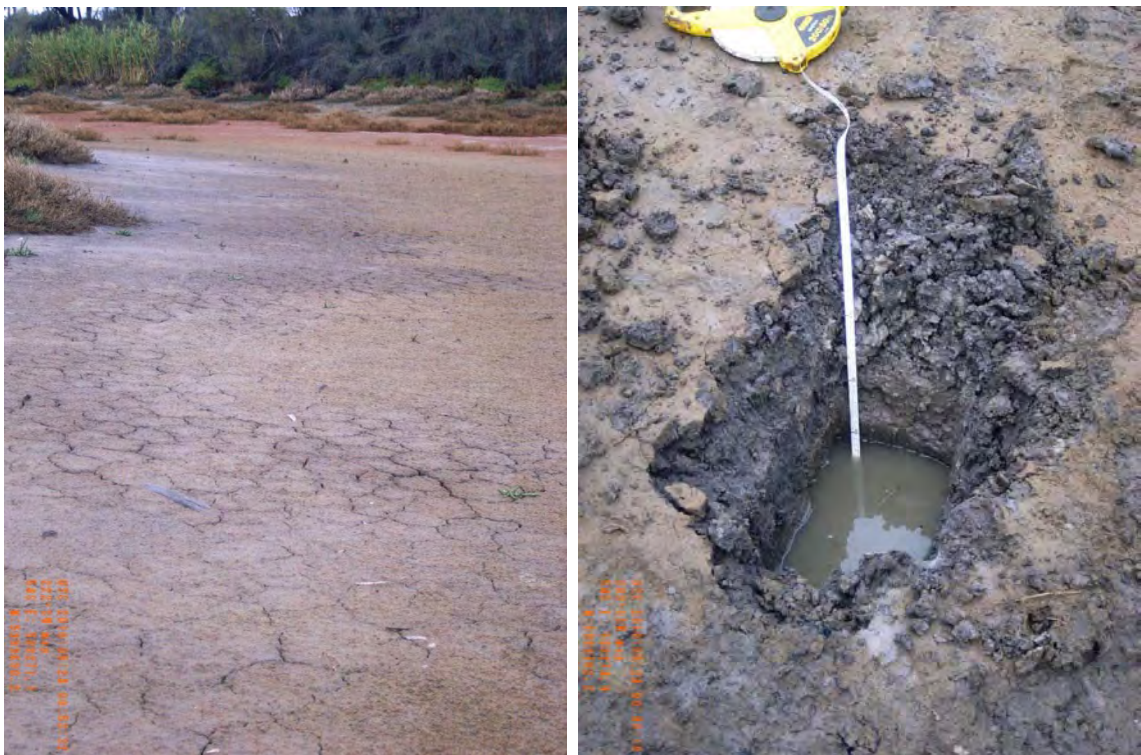
Figure 4 – Photographs of site 40855_2, showing the surface condition and the soil profile of very weak, very dark grey silty clay loam overlying firm, greyish brown, silty clayey sand.

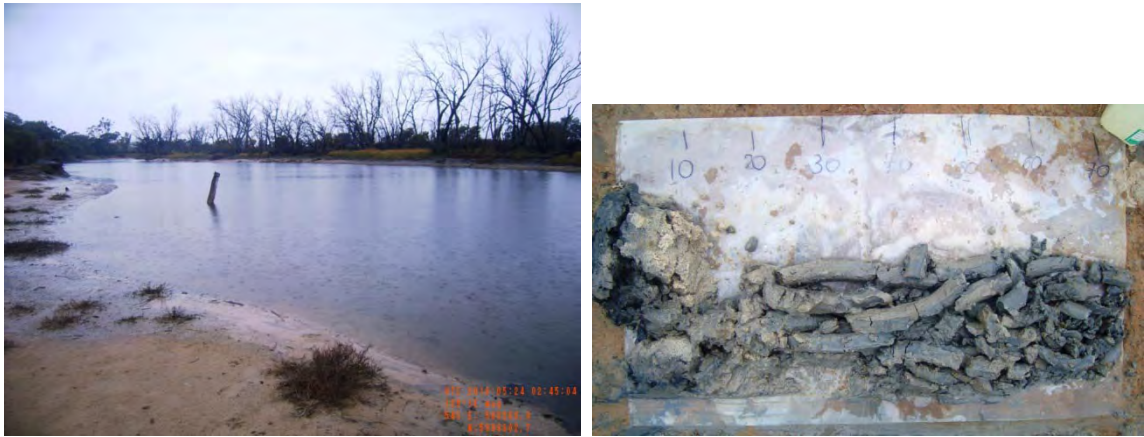
Figure 5 – Photographs of site 40855_3, showing the water surface (water column of 70cm), and the laid out soil profile of very soft, greyish brown clayey sand overlying weak, dark grey clayey sand and sandy clay.

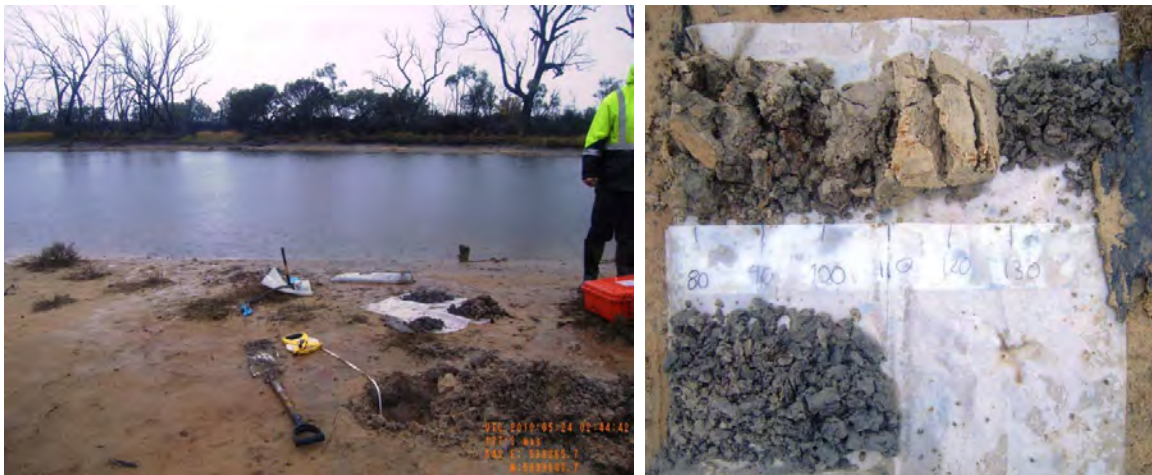
Figure 6 – Photographs of site 40855_4, showing the surface condition and the laid out soil profile of very weak, dark greyish brown sandy clay loam overlying weak, very dark grey, loamy sand and clay loam.

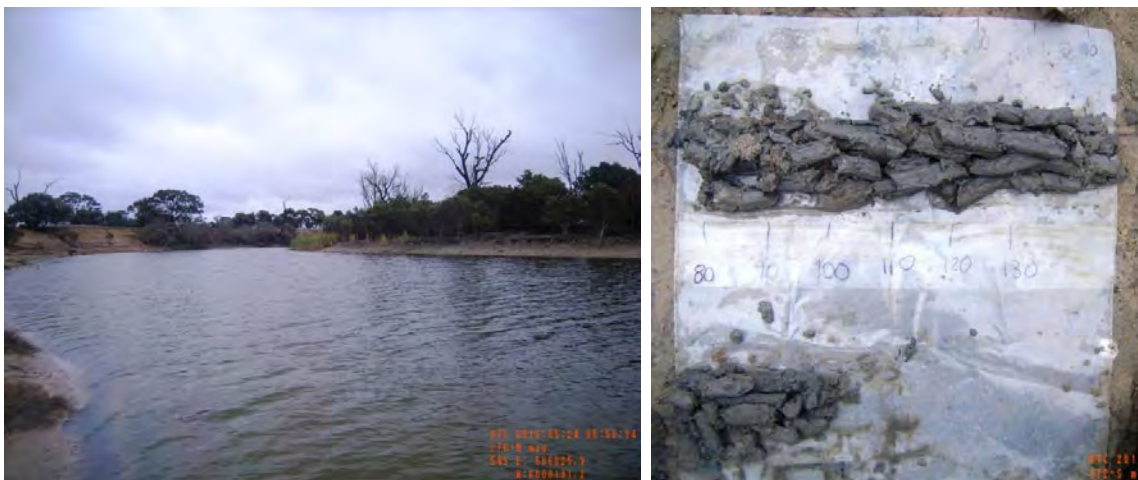
Figure 7 – Photographs of site 40855_5, showing the water surface (water column of 40cm), and the laid out soil profile of very weak, dark grey sandy loam overlying weak, dark grey to bluish grey sandy clay loam.

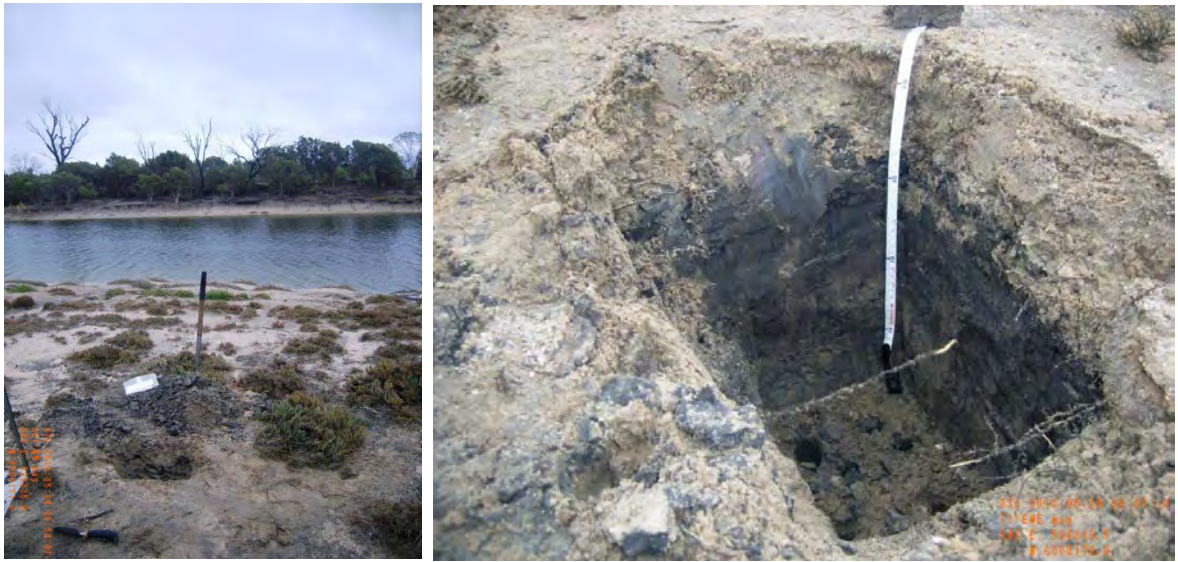
Figure 8 – Photographs of site 40855_6, showing the surface condition and the soil profile of loose, black sand and loamy sand overlying firm, dark grey, silty clay loam.

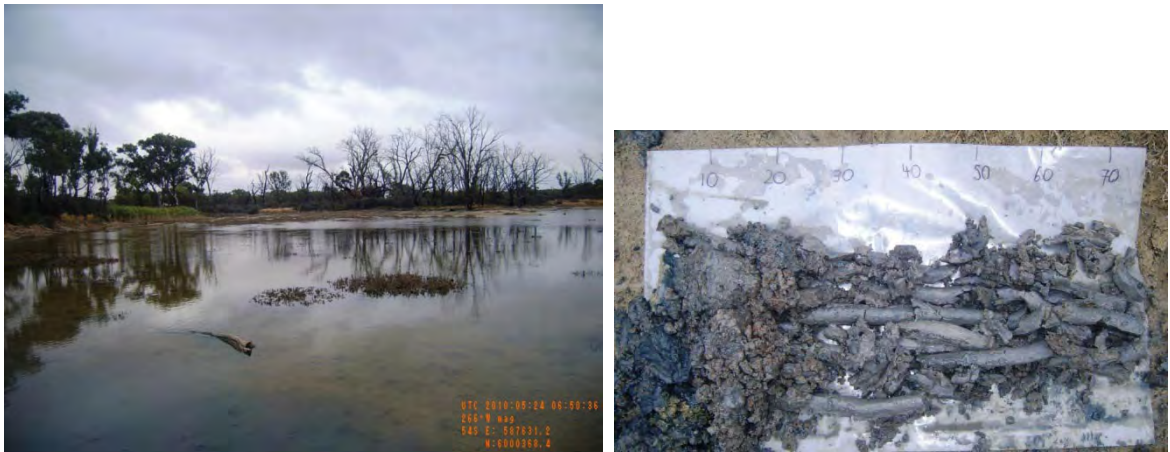
Figure 9 – Photographs of site 40855_7, showing the water surface (water column of 18cm), and the laid out soil profile of very soft, dark grey silty loam overlying weak, dark grey silty clay loam.

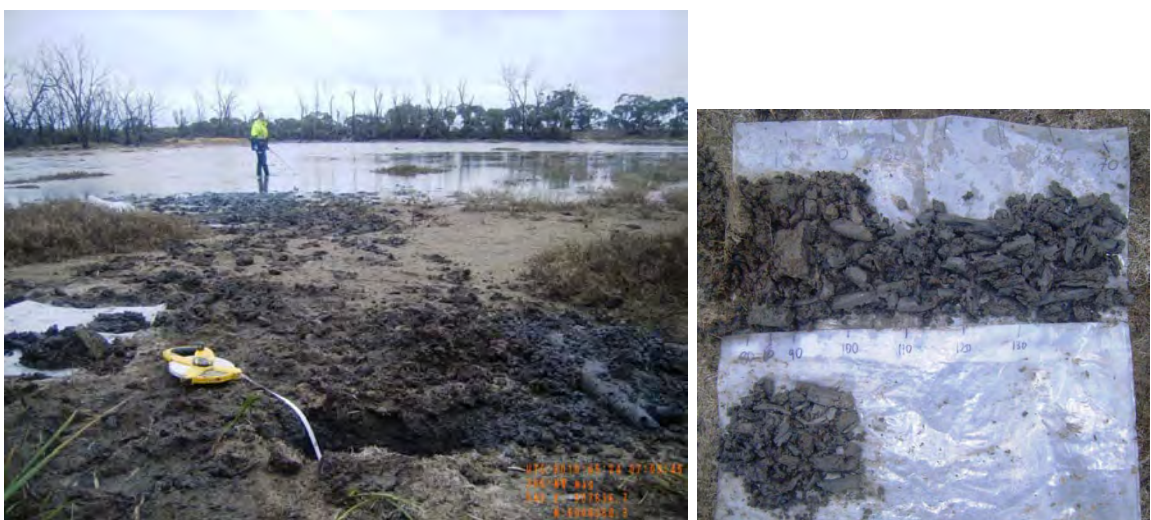
Figure 10 – Photographs of site 40855_8, showing the surface condition and the soil profile of very soft, very dark grey, silty clay loam overlying firm, very dark grey, sandy clay loam.

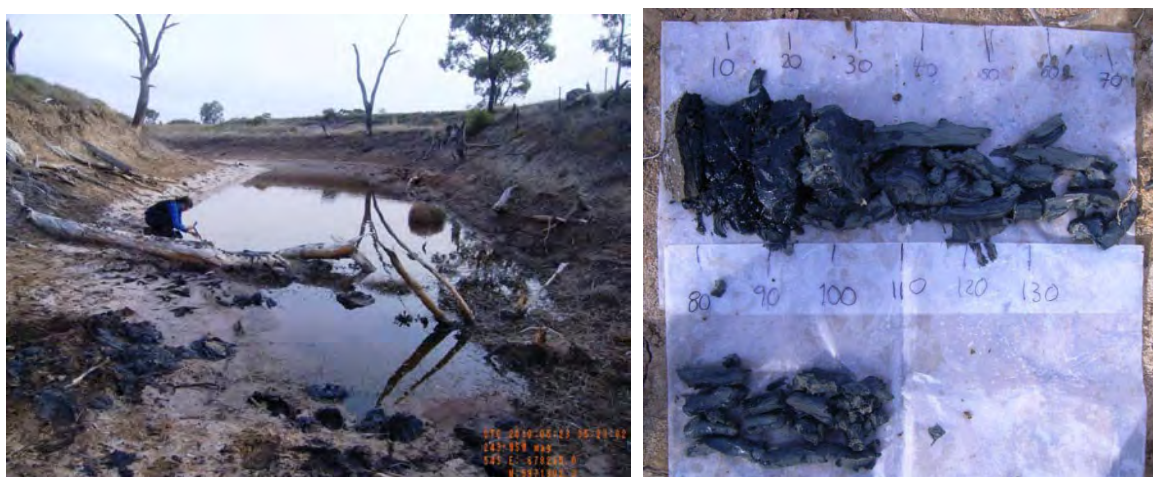
Figure 3 – Photographs of site 40858_1, showing the water surface (water column of 30cm), and the laid out soil profile of very soft, dark greyish brown to black (MBO) sandy clay loam and silty clay loam overlying very soft to firm, dark greenish grey silty clay loam.

- 40858_1: all samples have $pH_w < 8.0$. Surface soils (0 - 15cm) have pH_w 7.07 – 7.57 with subsoils (15 – 110cm) ranging 7.51 – 7.90. Surface soils $pH_{\text{incubation}}$ ranged 5.55 – 6.77 indicating hyposulfidic and monosulfidic conditions. Subsoils $pH_{\text{incubation}}$ ranged 6.64 – 6.76 indicating hyposulfidic conditions.

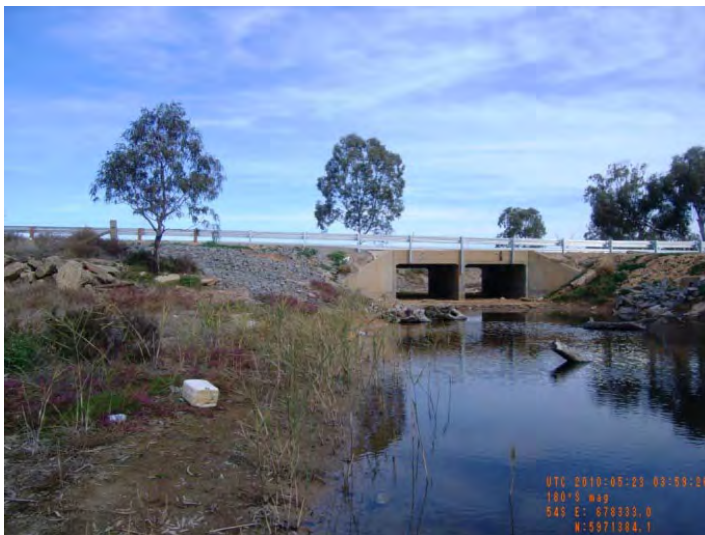
Figure 5 – Photographs of site 40859_1, showing the surface condition (no soil materials were collected here, only one water sample).

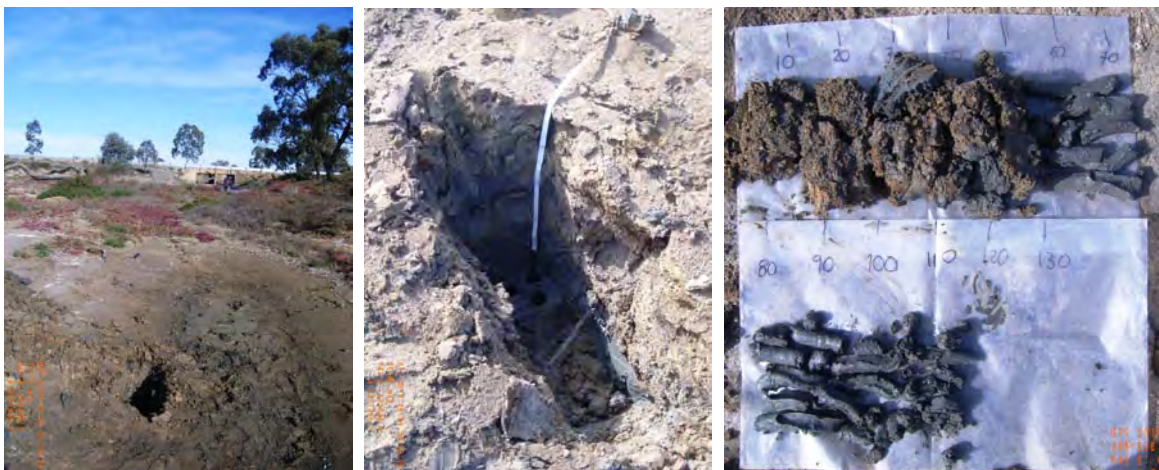
Figure 6 – Photographs of site 40859_2, showing the surface condition and soil profile of loose, dark greyish brown clay loam overlying soft, greenish black silty clay loam.

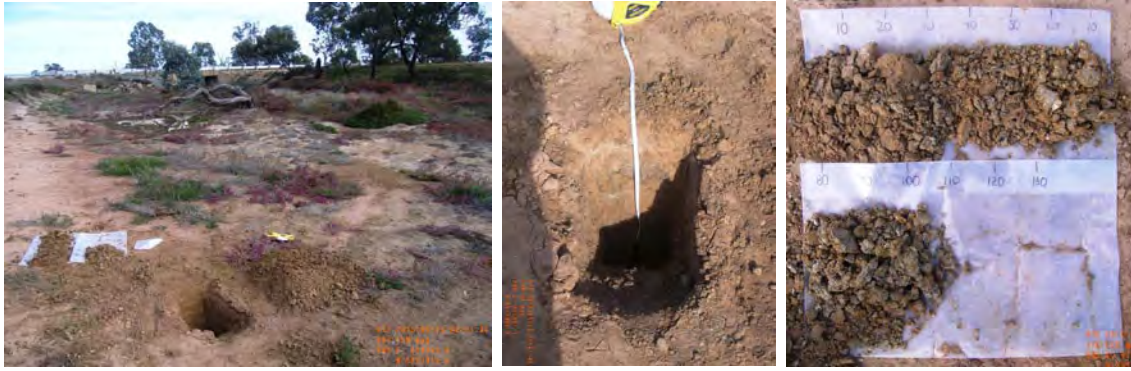
Figure 7 – Photographs of site 40859_3, showing the surface condition and the soil profile of durri crust and weak, dark greyish brown clayey sand overlying very firm, grey clay loam sandy.

- 40859_3: all samples have $pH_w < 8.5$. Surface soils (0 - 15cm) have pH_w 8.03 – 8.24 with subsoils (15 – 100cm) ranging 8.10 – 8.24. Surface soils $pH_{\text{incubation}}$ ranged 6.83 – 7.31 indicating hyposulfidic and other soil conditions. Subsoils $pH_{\text{incubation}}$ ranged 7.13 – 7.19 indicating other soil conditions.

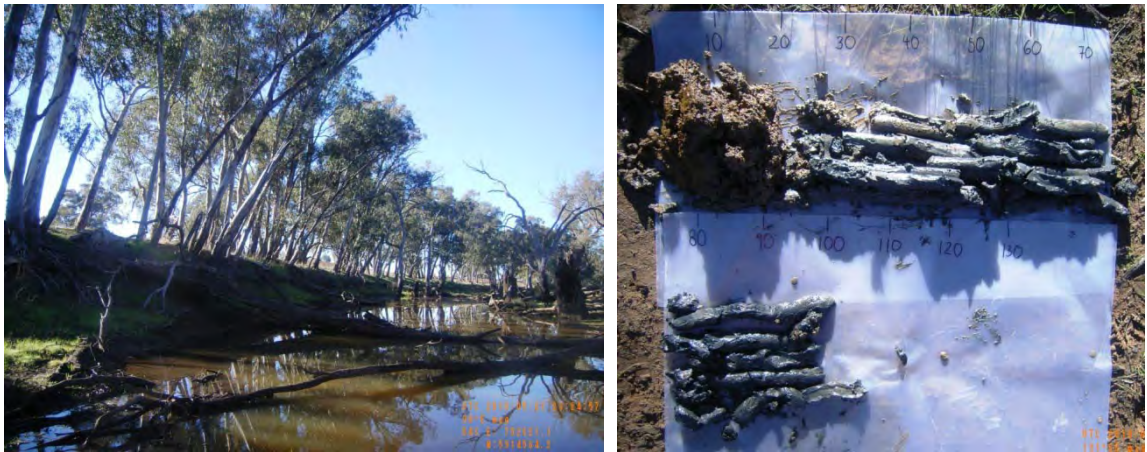
Figure 3 – Photographs of site 40860_1, showing the water surface (water column of 40cm), and the laid out soil profile of soft, dark yellowish brown silty clay loam overlying very weak, black silty clay loam.
