Assessment of Acid Sulfate Soil Materials in the Victorian Northern Flowing Rivers Region of the Murray-Darling Basin

Phase 1 Inland Acid Sulfate Soil Detailed Assessment within the Victorian Northern Flowing Rivers Region

For: Murray Darling Basin Authority

OCTOBER, 2010

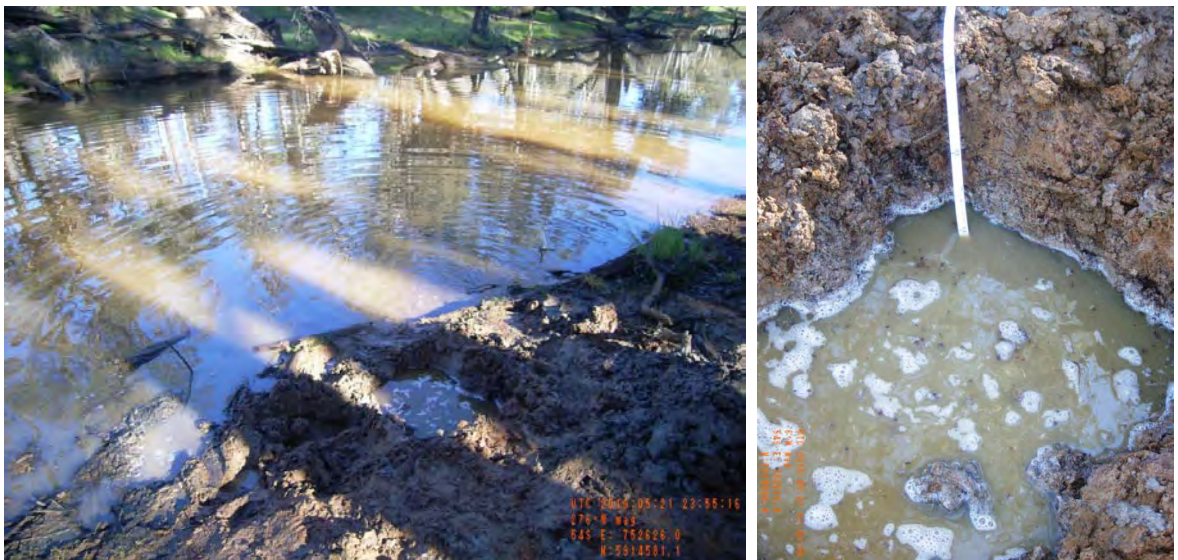
Figure 4 – Photographs of site 40860_2, showing the water surface condition and the soil profile of loose, greyish brown sandy clay loam and silty clay loam overlying soft, dark grey clay.

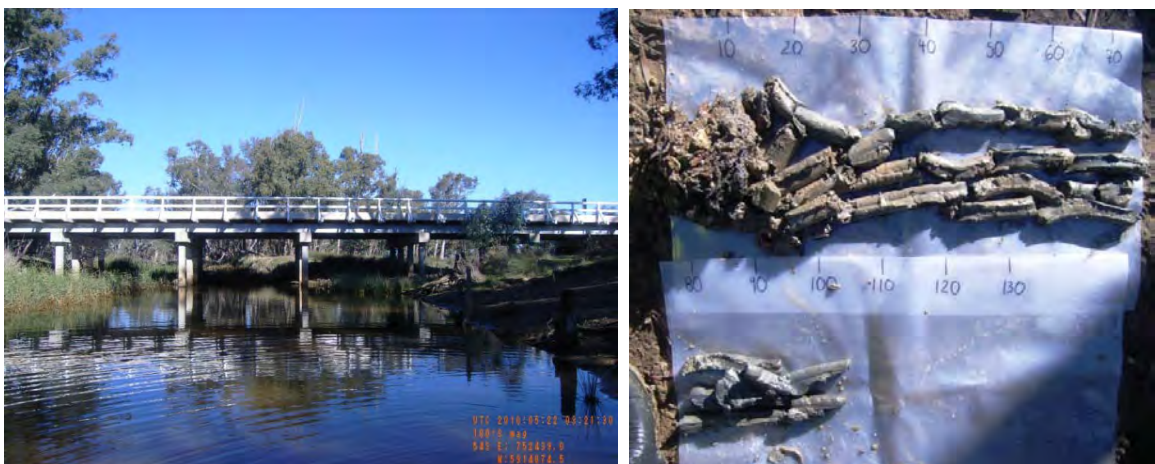
Figure 5 – Photographs of site 40860_3, showing the water surface (water column of 45cm), and the laid out soil profile of loose to weak, brown silty loam and clay overlying soft, very dark bluish grey silty clay loam.

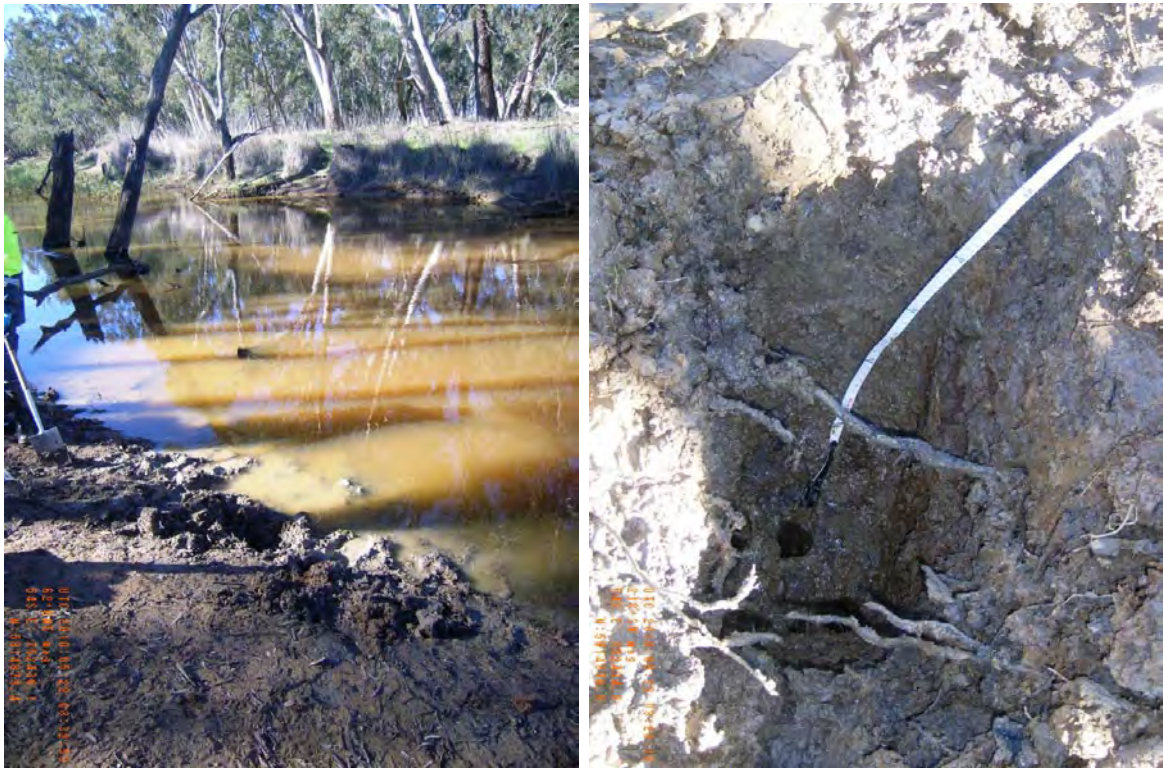
Figure 6 – Photographs of site 40860_4, showing the surface condition and the soil profile of soft, dark brown silty clay loam overlying very weak, dark greyish brown clay.

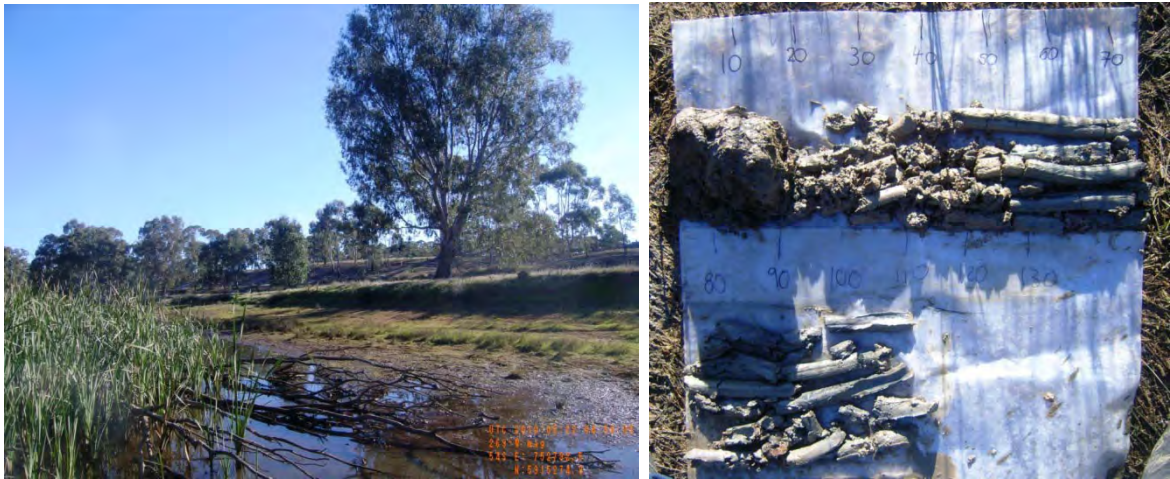
Figure 7 – Photographs of site 40861_1, showing the surface condition and the soil profile of weak, dark grayish brown silty clay loam overlying soft, dark grey clay.

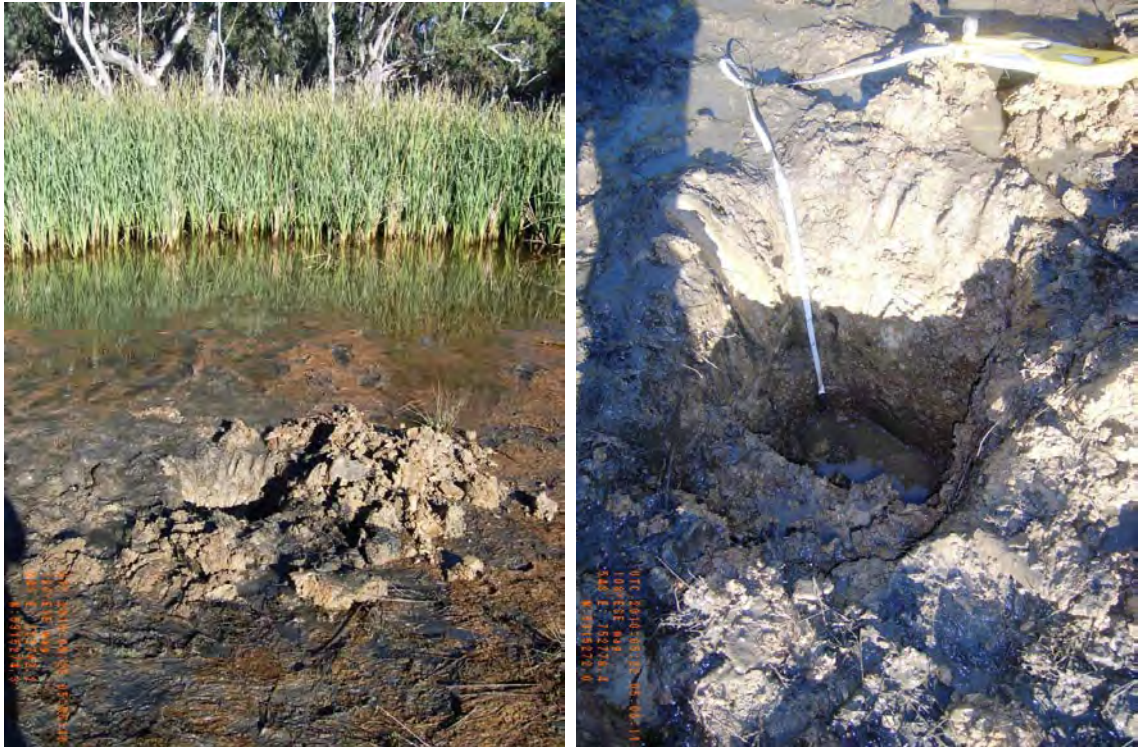
Figure 8 – Photographs of site 40861_2, showing the surface condition and the soil profile of very soft, yellowish brown clay loam and clay overlying very weak, very dark greyish brown silty clay loam.

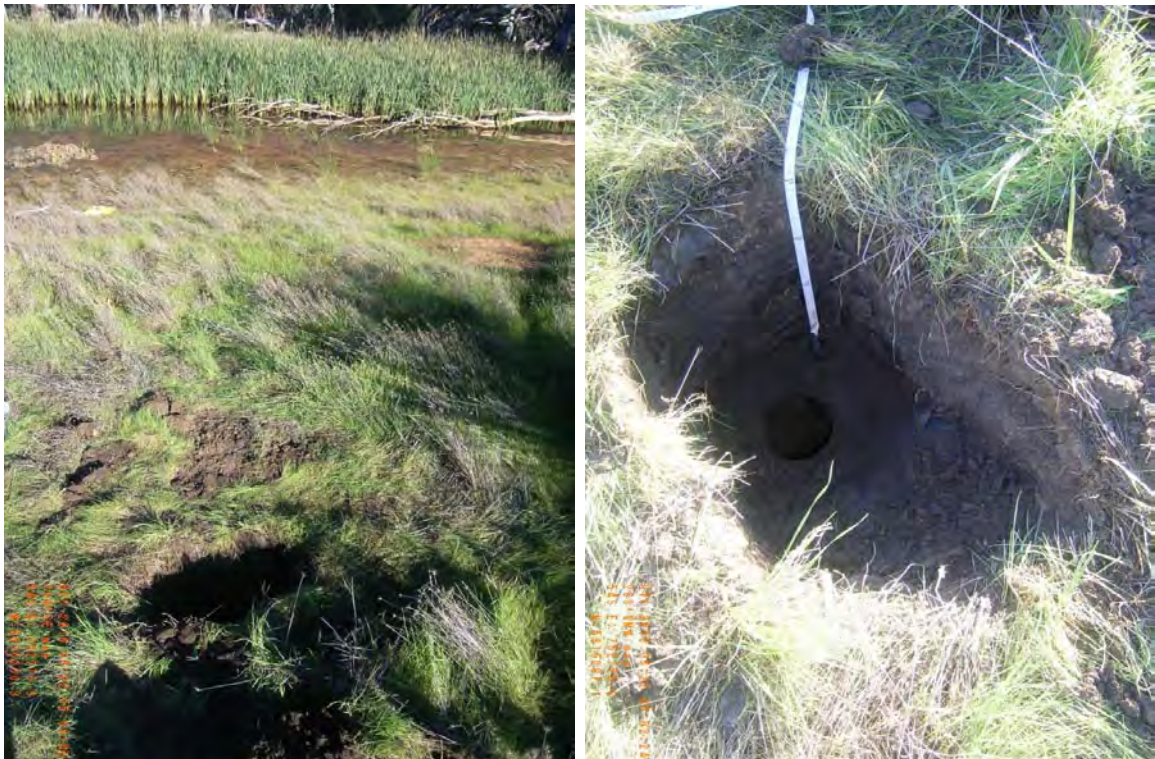
Figure 9 – Photographs of site 40861_3, showing the surface condition and the soil profile of loose to very weak, very dark greyish brown clay loam and silty clay loam overlying very weak, dark, yellowish brown sandy clay loam.

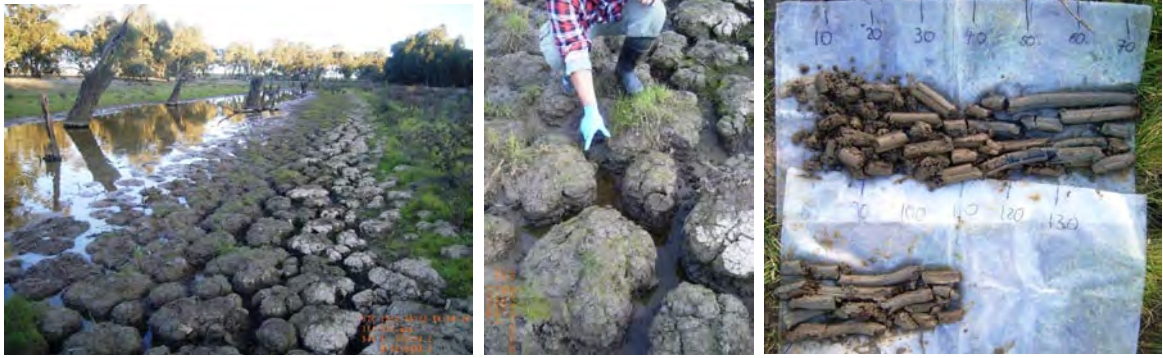
Figure 10 – Photographs of site 40861_4, showing the surface condition and the soil profile of very weak, brown silty clay loam overlying weak, brown some grey brown clay.

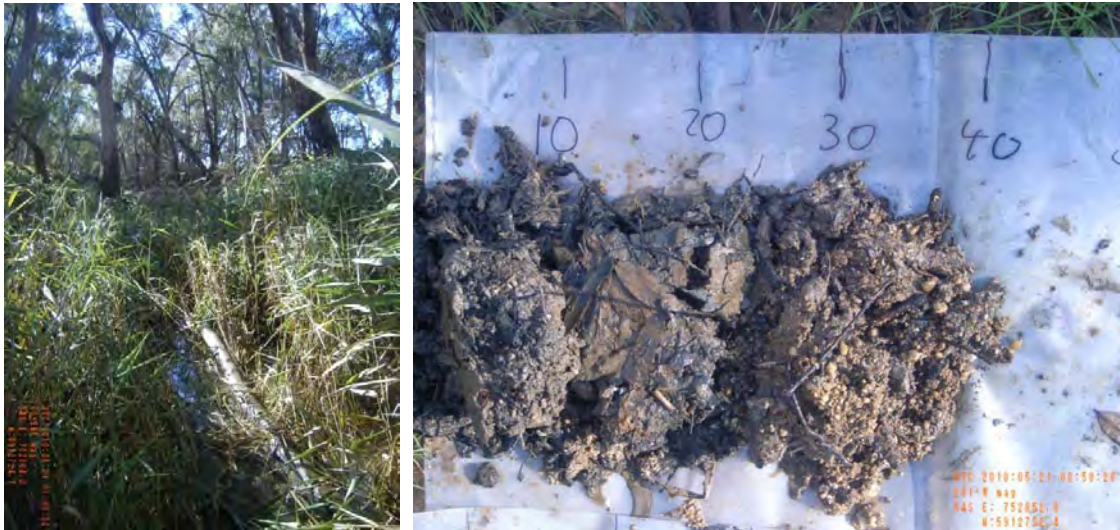
Figure 11 – Photographs of site 40862_1, showing the surface condition and the soil profile of loose, dark brown loam overlying loose, brown clayey sand.

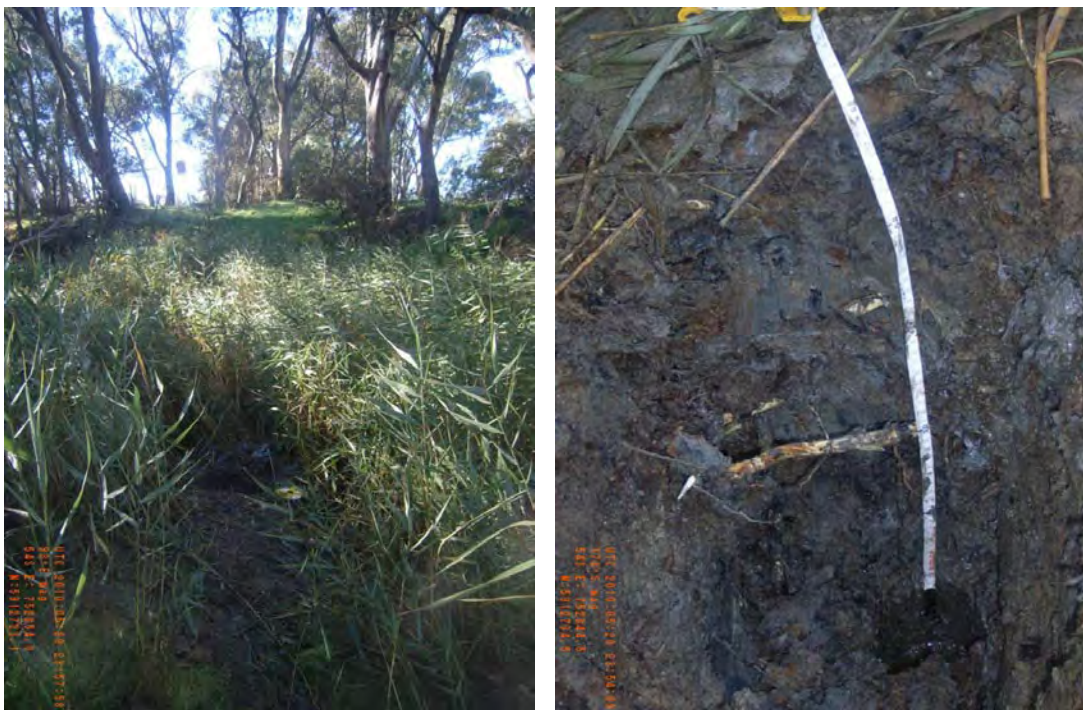
Figure 12 – Photographs of site 40862_2, showing the surface condition and the soil profile of very dark brown sandy loam overlying soft, bluish black silty clay loam.

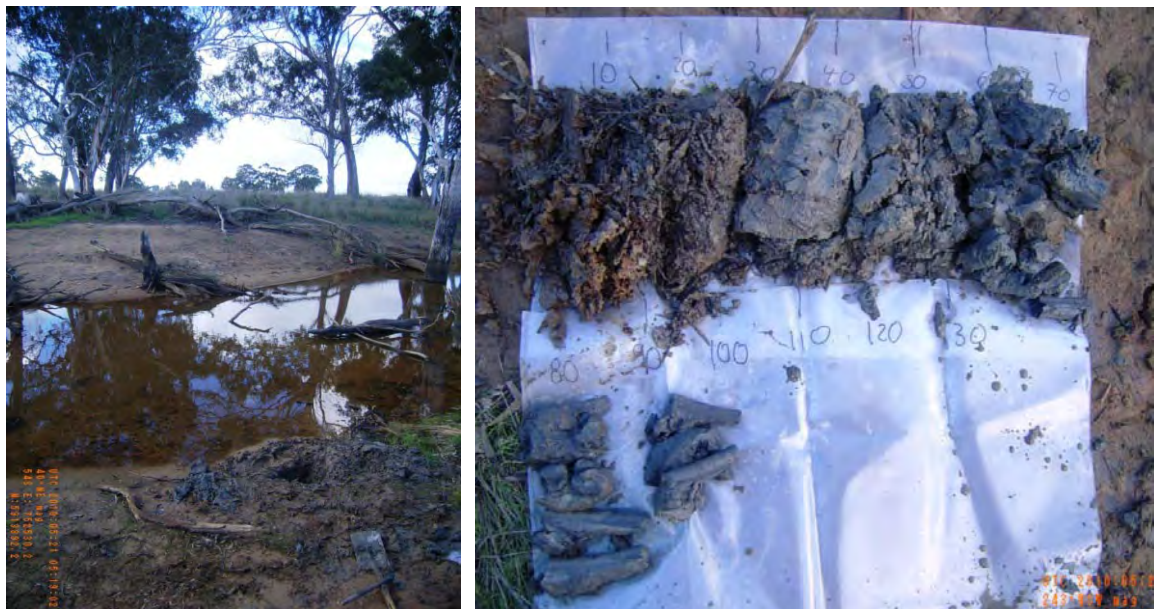
Figure 14 – Photographs of site 40863_2, showing the surface condition and the soil profile very soft, dark grey to dark brown clay loam overlying soft, dark greenish grey clay.
